Monitoring of Animal  
Underpasses on National  
Highway 44 (Earlier 7) Passing  
Through Pench Tiger Reserve,  
Maharashtra

ECOLOGICAL IMPACT ASSESSMENT OF EXISTING AND PROPOSED  
ROAD INFRASTRUCTURE ON IMPORTANT WILDLIFE CORRIDORS IN  
INDIA FOR STRATEGIC PLANNING OF SMART GREEN  
INFRASTRUCTURE

**Citation:** *Habib, B., Saxena, A., Jhala, Y. V. and Rajvanshi, A. (2020): Monitoring of animal underpasses on National Highway 44 (Earlier 7) passing through Pench Tiger Reserve, Maharashtra, India. TR. No. 2020/09 – Pp 30.*

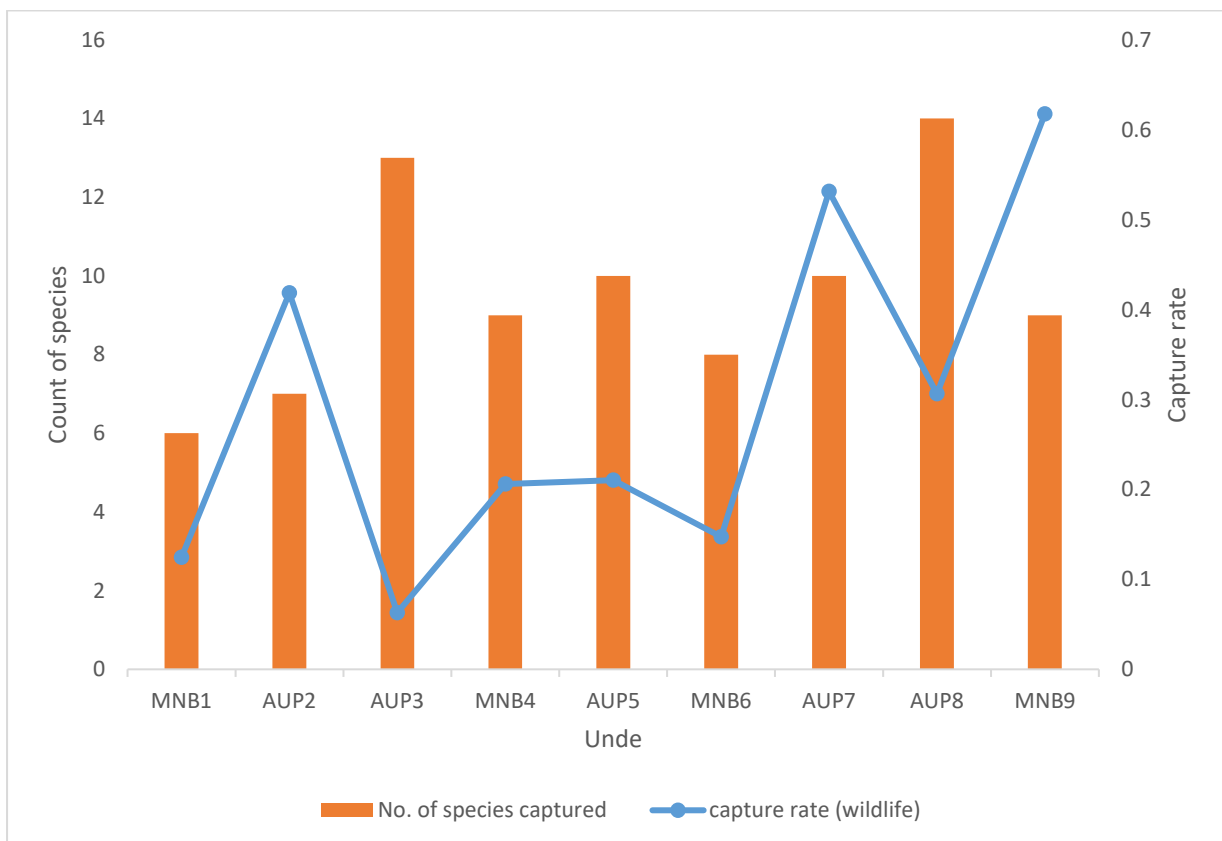
**Figure 3:** Capture rates and number of wild species recorded under different crossing structures

Among crossing structures, higher capture rates for wildlife (wild animals captured per camera per day) were recorded under AUP7 (100m) and MNB9 (50m). Highest number of species were captured under AUP8 (14 species), followed by AUP3 (13 species) (Figure 3).

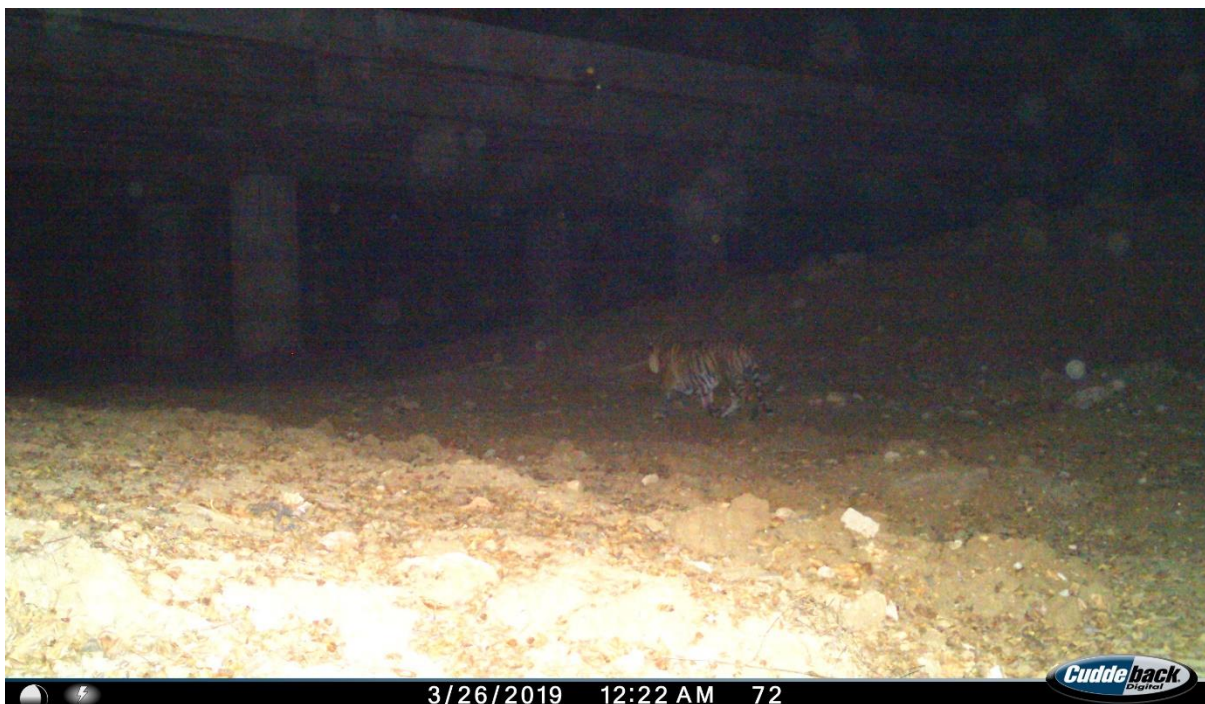
Wildlife were observed to use the crossing structures in two ways: crossing – which is the movement of animals across (perpendicular to) the structure (Figure 5(a)), and use – which is the movement of animals near the underpass either grazing or walking parallel to the structure and not crossing (Figure 5(b)). For a single individual/group of individuals, one or both of the actions were observed.

**Figure 5 (a):** A crossing event is defined as the movement of an animal across/towards a crossing structure

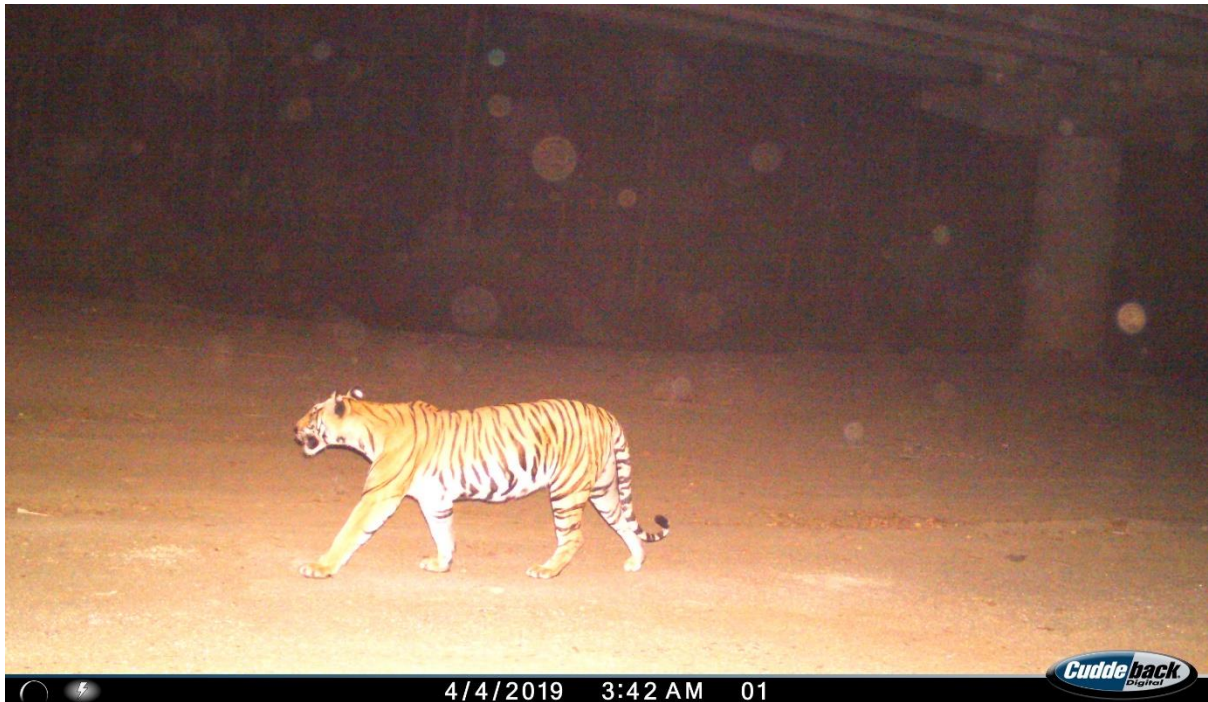
**Figure 5 (b):** Use of underpass by animal is defined as the parallel movement near the structure (not crossing).

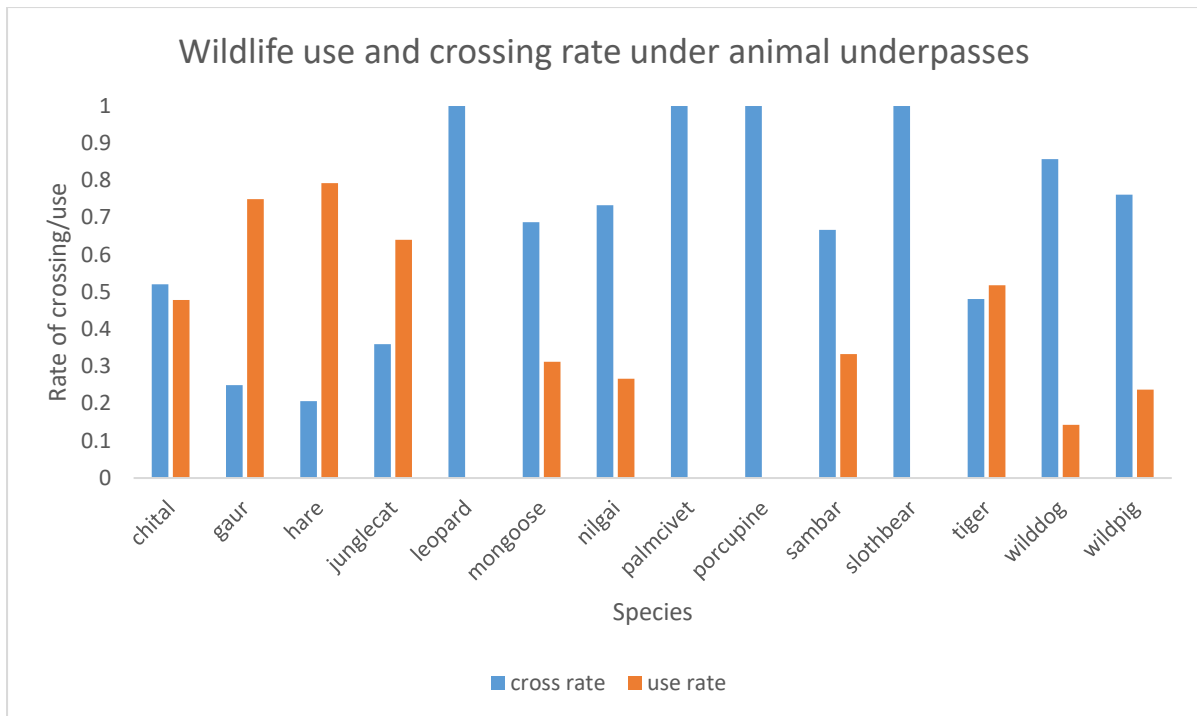
**Figure 6:** Rates of crossing and use of underpasses by wildlife

The rates at which animals crossed and used the underpasses varied between species (Figure 6). Only crossing events were recorded for leopard, palm civet, porcupine and sloth bear. Gaur, hare, jungle cat and tiger showed higher rate of use than crossing. Chital, mongoose, nilgai, sambar, wild dog and wild pig also used the crossing structures, but the rate of crossing was higher. Higher rate of use could mean greater amount of time spent under the underpasses grazing or walking parallel to the structures.

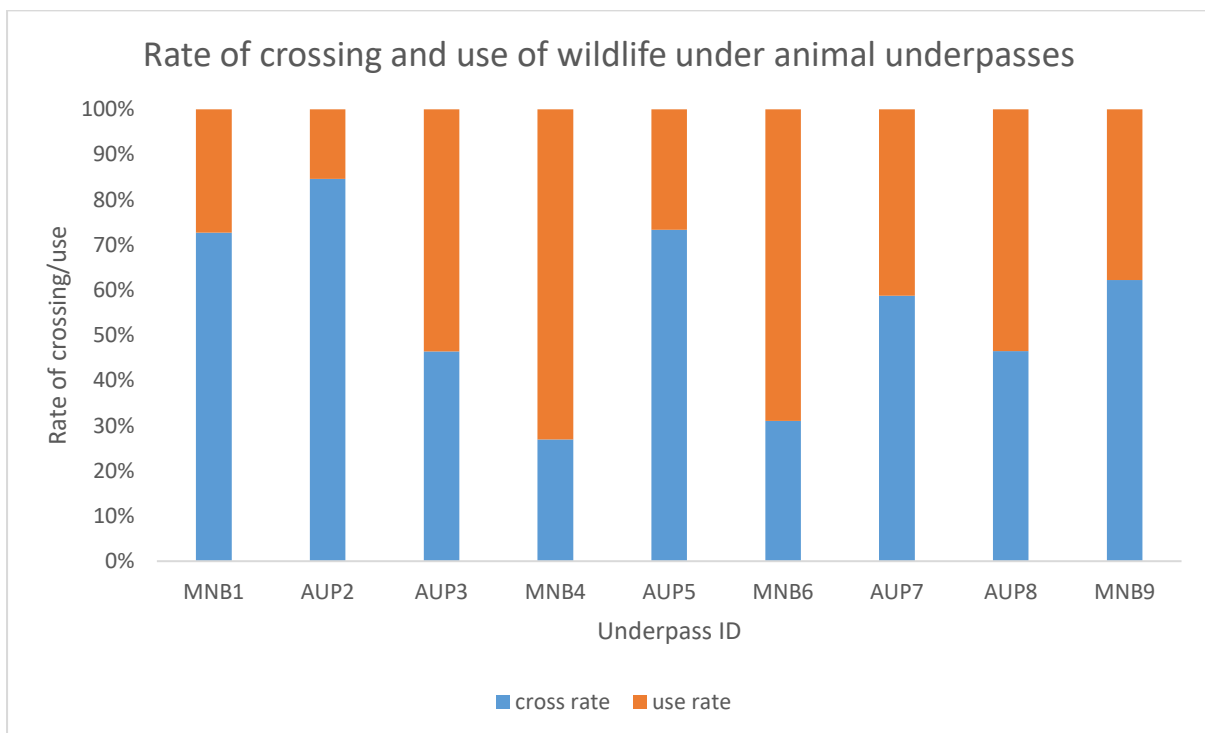
**Figure 7:** Comparison of crossing and use rates by wildlife under different underpasses.

The rates of crossing and use varied among crossing structures as well (Figure 7). Highest rate of crossing was observed under structure AUP2. In terms of number of occasions, highest number of crossings were observed under structures AUP7 and AUP8.

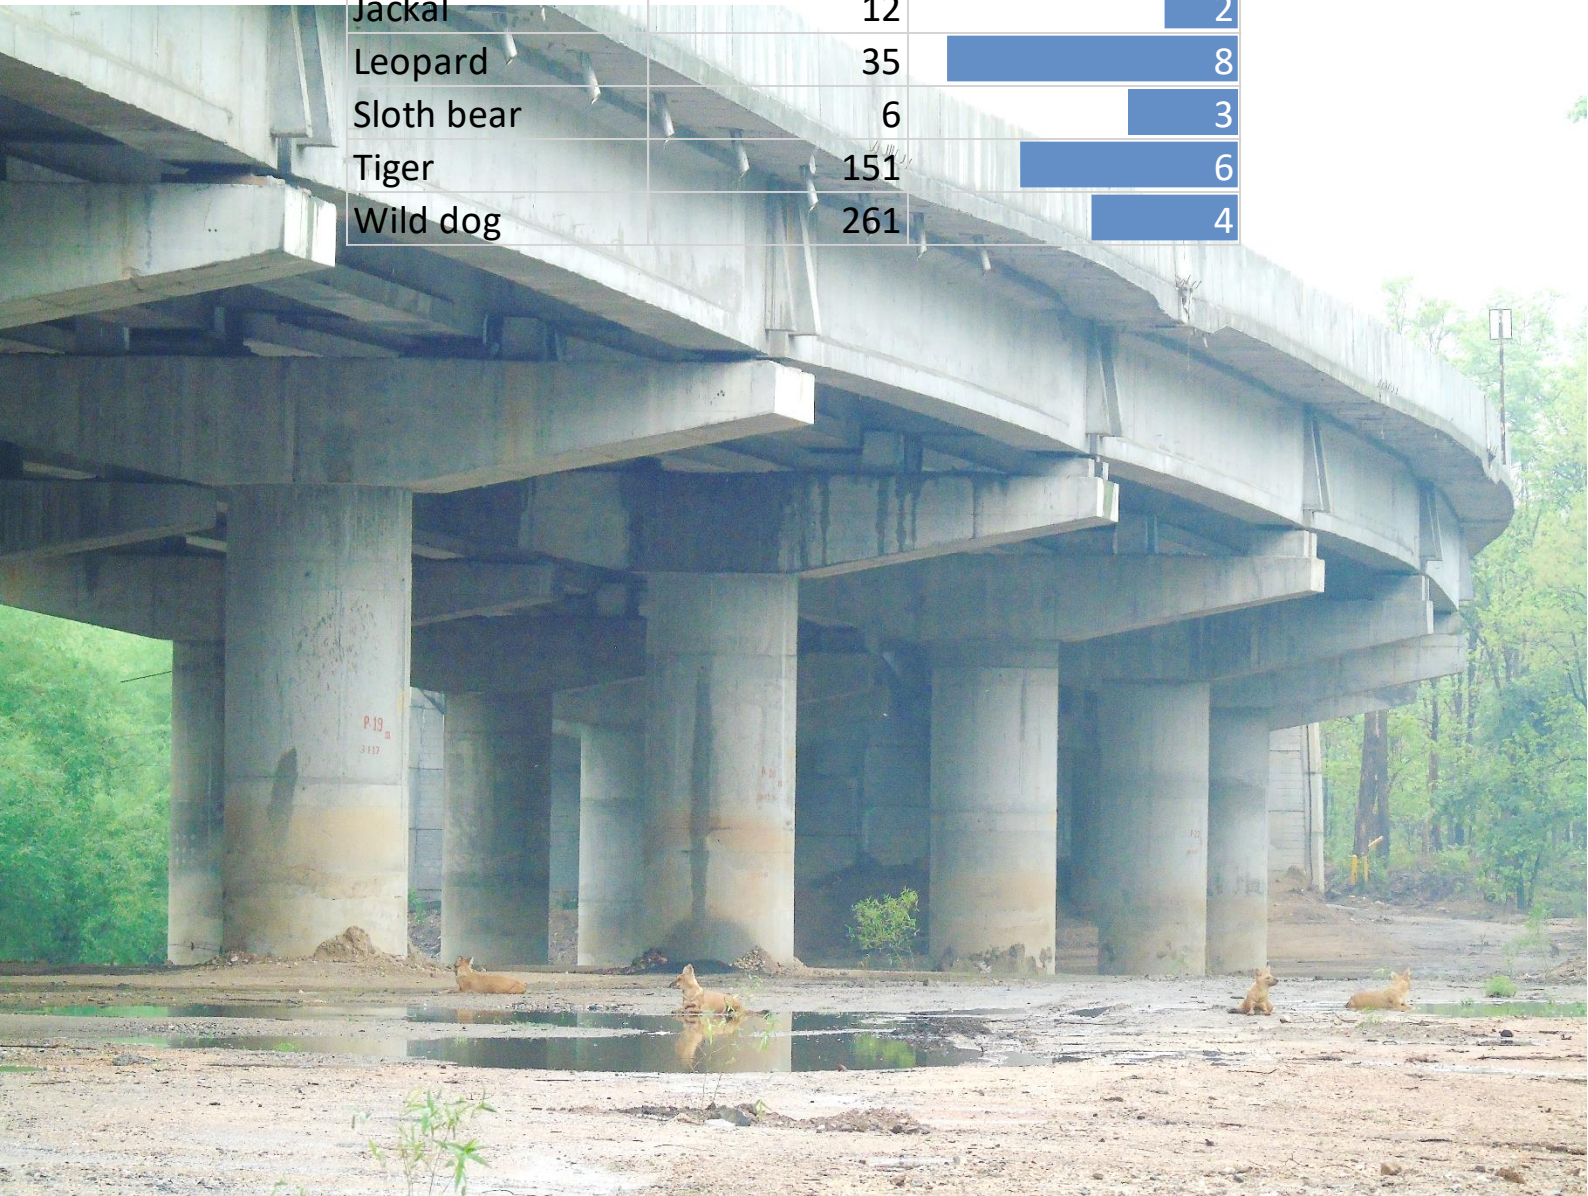
**Figure 9:** Number of captures of tigers of different age-sex classes under crossing structures

A total of 89 tiger crossings were recorded from six of the nine crossing structures. A total of 11 tiger individuals including 5 males, 3 females and 3 sub adults were identified using the crossing structures (Figure 9). 10 of the 11 recorded individuals were found to use the structures repeatedly (more than one occasion). On 25% of all crossing occasions, tigers were found to 'use' structures, i.e., they were captured on multiple camera traps walking parallel to or under the structures in the same occasion.

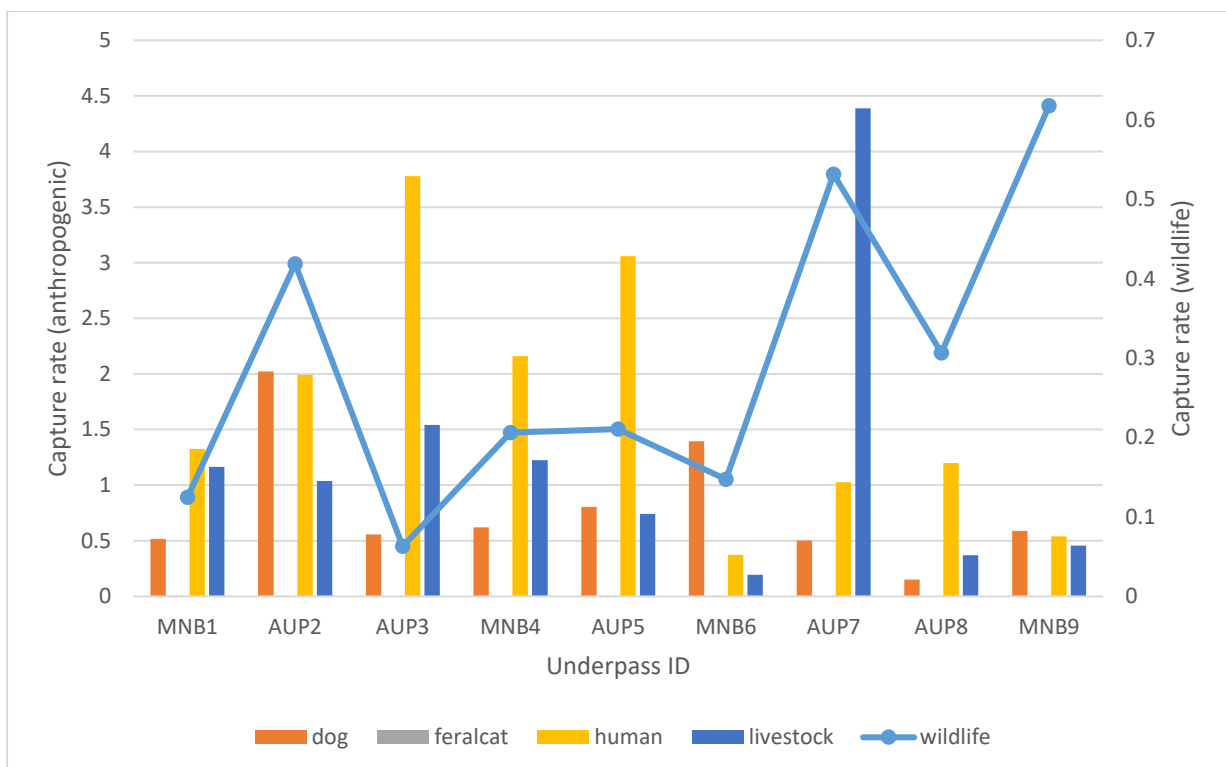
**Figure 10:** Capture rates of wild, feral and domestic animals, and humans under different underpasses

A total of 91,284 captures of humans, domestic cattle, feral and domestic cats and dogs were obtained from the underpasses (Figure 10). Presence of anthropogenic disturbances under crossing structures was found to reduce the use of the structures by wildlife.

Villagers, livestock and feral and domestic dogs have been found using 4 out of the 9 crossing structures. Fewer wild animals have been photocaptured at these structures. It is therefore suggested to take steps to reduce this anthropogenic presence in the crossing structures. The dirt roads that used to access the crossing structures could be barricaded or removed completely to reduce this access by villagers.

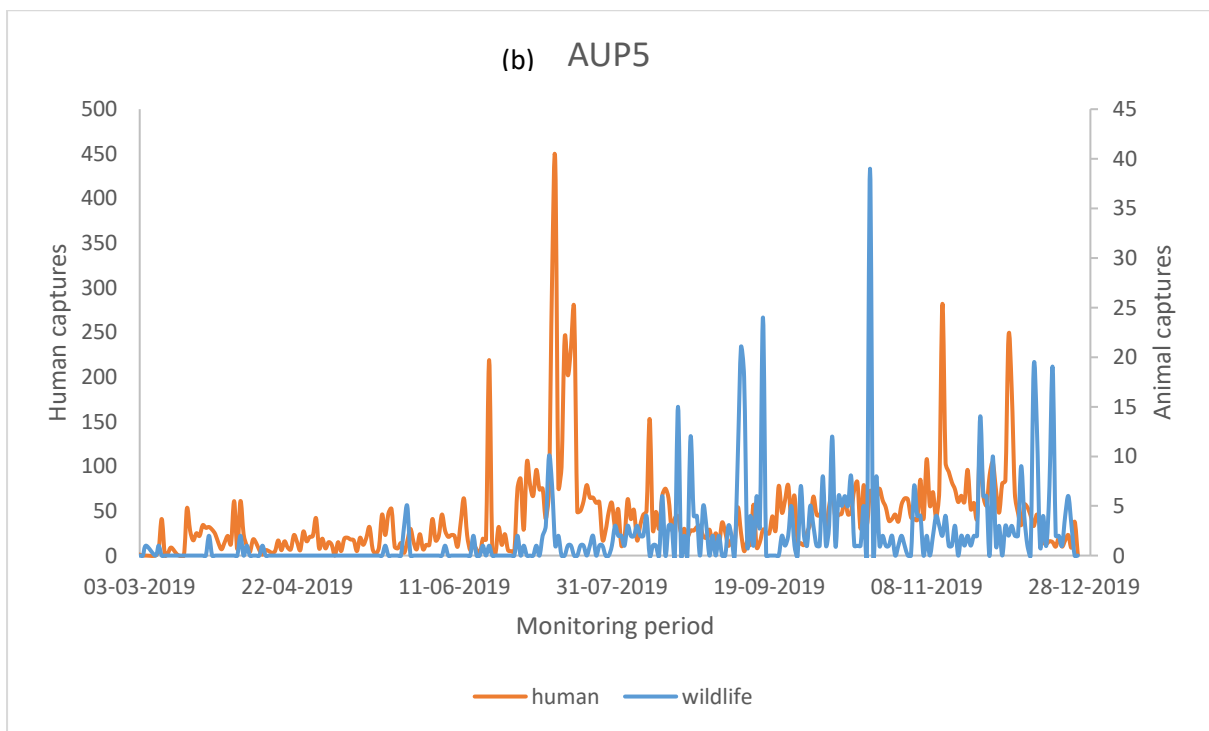
**Figure 11:** Trend of human and wild animal captures during the monitoring period under (a) AUP3, and (b) AUP5.

However, efforts to reduce human-related presence under the structures have resulted in increased use by wildlife (Figure 11 (a) and (b)). Both structures have village roads and small dirt roads that were used by the locals. However, efforts to divert and reduce the use of these roads by humans has resulted in visible increase in use of these underpasses by wildlife.

Small roads under two underpasses (AUP3 and AUP5) leading to villages (Dulara and Navegaon) are used by vehicles, and are a source of disturbance that inhibits movement of animals under these structures. These cannot be completely closed down. Therefore it is suggested to barricade these roads to prevent traffic noise and light from vehicles from causing disturbance under the structures.
