December 2020

MITIGATION MEASURES FOR DOUBLING OF THE TINIAGHAT - CASTLEROCK - CARONZOL SWR RAILWAY TRACK, KARNATAKA

भारतीय वन्यजीव संस्थान
Wildlife Institute of India

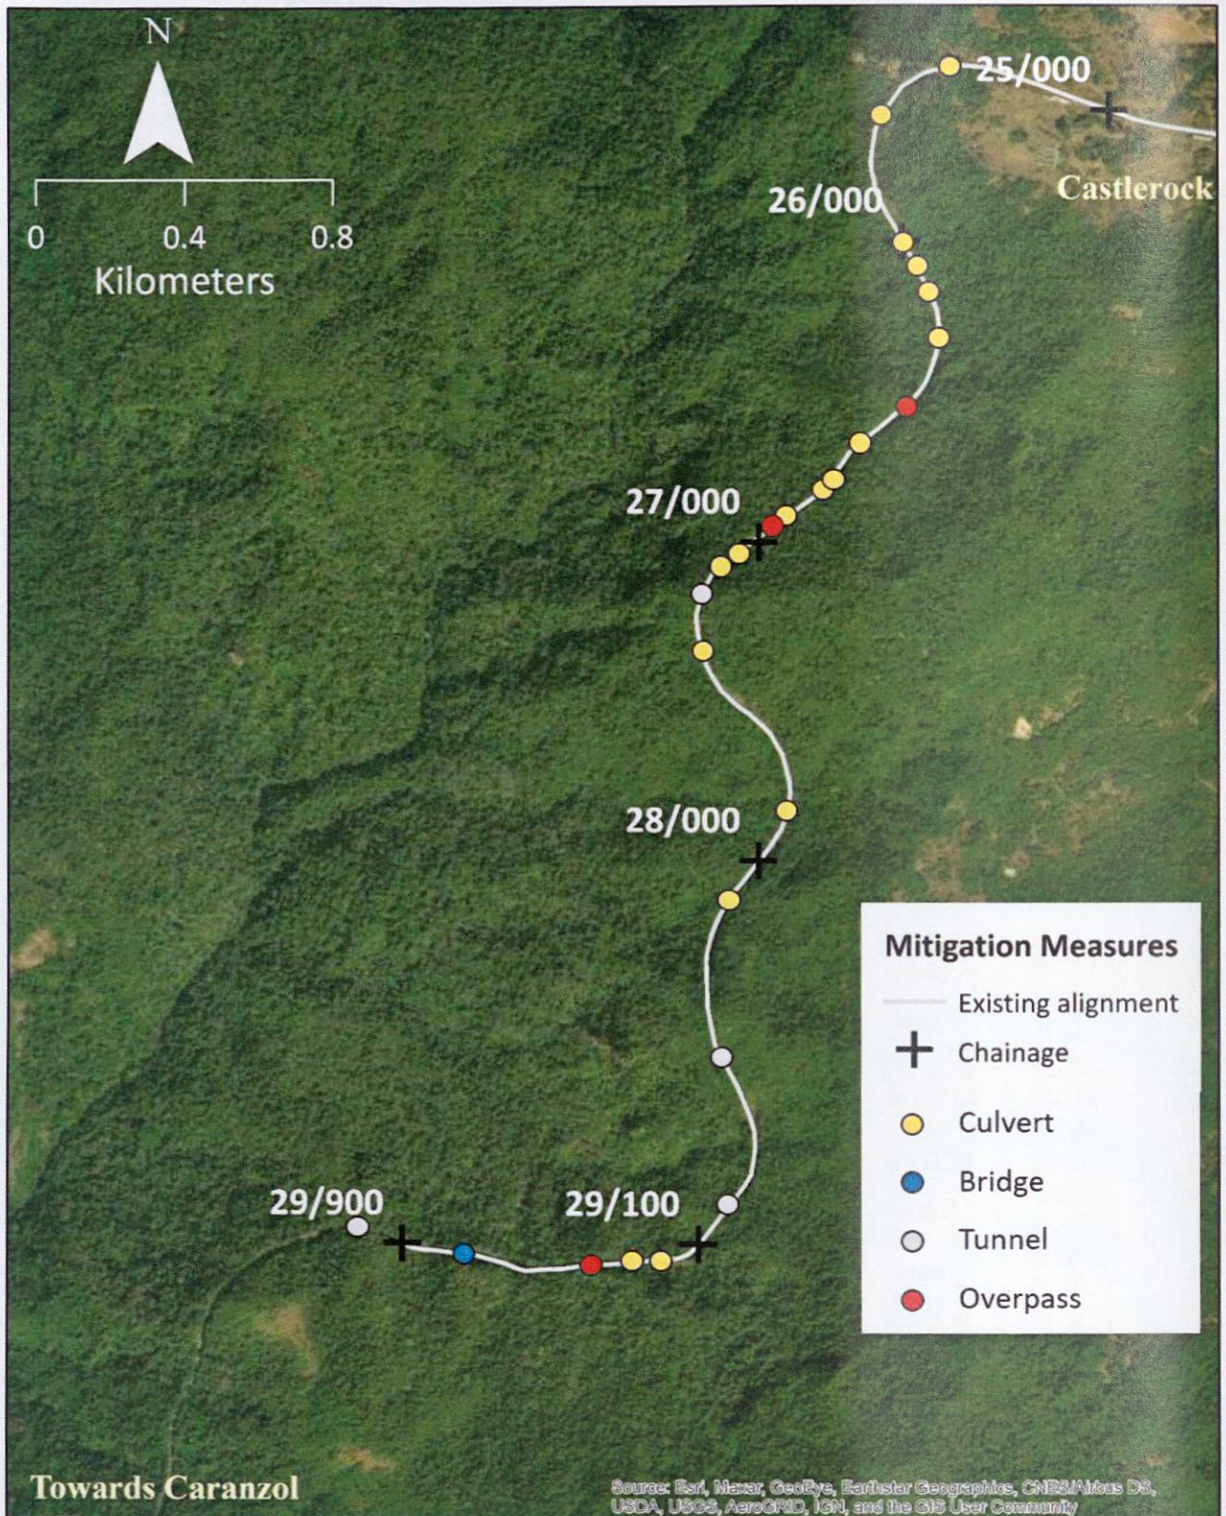
Figure 2: Mitigation measures recommended on the existing and proposed railway tracks in the Castlerock-Caranzol segment (Chainage 25/000 to 29/900)

Given below are details of the proposed mitigation measures on the existing and proposed railway track (Tables 1 & 2; Figures 1 & 2). It is important to assert that the recommended measures are to be implemented on both the existing and the proposed railway track for the measures to be effective. Once the mitigation measures are completed on the new track, railways can initiate the construction of mitigation measures on the existing track in a phased manner. Areas between mitigation measures need to be fenced to avoid animal hits by rail, and to funnel animals towards the mitigation measures. This would also discourage animals from entering the railway track.

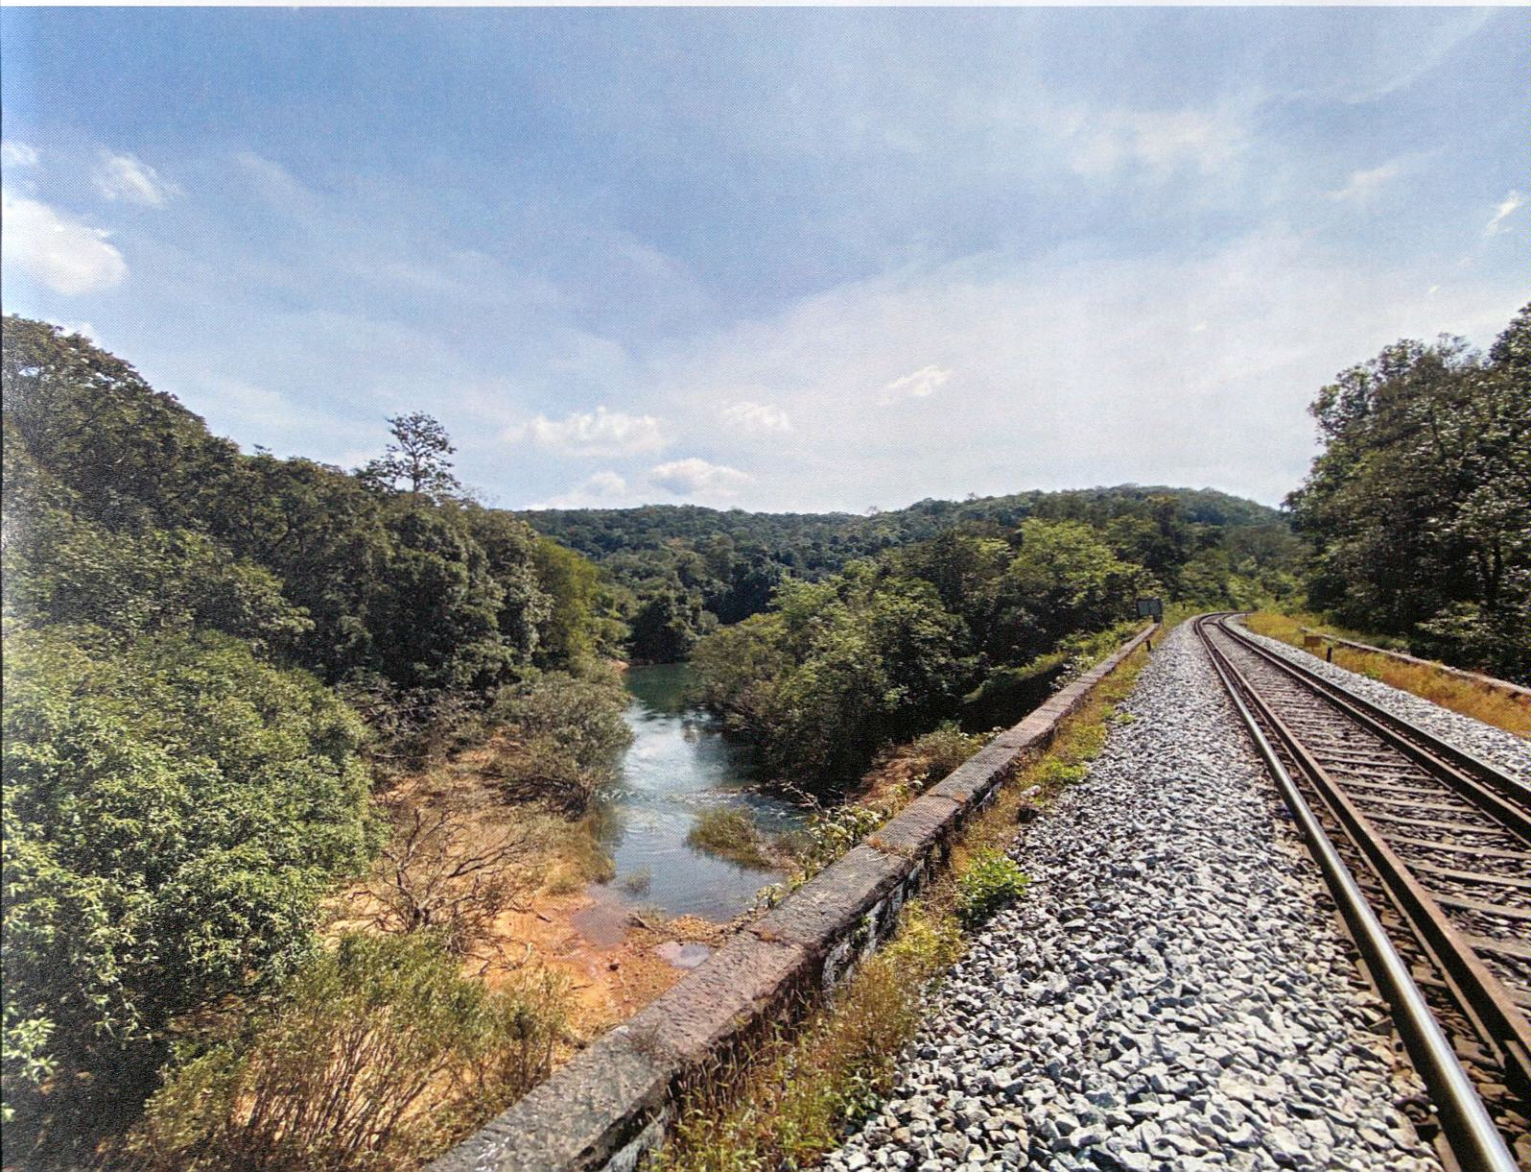
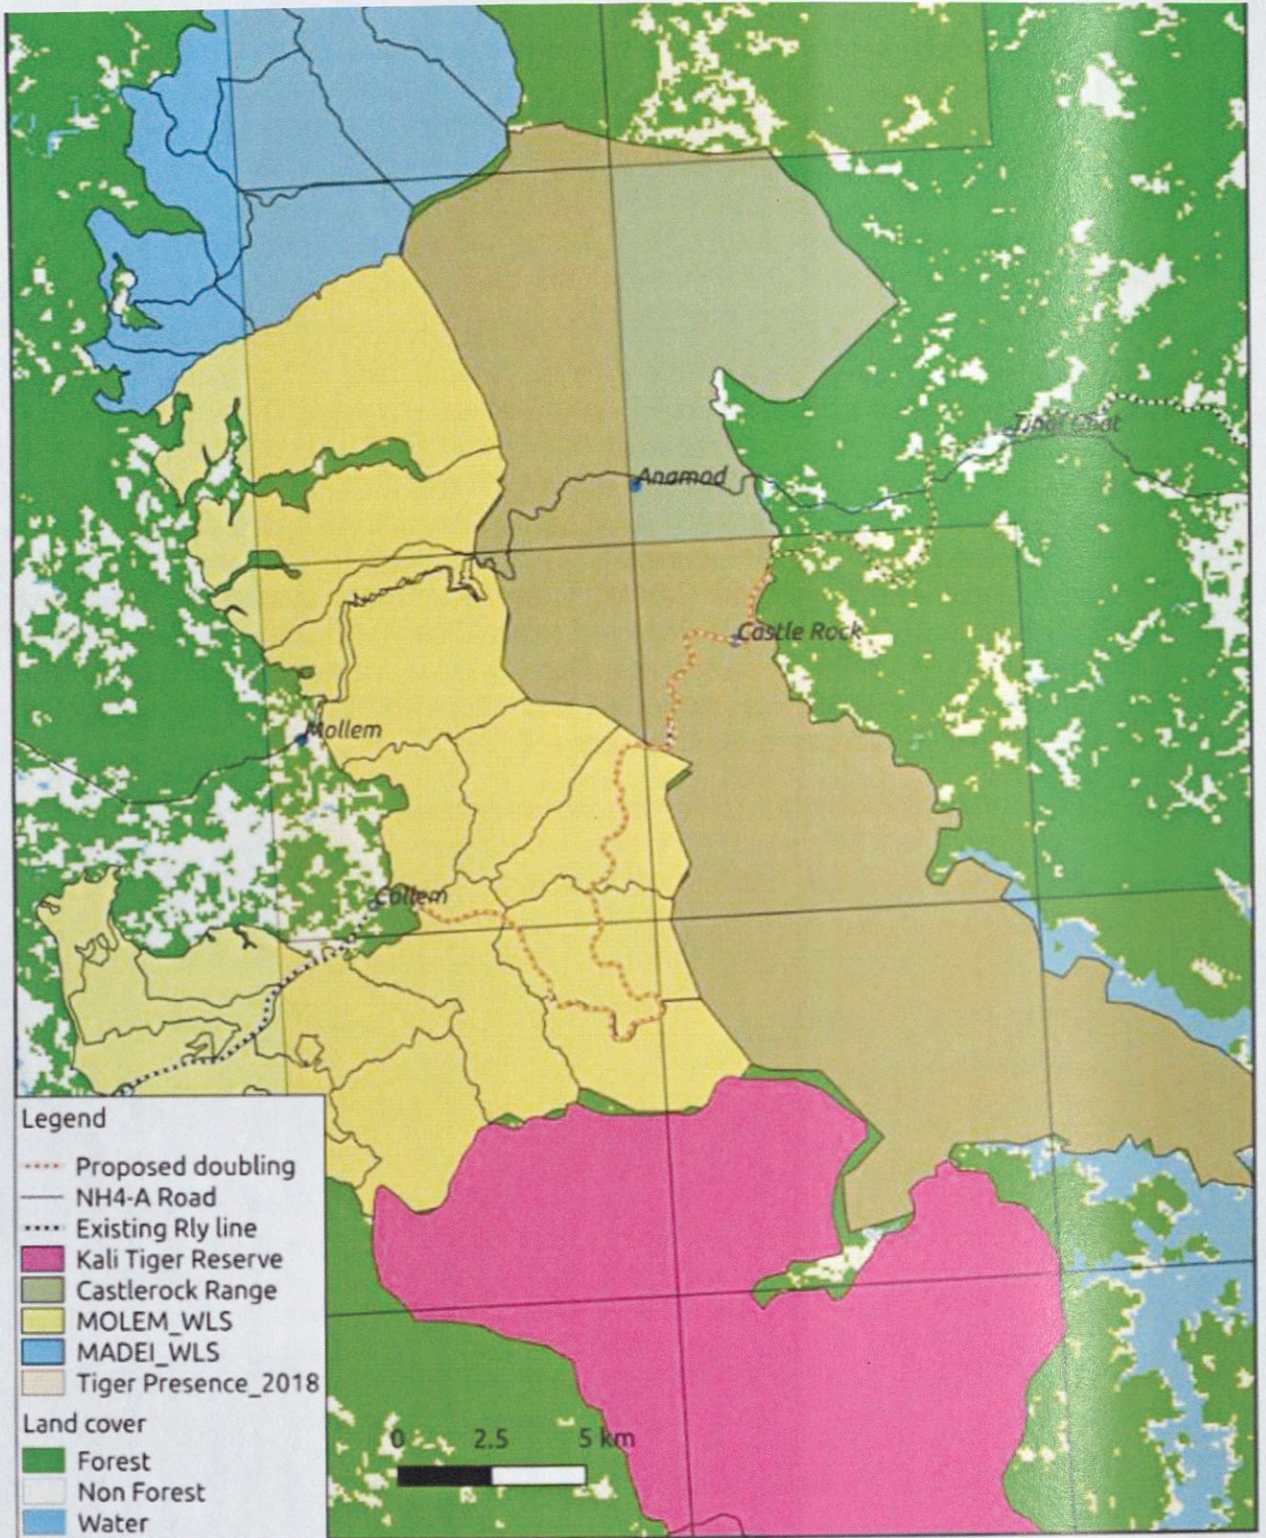
Figure 1: Alignment of proposed doubling of railway track passes through ecologically sensitive areas of the region viz., Kali Tiger Reserve, Molem Wildlife Sanctuary and Castlerock Range.

The proposed railway track passes through ecologically sensitive areas of the Western Ghats (Figure 1). The proposed doubling of railway track lies between the forested tracts of Tinaighat and Caranzol. Tinaighat is a small village on the Panjim (Goa)- Belgavi (Karnataka) highway. The forests of Tinaighat lie within Dandeli Wildlife Sanctuary. Dandeli earned the status of a Wildlife Sanctuary in the year 1956. Part of the area was carved out from Anshi National Park in 1987. In 2007, both these areas were together declared as a Tiger Reserve and were renamed as Kali Tiger Reserve in 2015. Today, Kali Tiger Reserve along with other forested areas in both Goa and Maharashtra covers an area of about 2200 km². The existing railway track between Tinaighat and Caranzol section lies within the Protected Area of Castlerock Range which is a part of Kali Tiger Reserve. The forest parts of Tinaighat and Castlerock are evergreen in nature and ecologically valuable for many herpetofauna, avifauna and mammals. Evergreen forests are seen in the Ghats of Castlerock, steep slopes and deep valleys. Most trees are of softwood species, which are relatively slender with clear boles in the deep soil.

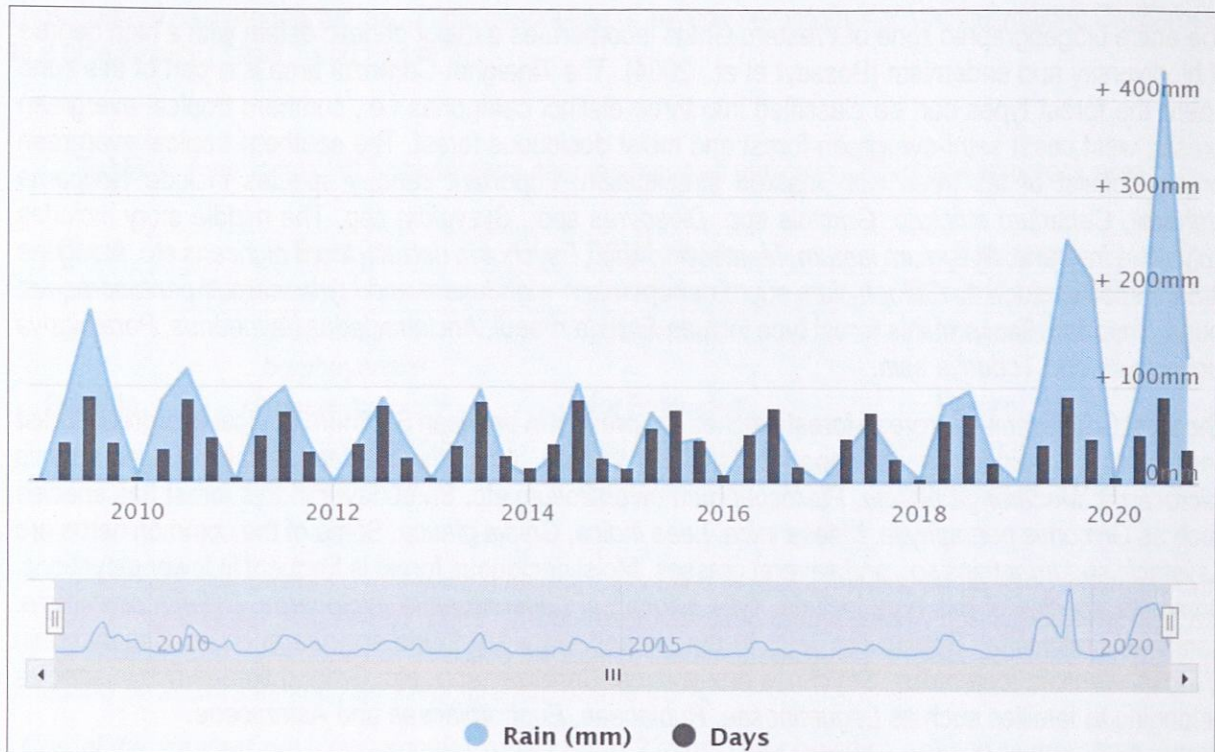
Figure 2: Observed annual rainfall around Castlerock area for 2010-2020 (Source: World Weather Online, 2020)

The topography of the region is predominantly undulating with flat terrain in some stretches of the section. The stretch between Tinaighat to Castlerock is relatively flatter while the terrain from Castlerock towards Caranzol is undulating with cliffs and gorges. The study area receives high rainfall during the monsoons (June-September) due to the active southwest monsoon winds (Figure 2).

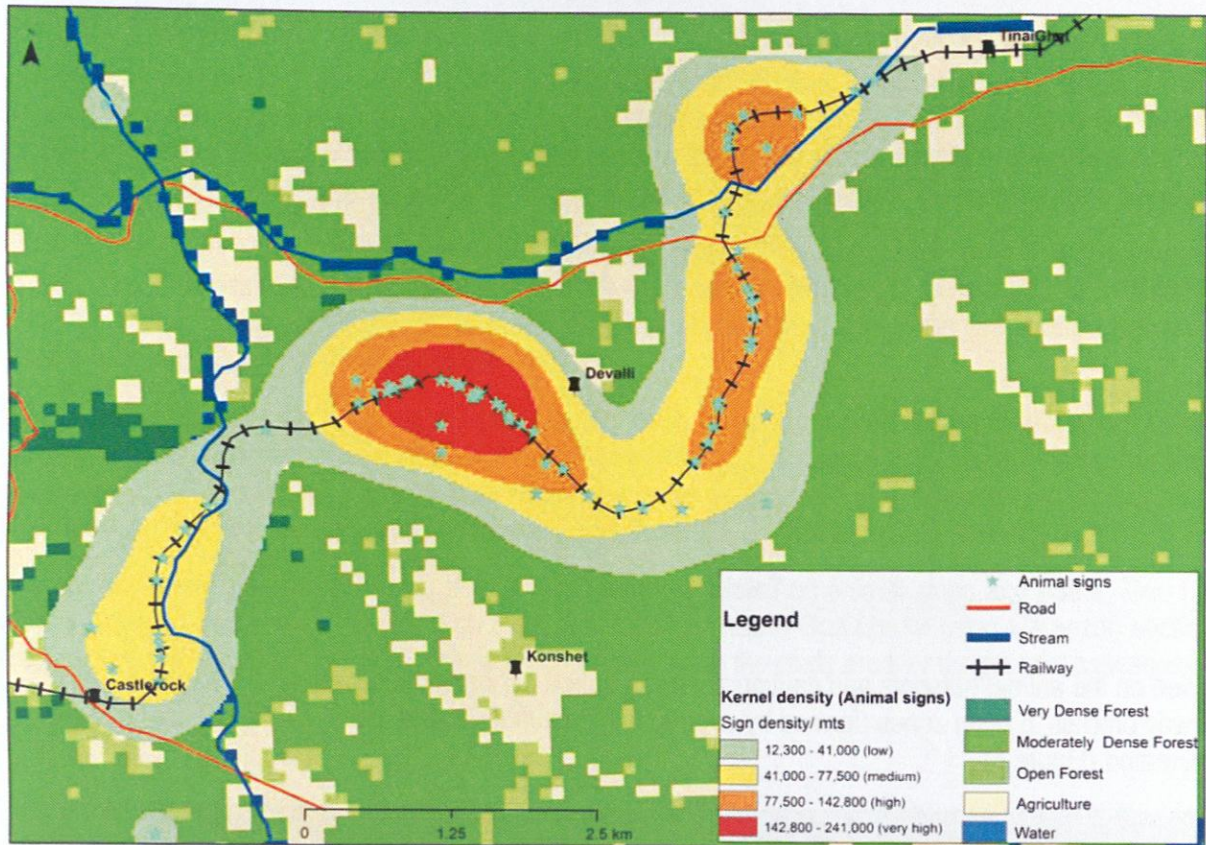
Figure 4: Kernel density of signs collected by IISc during their survey in 2019 between Tinaighat-Castlerock. The clusters were classified as low (light green), medium (yellow), high (orange), and very high (red) based on density of signs found (Source: Suresh et al., 2020)

To identify areas of high use by mammals, IISc conducted camera trap, sign surveys and collected opportunistic mammal presence data along the existing railway track from the Tinaighat to Castlerock section (Suresh et al., 2020). The camera trap study carried out over 72 trap nights in this section captured 23 images belonging to 5 mammal species including gaur, porcupine, sambar, small Indian civet, and chital. Indirect signs (n = 406) including pug/hoof marks, pellets/scats/droppings and feeding signs for mammals such as gaur, langur, sambar, and leopard were recorded during the study on transects laid parallel to the railway track up to 10 m. Direct sightings (n = 10) of mammals such as gaur, langur, barking deer, porcupine and bonnet macaque were also recorded during the study. On the basis of animal evidence collected, Suresh et al. (2020) identified 3 main clusters of animal activity/movement along the study section (Figure 4), details of which are given in the Table 2.

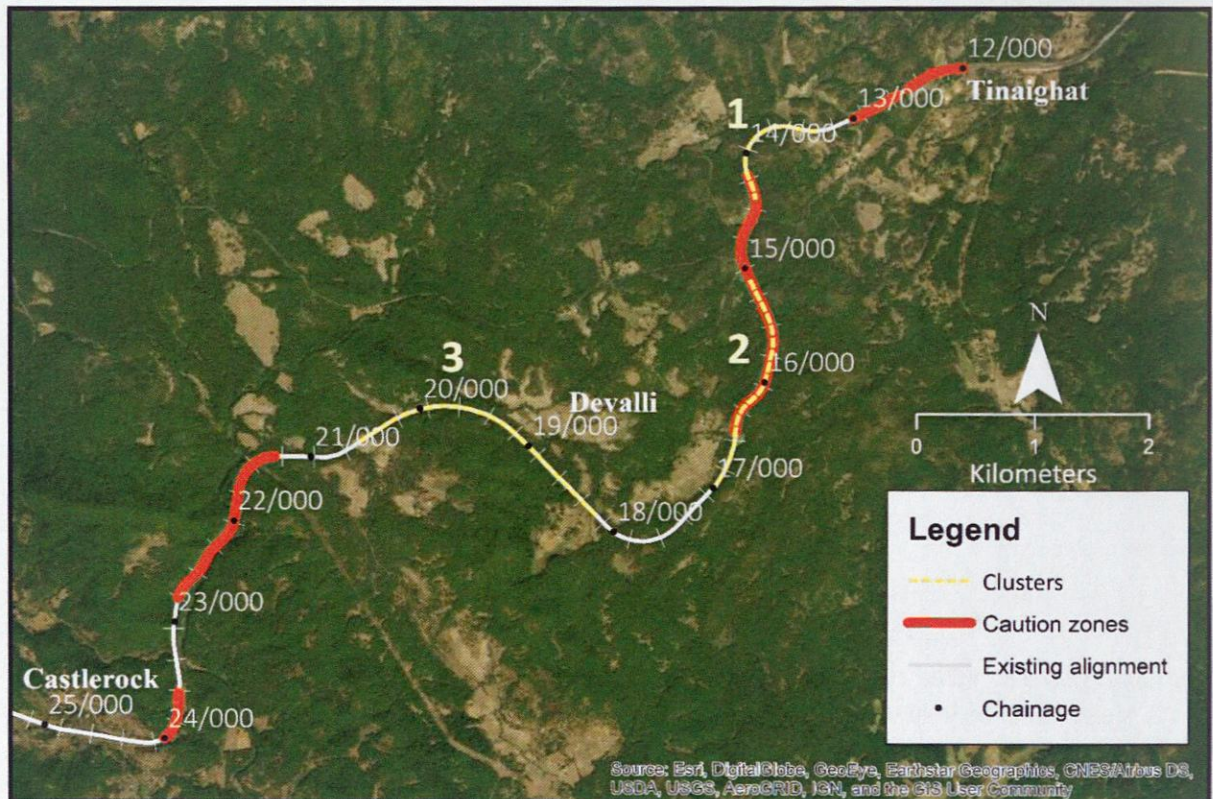
Figure 5: Consolidated map of the animal hotspots and caution zones identified (Suresh et al., 2020) on the Tinaighat – Castlerock section.

Based on the animal hotspots and caution zones identified through field survey and consultation with railway officials, 5 main zones (formed by overlapping 3 animal clusters and 4 caution zones) can be delineated (Figure 5).

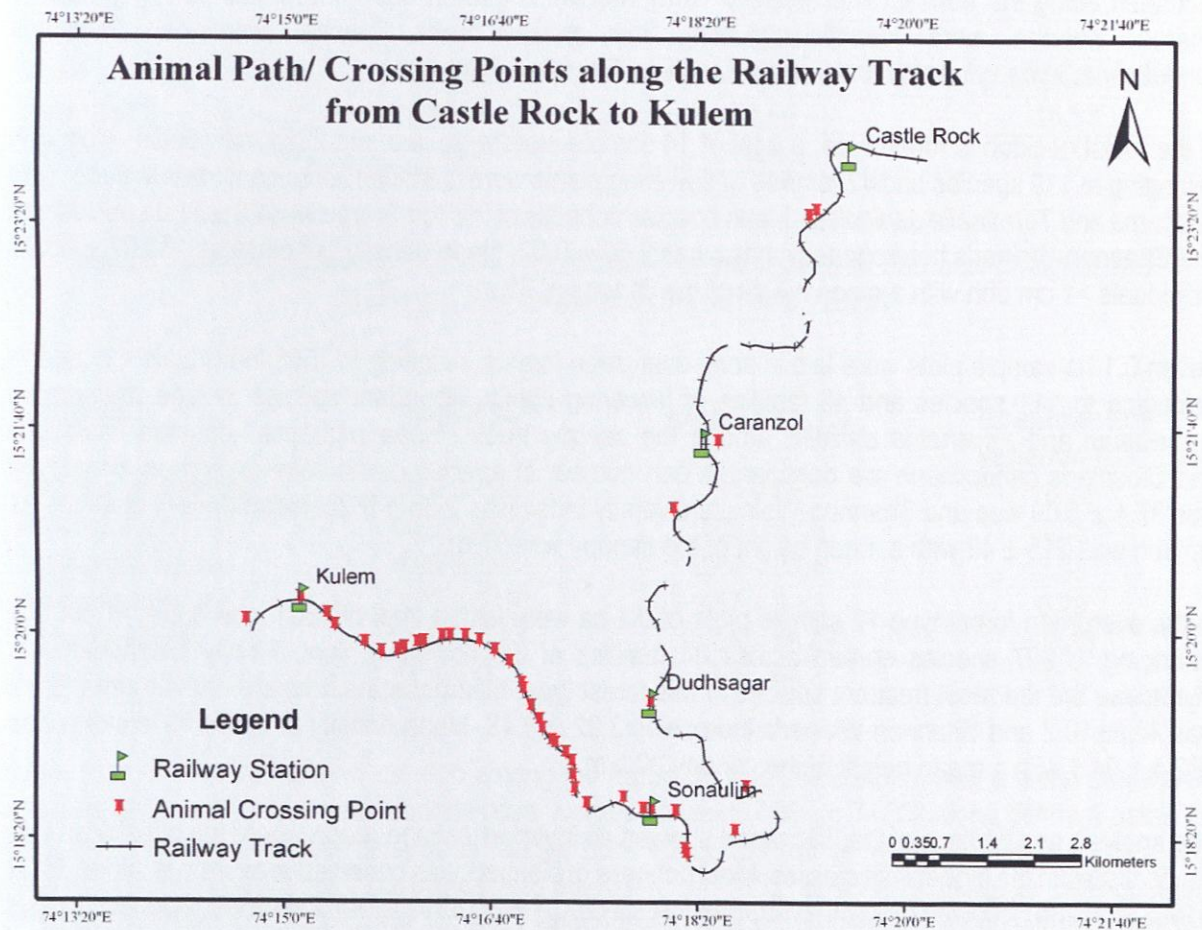
Figure 6: Locations of animal crossing points on the Castlerock – Kulem railway track identified in Sukumar and Sitharam (2017).

Animal movement paths or crossing points were recorded based on animal signs and paths. Two (2) animal crossing points were identified on the Castlerock-Karnataka-Goa border (near Caranzol) section (Figure 6). Area outlined in red is the railway section relevant to the study area for the present assessment during November-December 2020 (Castlerock - Caranzol).

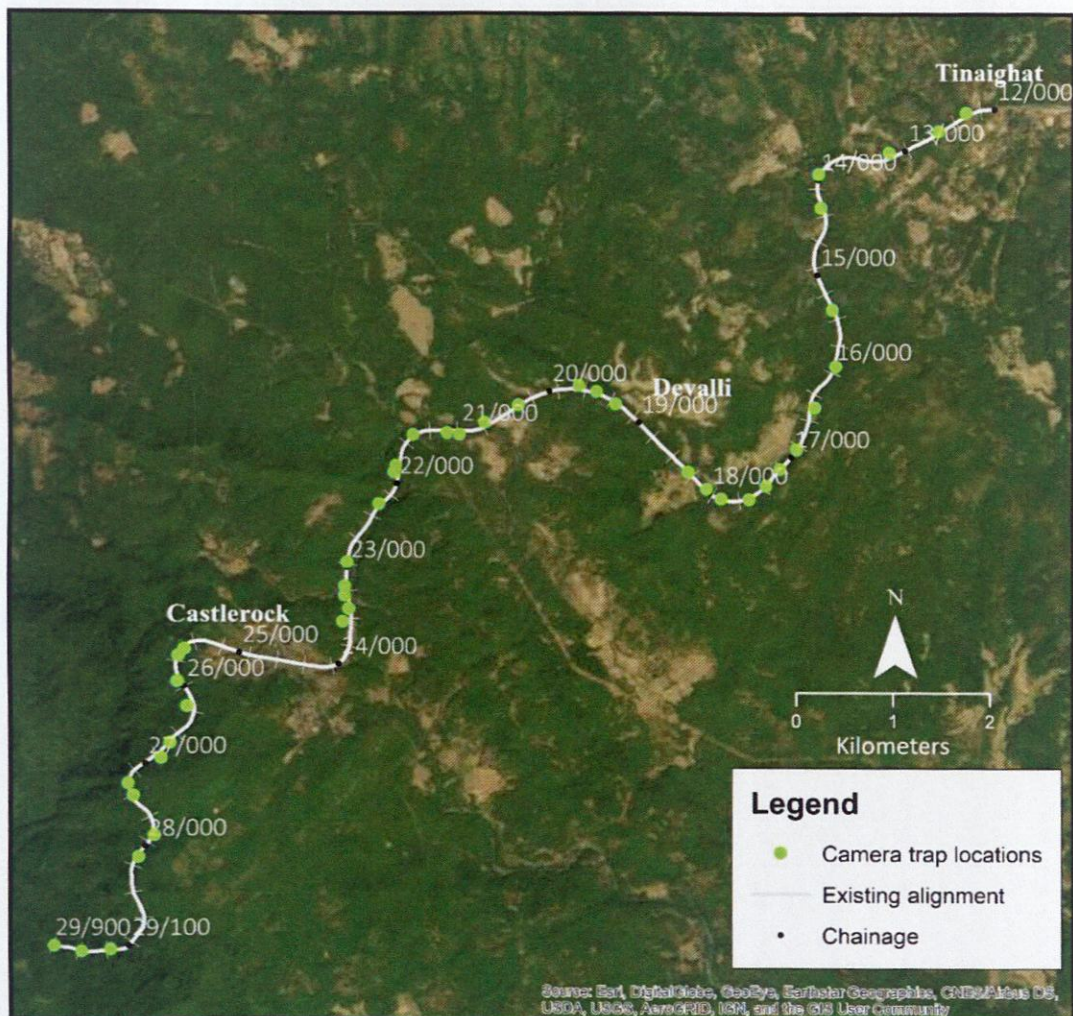
Figure 7: Locations of camera traps deployed during the present study along the existing railway track on the Tinaighat-Castlerock-Caranzol section (Chainage 12/000 – 29/900) from 20.11.2020 - 04.12.2020

We deployed 44 camera traps all along the study section for a period of 15 days (20.11.2020 to 4.11.2020; Figure 7). Camera traps were deployed on animal trails, or trails intersecting water channels, drainage structures, and on tunnels, where possibility of animal movement was possibly high. Cuddeback C1 (white flash) cameras were used for the exercise that were set to capture interval of 3s (minimum interval) to maximise animal captures. We attempted to deploy one camera trap every 250 m of the track length, however additional camera traps were also deployed if more than one potential site was observed within 250 m. Camera traps were not deployed along railway track sections with retaining walls, steep slopes and human habitation on either side.

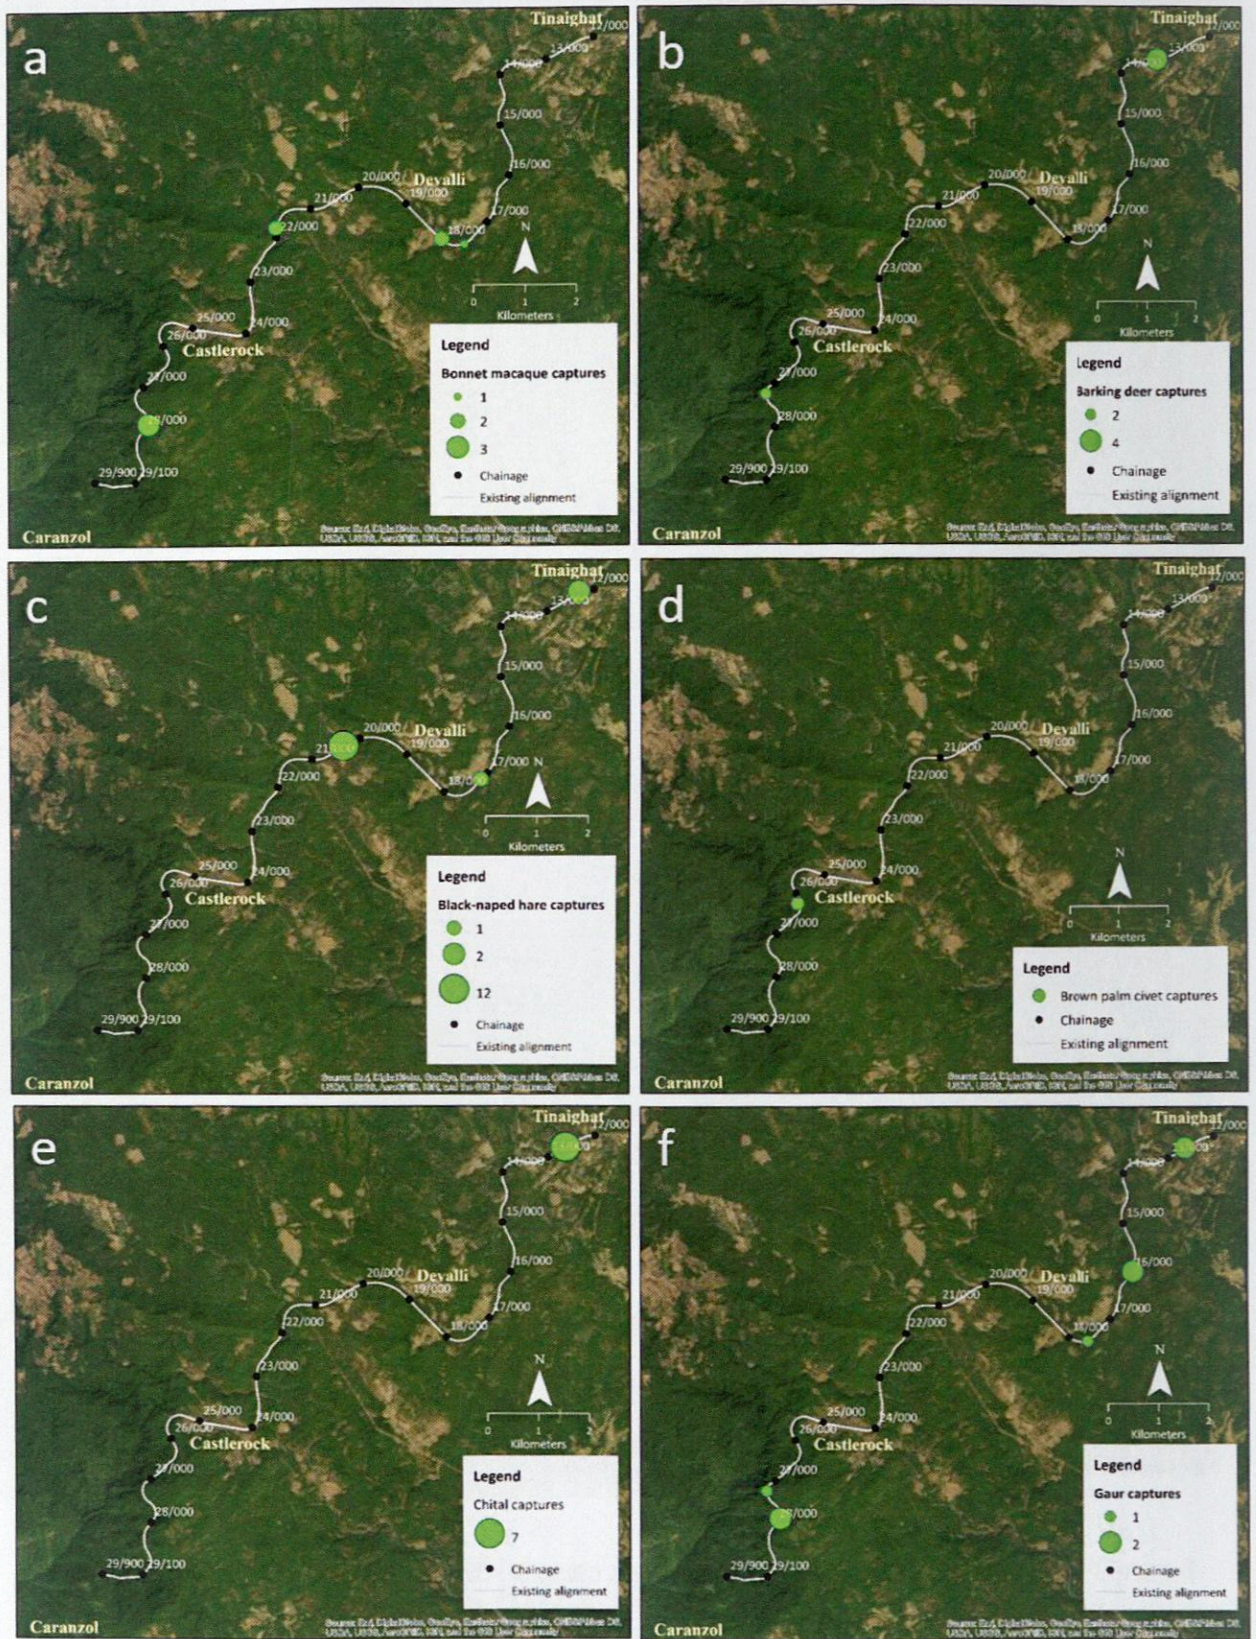
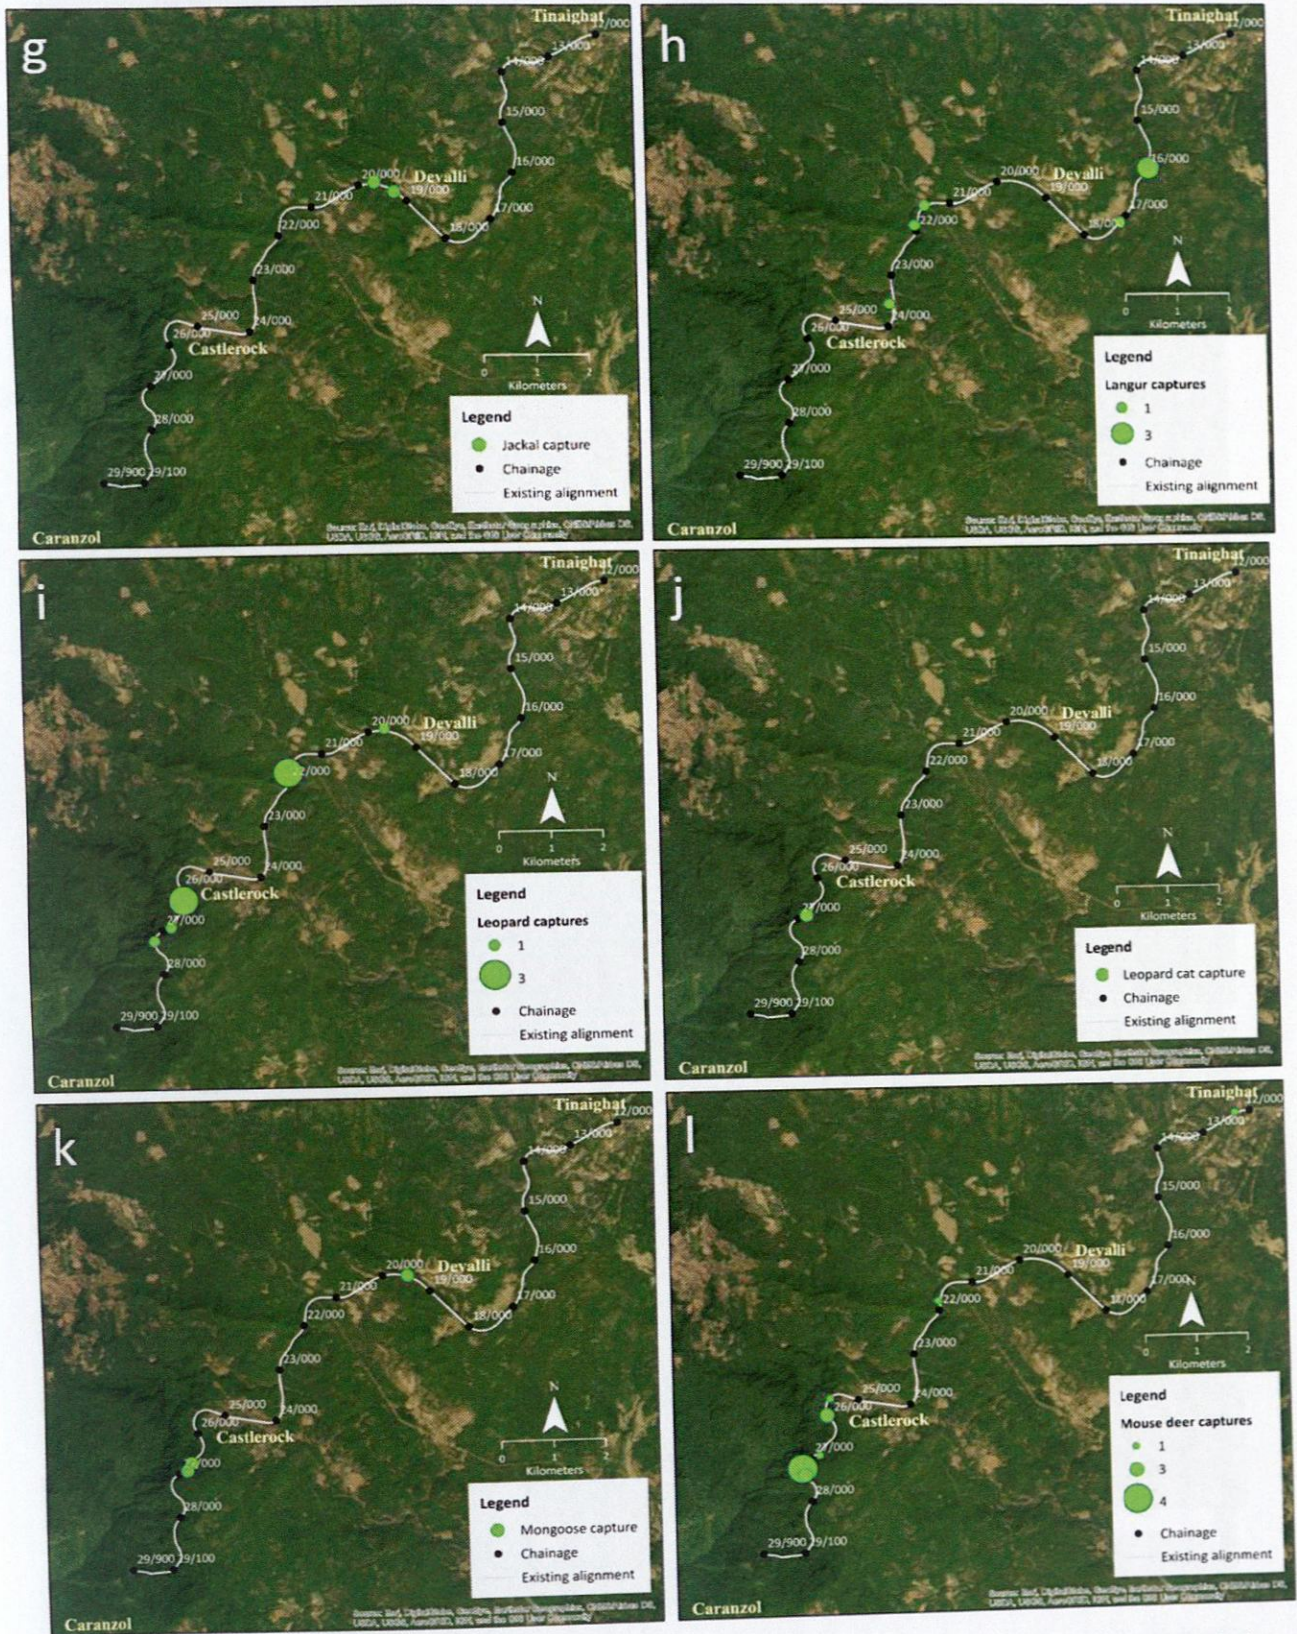
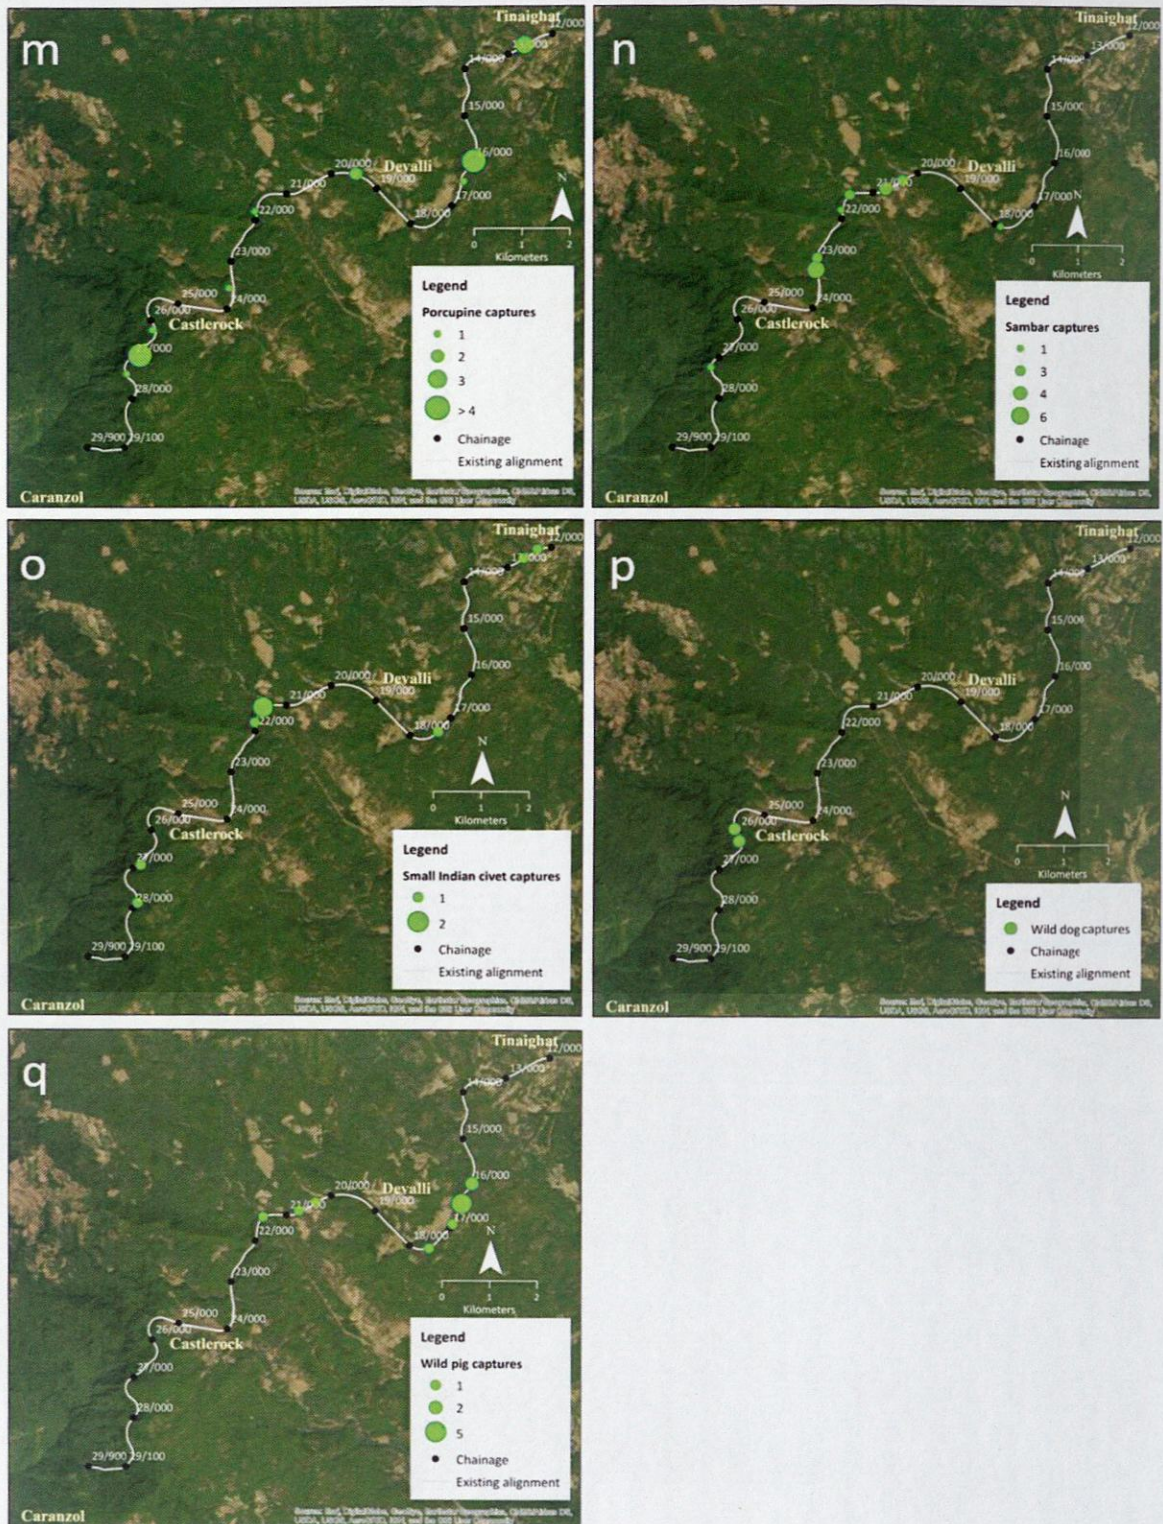
Figure 9 (a – f): Spatial detection maps of mammals captured during the camera trap survey: a. Bonnet macaque, b. Barking deer, c. Black-naped hare, d. Brown palm civet, e. Chital, f. Gaur.

Figure 9 (g – l): Spatial detection maps of mammals captured during the camera trap survey: g. Jackal, h. Langur, i. Leopard, j. Leopard cat, k. Side-striped mongoose, l. Mouse deer.

Figure 9 (m – q): Spatial detection maps of mammals captured during the camera trap survey: m. Porcupine, n. Sambar, o. Small Indian civet, p. Wild dog, and q. Wild pig.

Black-naped hare and porcupine were the most frequently captured small mammal species, while sambar and mouse deer were the most frequently captured ungulate species. While chital was captured predominantly in the railway section where surrounding terrain was flat (Tinaighat area), sambar presence was widespread. Mouse deer captures were mostly obtained from in/near the Castlerock Sanctuary area. Wild pig captures were obtained from areas near agricultural fields (Figure 9 a-q).

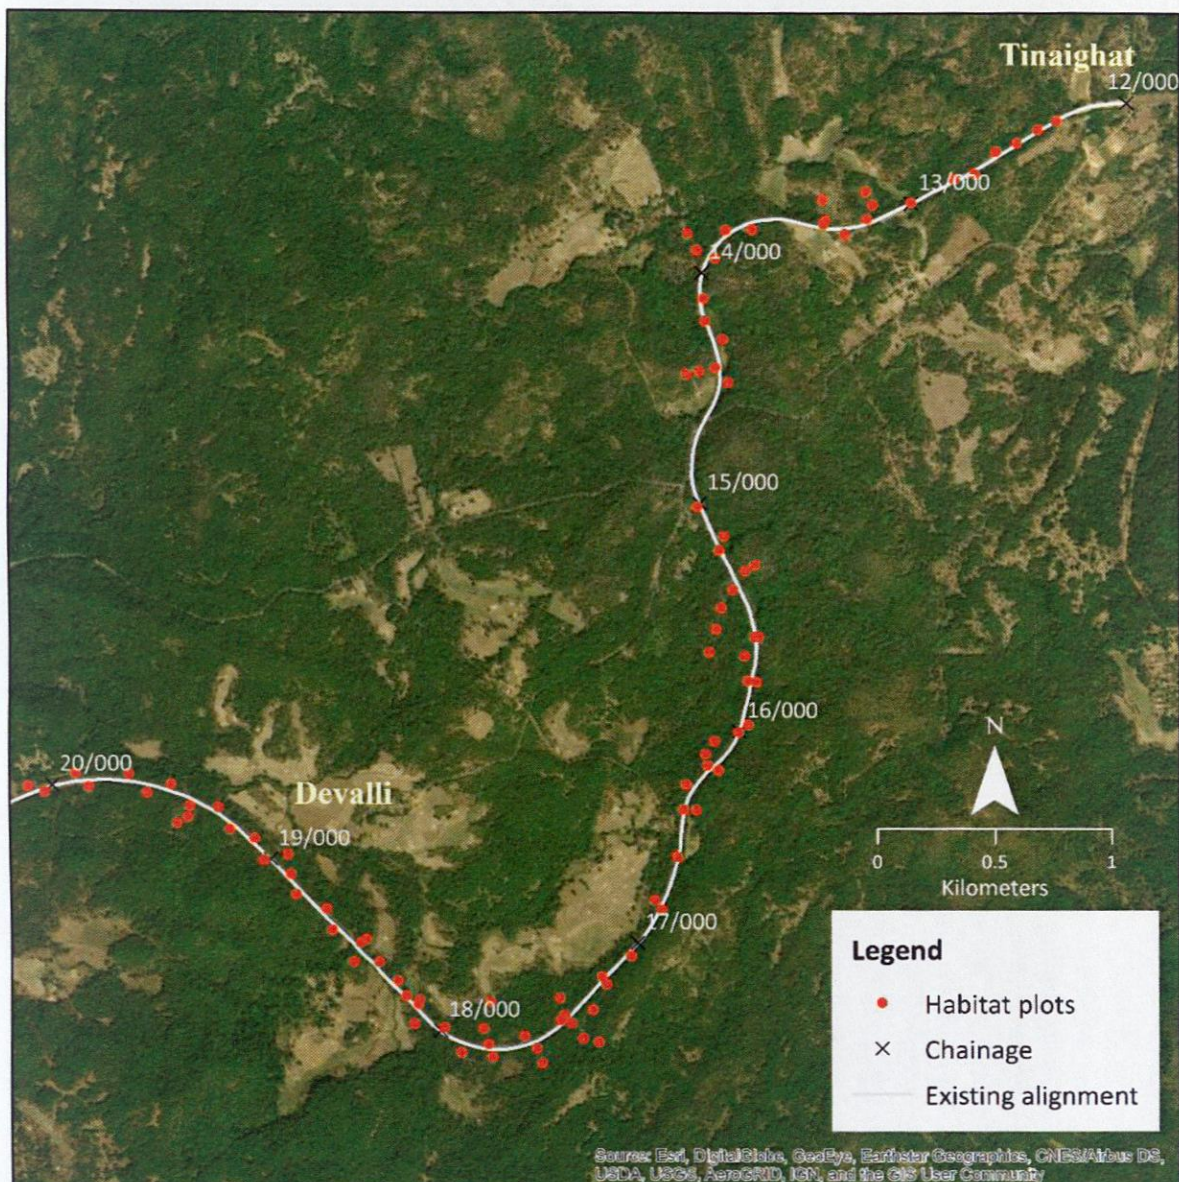
Figure 10 (a): Locations of plots along railway track for recording habitat and vegetation characteristics, and animal signs between chainages 12/000 and 20/000 during the present survey from 19.11.2020 – 04.12.2020.

The rapid survey to suggest mitigation measures against the proposed doubling of railway track was carried out between Tinaighat and Caranzol stretch (25km). To understand habitat characteristics, we laid circular plots of 10 m radius along forest edge on both side of the railway track. We also laid plots along forest trails across the tracks. The circular plots were laid every 200m apart on either side of the track for the 25 km stretch (Figure 10 a-b). Along the trail a maximum of three plots were laid every 50 m apart. We looked for the presence of any mammalian signs (e.g., scats, pellets, pug mark/hoof mark/footprint, scratch mark) in each of the circular plots. We also noted the tree cover, shrub cover, ground cover estimates and other factors influencing animal presence.

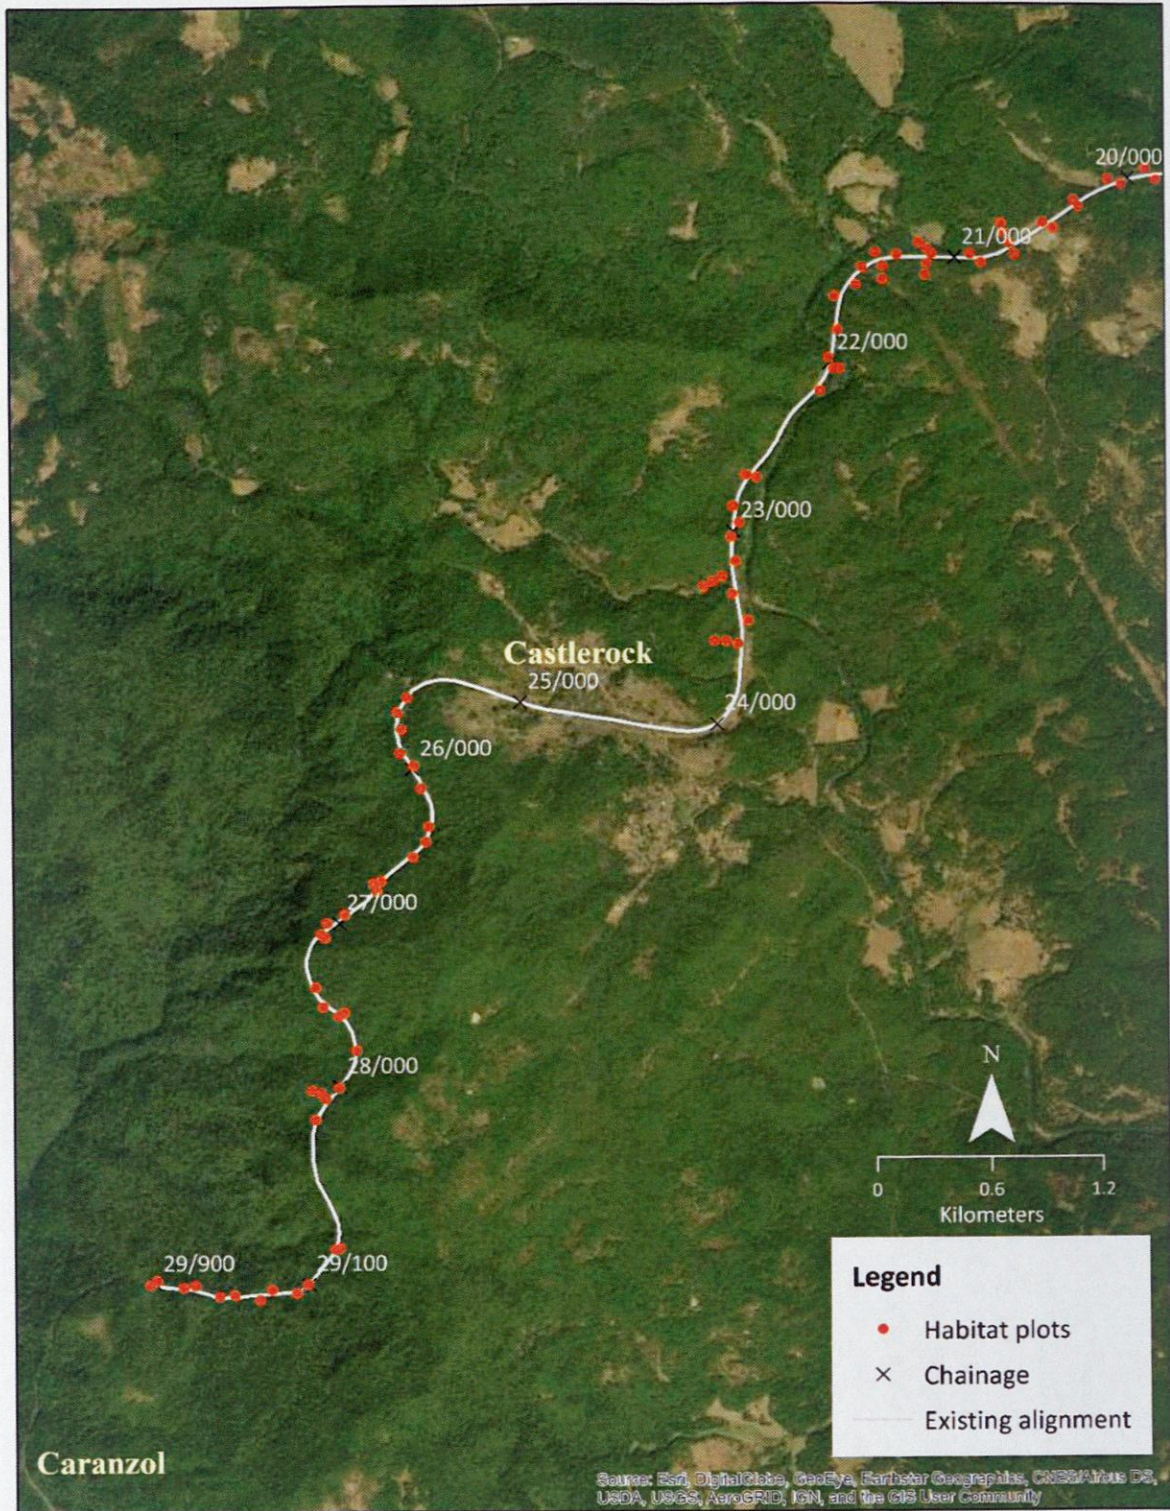
Figure 10 (b): Spatial location of plots along railway track for recording habitat and vegetation characteristics, and animal signs between chainages 20/000 and 29/900 during the present survey from 19.11.2020 – 04.12.2020.

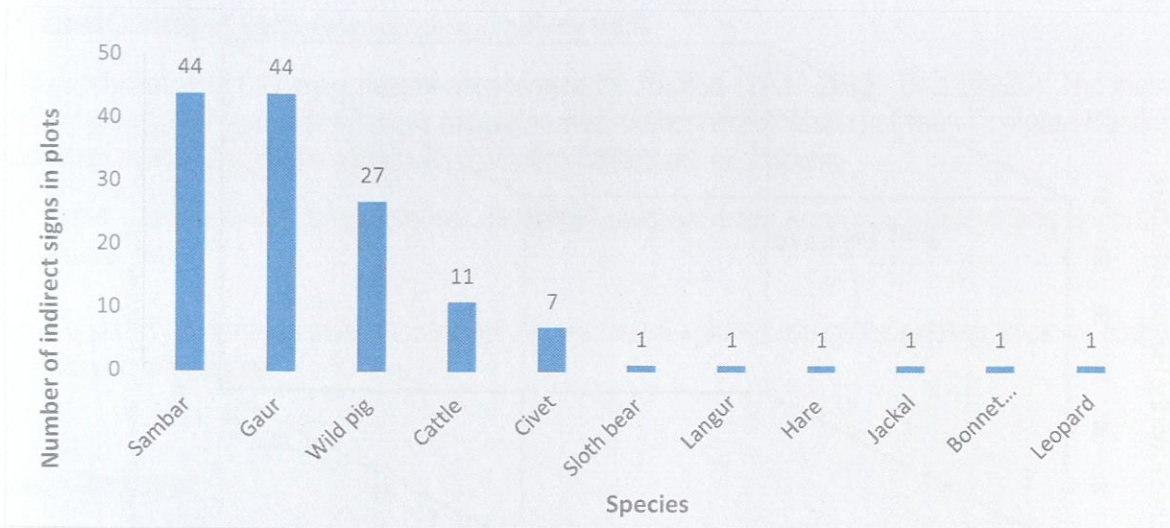
Figure 12. Number of indirect signs of mammalian species found along the forest edge plots between Tinaighat-Caranzol railway line stretch
