December 2020

MITIGATION MEASURES FOR DOUBLING OF THE TINIAGHAT - CASTLEROCK - CARONZOL SWR RAILWAY TRACK, KARNATAKA

भारतीय वन्यजीव संस्थान
Wildlife Institute of India

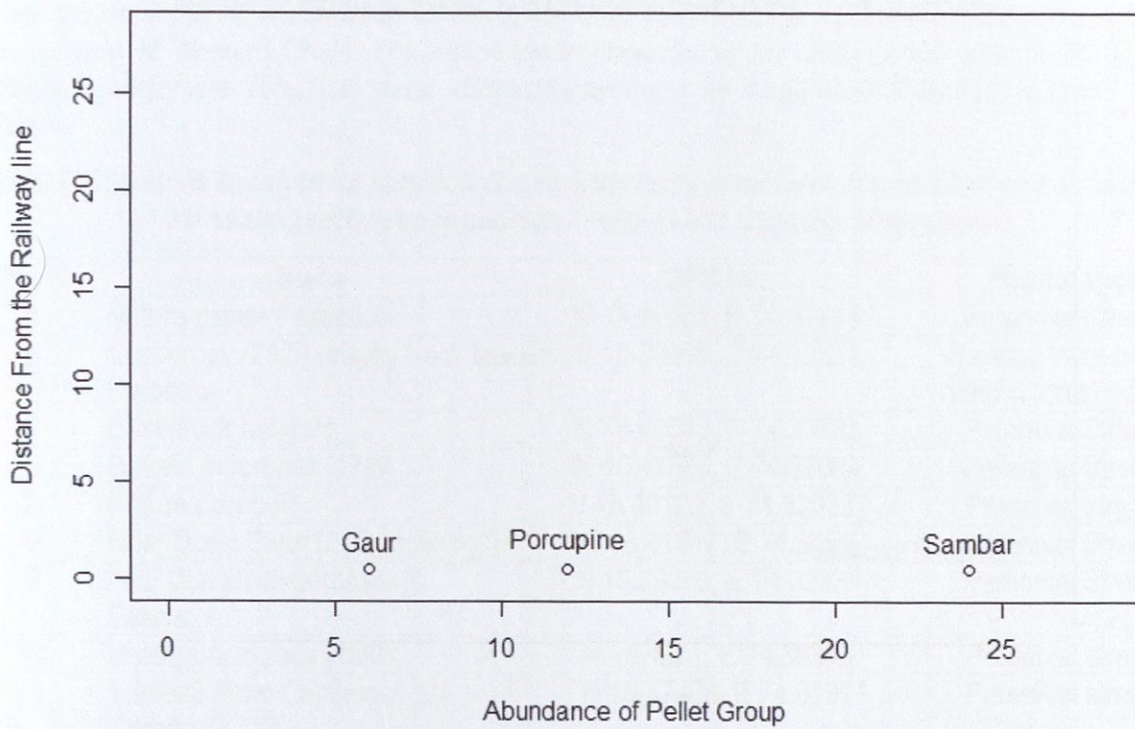
Figure 13. Pellet abundance along the forest edge with respect to the distance to existing railway line between Tinaighat-Caranzol sections

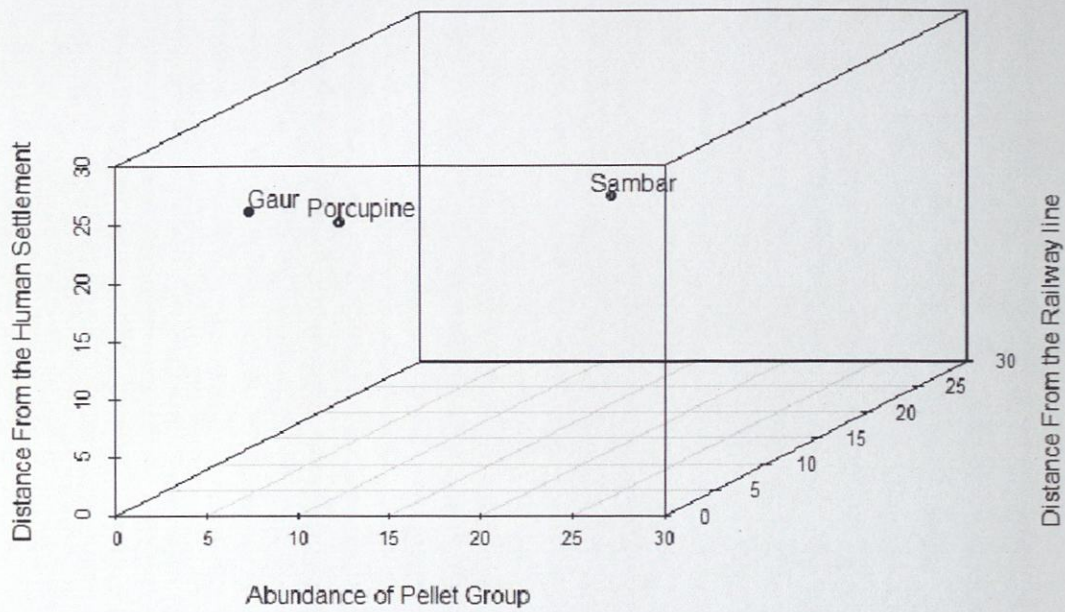
Figure 14. A three-dimensional plot of species presence with respect to the human settlement and distance to the existing railway line between Tinaighat-Caranzol section

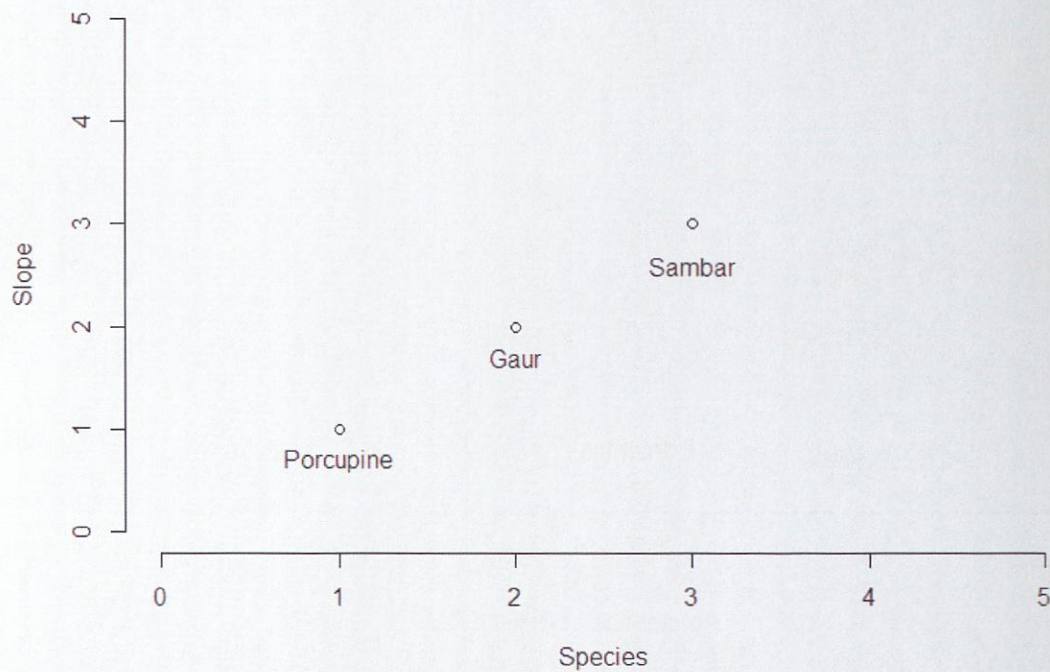
Figure 15. Species presence with respect to slope between Tinaighat-Castlerock-Caranzol Section. (Slopes are in scale of 1-5 where 0-1 flat terrain, 2-gentle slope, 3-moderate slope, 4-step slope and 5-very steep slope).

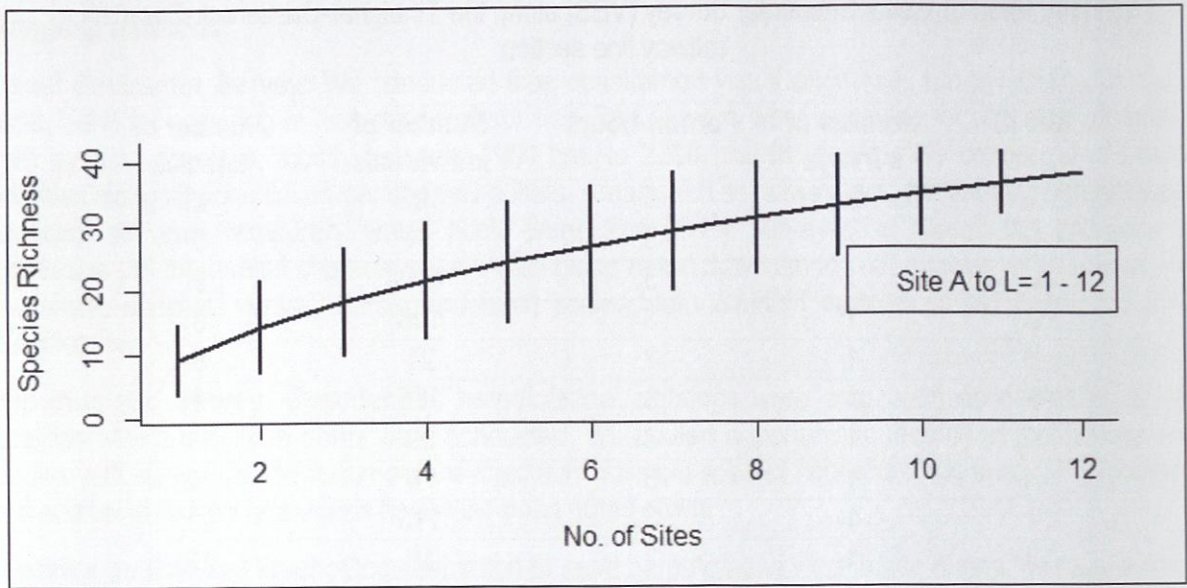
Figure 16: Species accumulation curve of herpetofauna for all survey sites between Tinaighat-Castlerock-Caranzol section.

Diversity indices such Shannon's and Simpson's Index were also enumerated to show herpetofaunal assemblages (Table 9). Species accumulation curve (Figure 16) shows that the species richness has not reached asymptote. X-axis in the following graph denotes number of sites surveyed (i.e., Site "A" = 1, Site "B" = 2, Site "C" = 3 etc.).

Species accumulation curve also indicates the inventory is far from complete (Figure 16). Long term and multi-seasonal survey would likely record species that are seasonal in their activity pattern, such as those in genera *Pedostibes*, *Rhacophorus*, *Sphaerotheca*, Caecilians (such as *Indotyphlops*) *Calliophis*, *Uropeltis* etc. During our study, 47 species of herpetofauna belonging to 23 species (19 genera and 10 families) of amphibians and 24 species (19 genera, 8 families) of reptiles were recorded (Annexure-I; see Figures 18 and 19). Out of these reptilian diversity family, Colubridae dominated the species list (10 spp.) followed by family Gekkonidae (5 spp.) (Annexure-I), whereas in case of amphibian diversity, family Dicroglossidae (6 spp.) were majority followed by family Rhacophoridae (5 spp.) (Annexure-I).

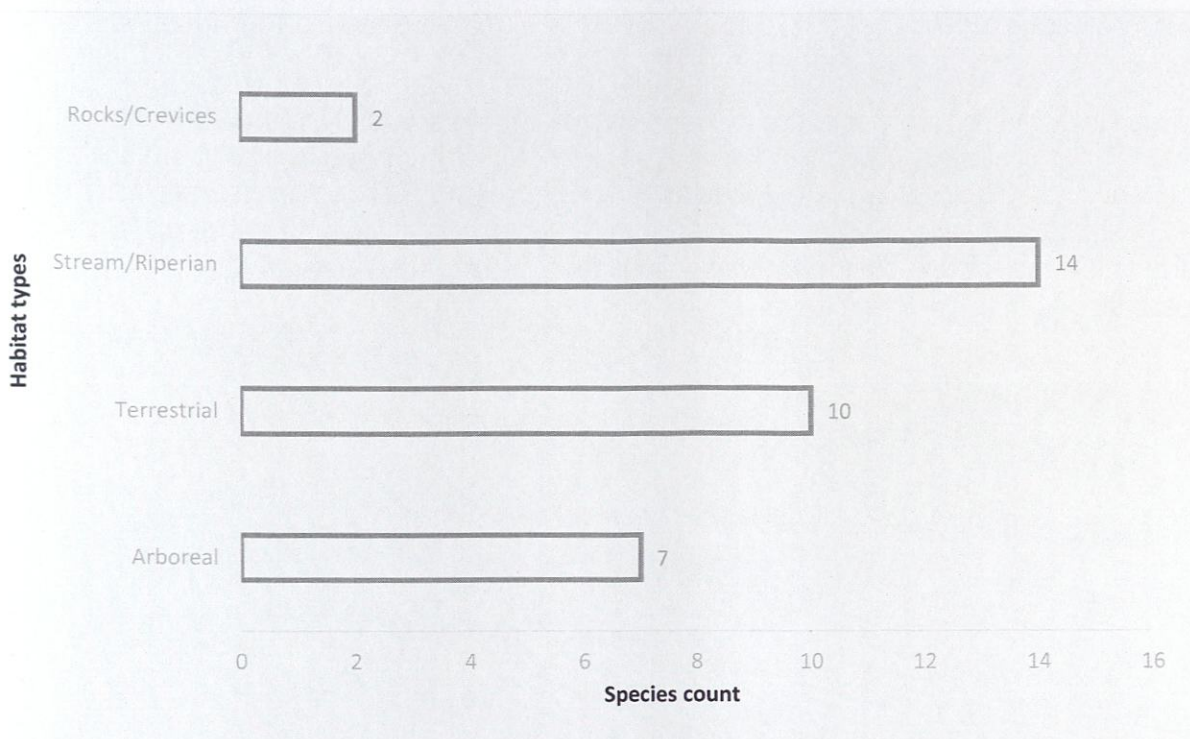
Figure 17: Encountered niche of all recorded herpetofauna during our survey between Tinaighat-Castlerock-Caranzol section

Amongst the recorded herpetofaunal diversity 43% of the species (14 spp.) were found to be along the streams and its riparian zones (Figure 17). Streams and riparian habitats are important specifically for amphibians and also for few species of reptiles. All these stream and waterbodies lie in near vicinity (≤ 50 meter) to the existing railway track and some streams are even passing the railway line through culverts.

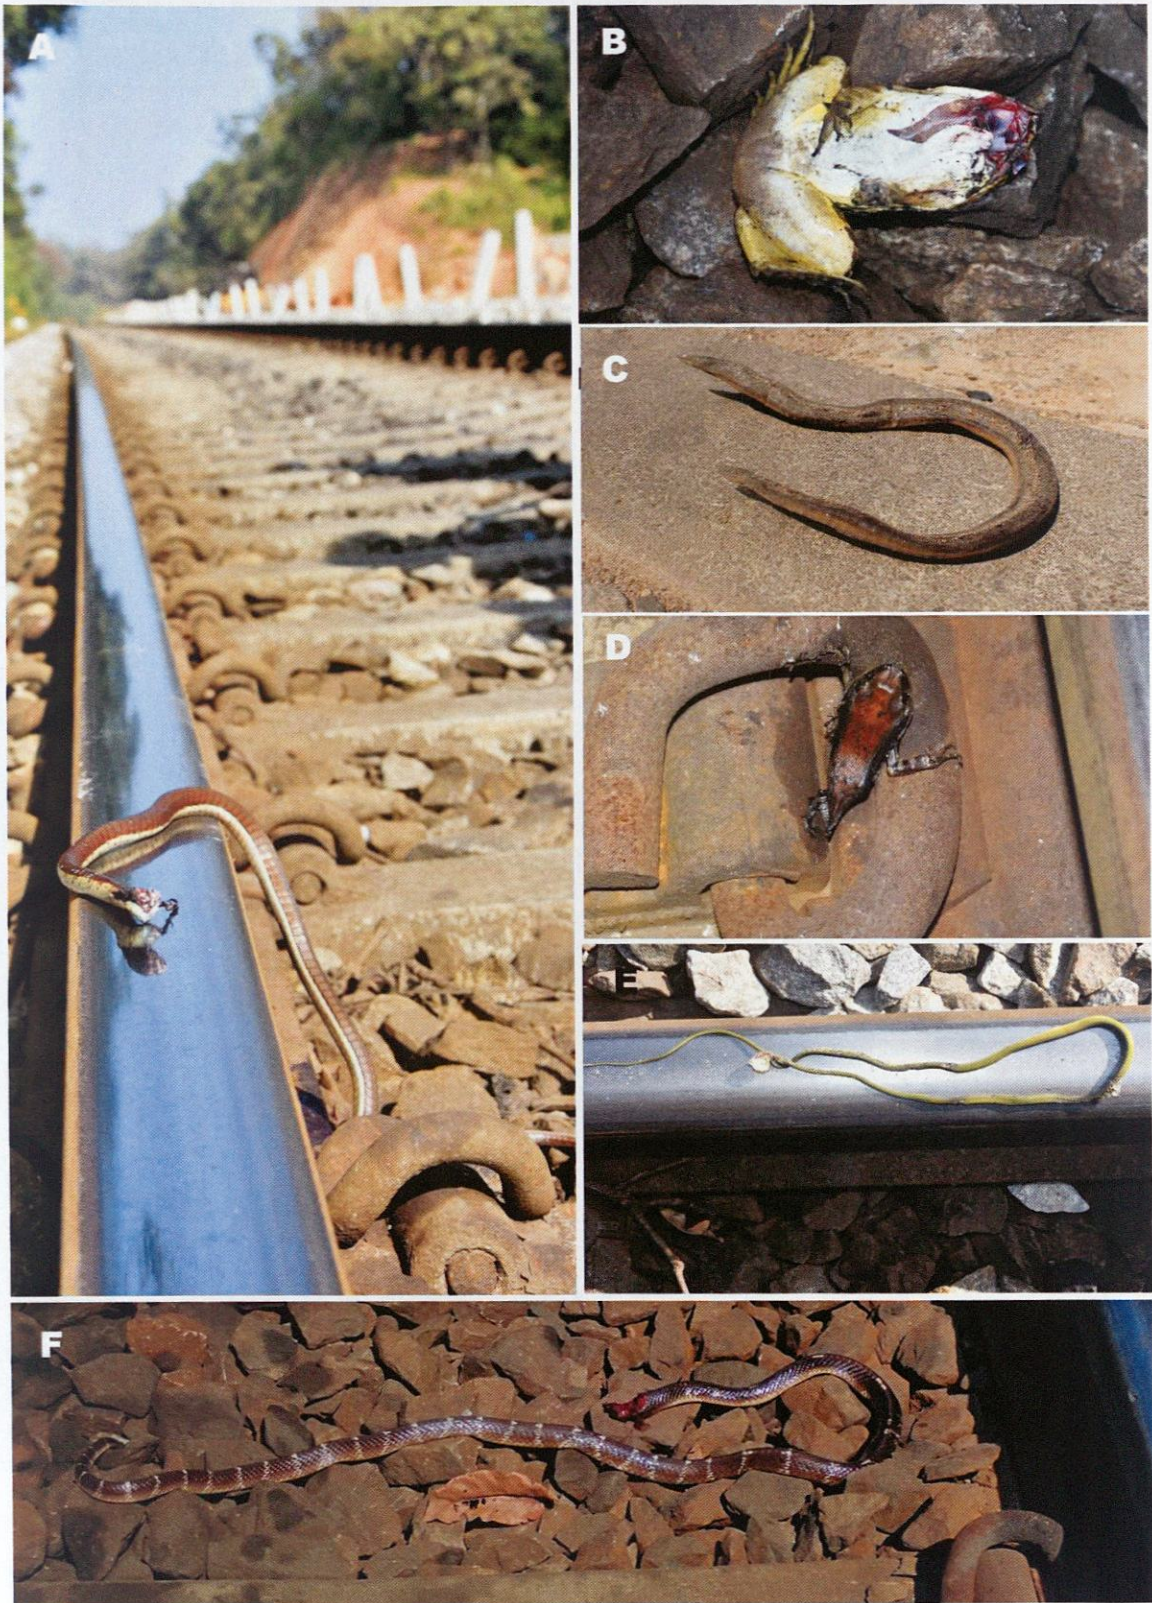
Figure 20: Snapshot of rail killed herpetofauna (A. *Dendrelaphis* sp., B. *Hoplobatrachus tigerinus*, C. *Ichthyophis* sp. (deshicated), D. *Hydrophylax malabaricus*, E. *Ahaetulla borealis*, F. *Bungarus caeruleus*).

Total 12 species of herpetofauna (6 spp. of amphibians, 6 spp. of reptiles) were recorded (Annexure-II; Figure 20). Species wise, snake was the maximum rail killed taxa, and in terms of individualistic count *Indosylvirana* sp. has been frequently encountered (5 individuals) as rail kill. Snakes were found to be most frequently killed on the railway track, as they may be using the track (warm railway lines, sleepers etc.) for thigmothermy (mode of passive thermoregulation). Our preliminary investigation is just indicative but not exhaustive of the actual rail kill scenario which could be much higher during rainy season. The highest representative (as in no. of individuals) of *Indosylvirana* appearing as a rail kill is perhaps due to their ongoing breeding season which we have encountered in our stream survey. This reflects a snapshot of the scenario where more number individual of a species might face unfortunate death on railway tracks during their respective breeding seasons.

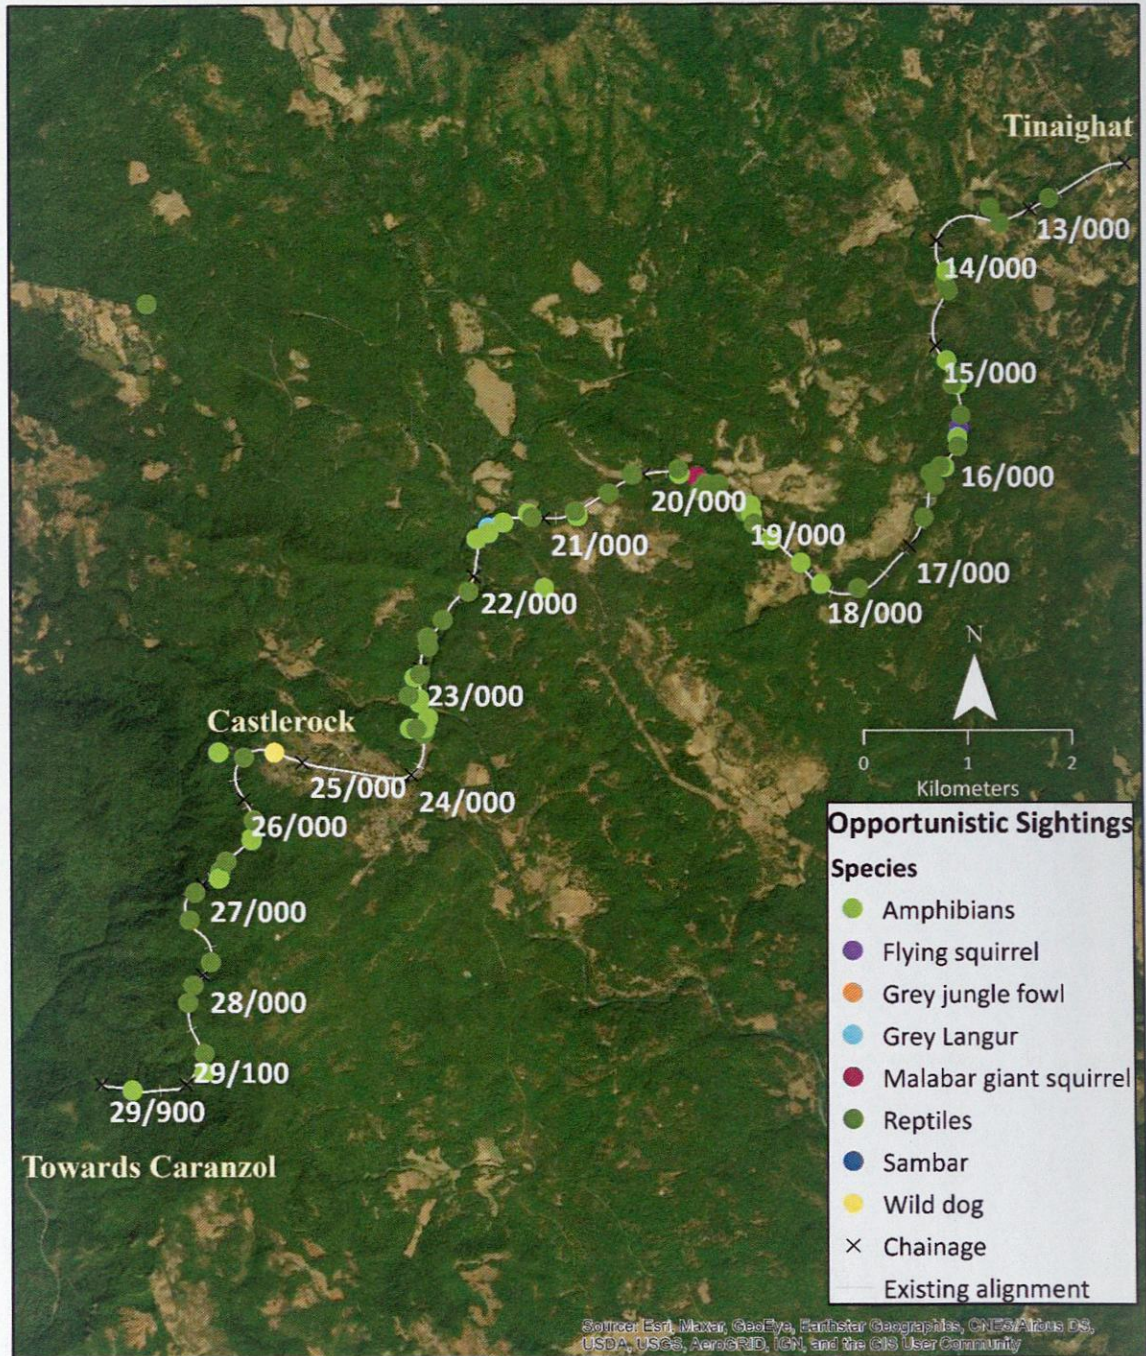
Figure 21: Opportunistic sightings of species recorded during the survey from Tinaighat to Caranzol section between 19.11.2020 – 04.12.2020

During the course of the survey, we also recorded opportunistic data viz., animal signs, sightings and rail/road mortality encountered during track surveys, as well as data from the Forest Department of Karnataka viz., rail mortality records and camera trap captures of mammals near the railway track. These data points were plotted and further used to identify potential animal crossing zones along the existing railway track (Figures 21, 22 and 23). Amphibian and reptile mortality data collected during the survey were also used.

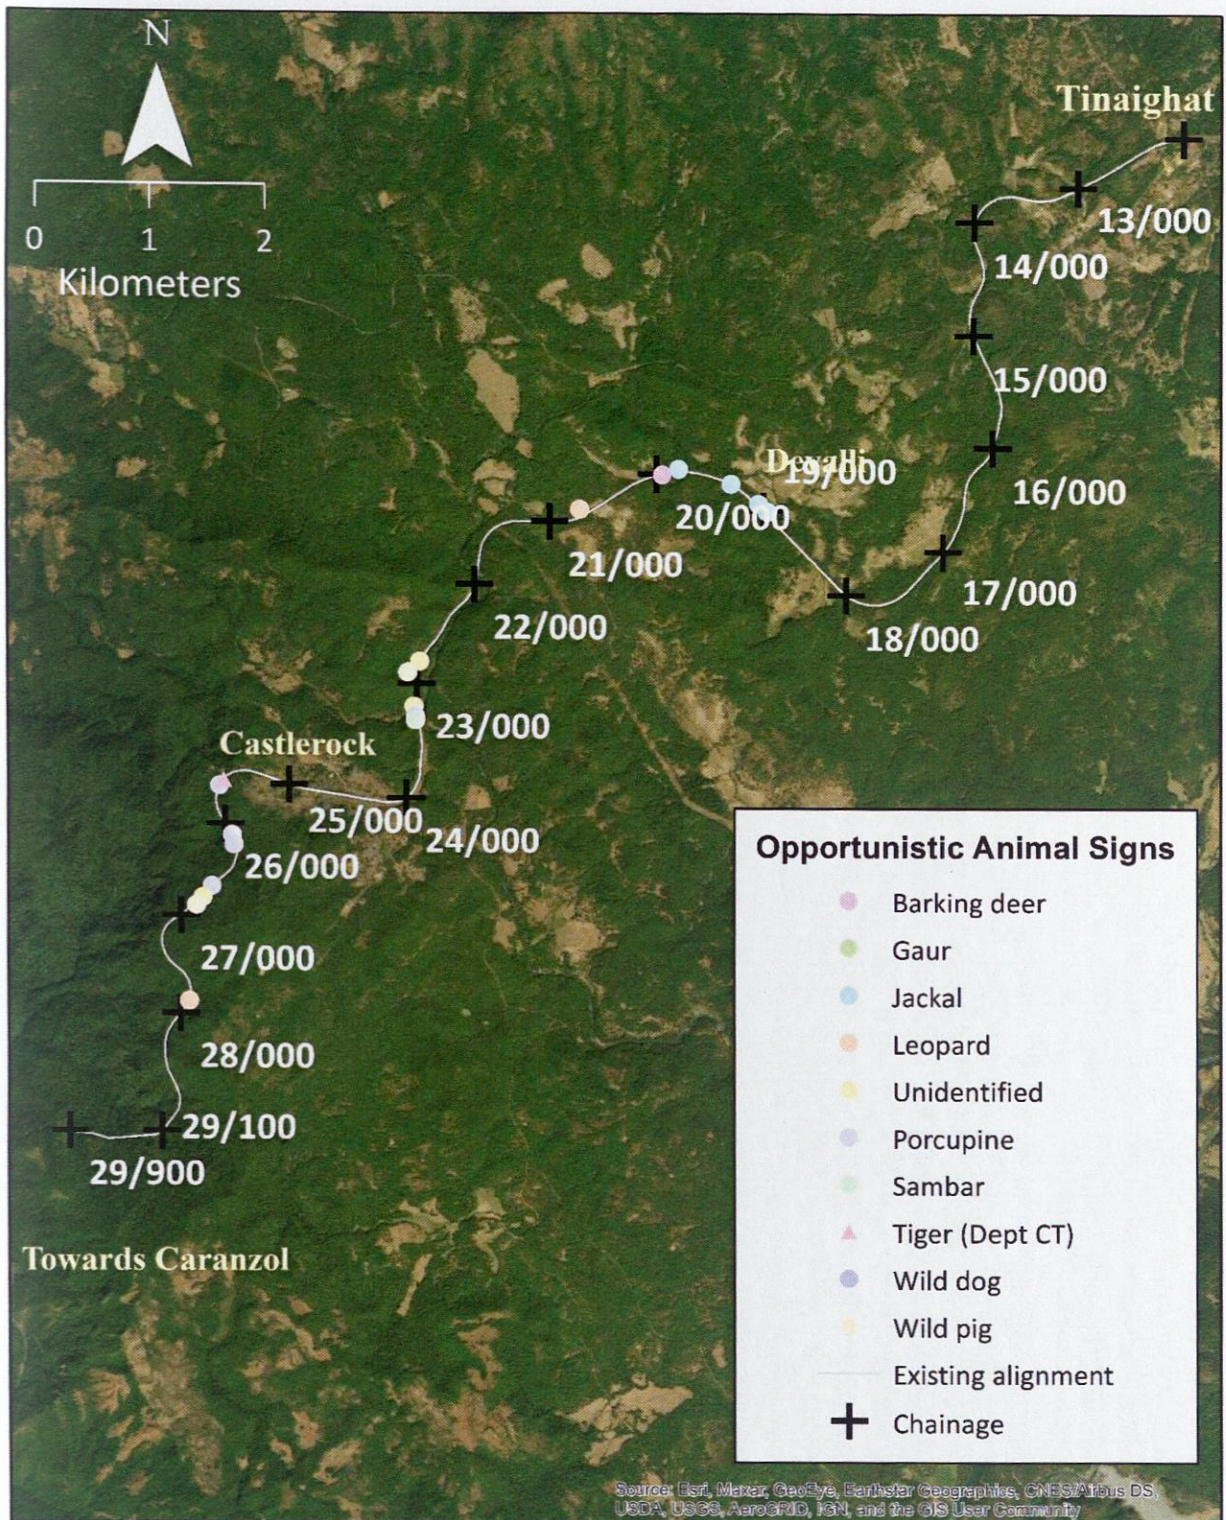
Figure 22: Opportunistic indirect signs recorded during the survey from Tinaighat to Caranzol section between 19.11.2020 – 04.12.2020. The map also includes the locations of two tiger captures obtained by camera set up by the Forest Department near the railway track.

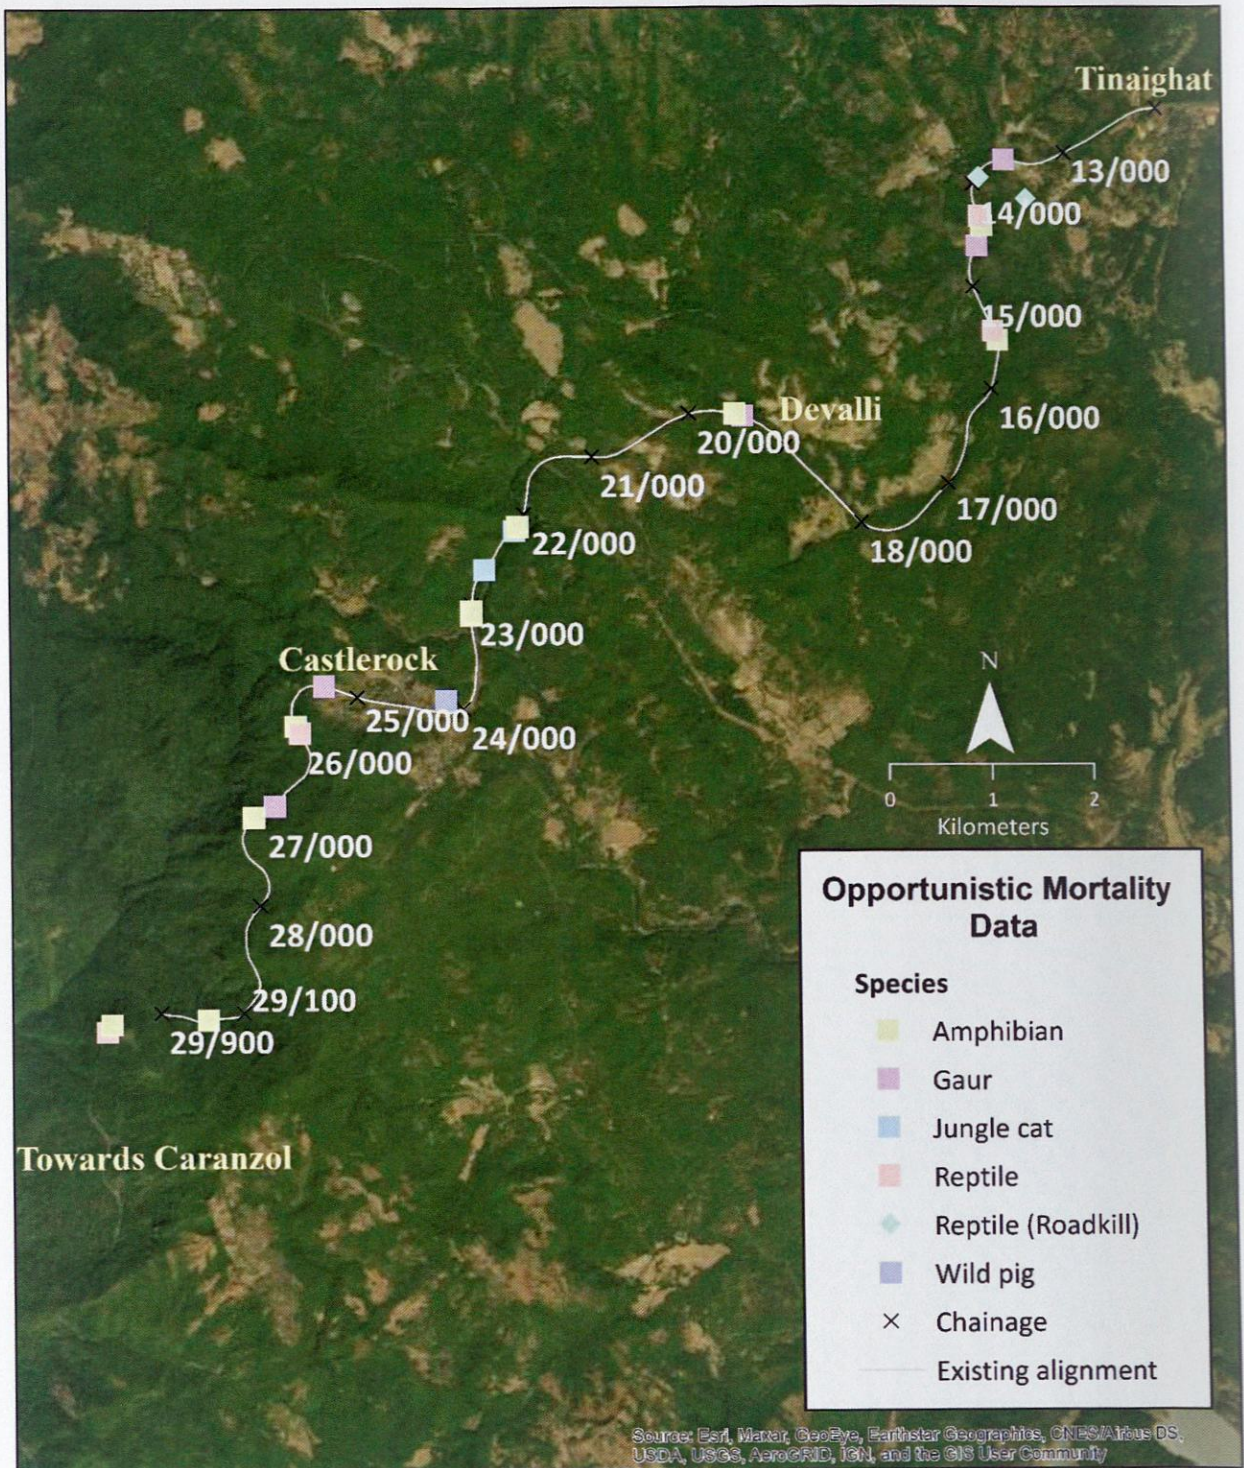
Figure 23: Animal mortality reported along the railway track and road (collected from the Karnataka Forest Department) and recorded during the survey by the team during 19.11.2020 – 04.12.2020 along the Tinaighat-Caranzol section.

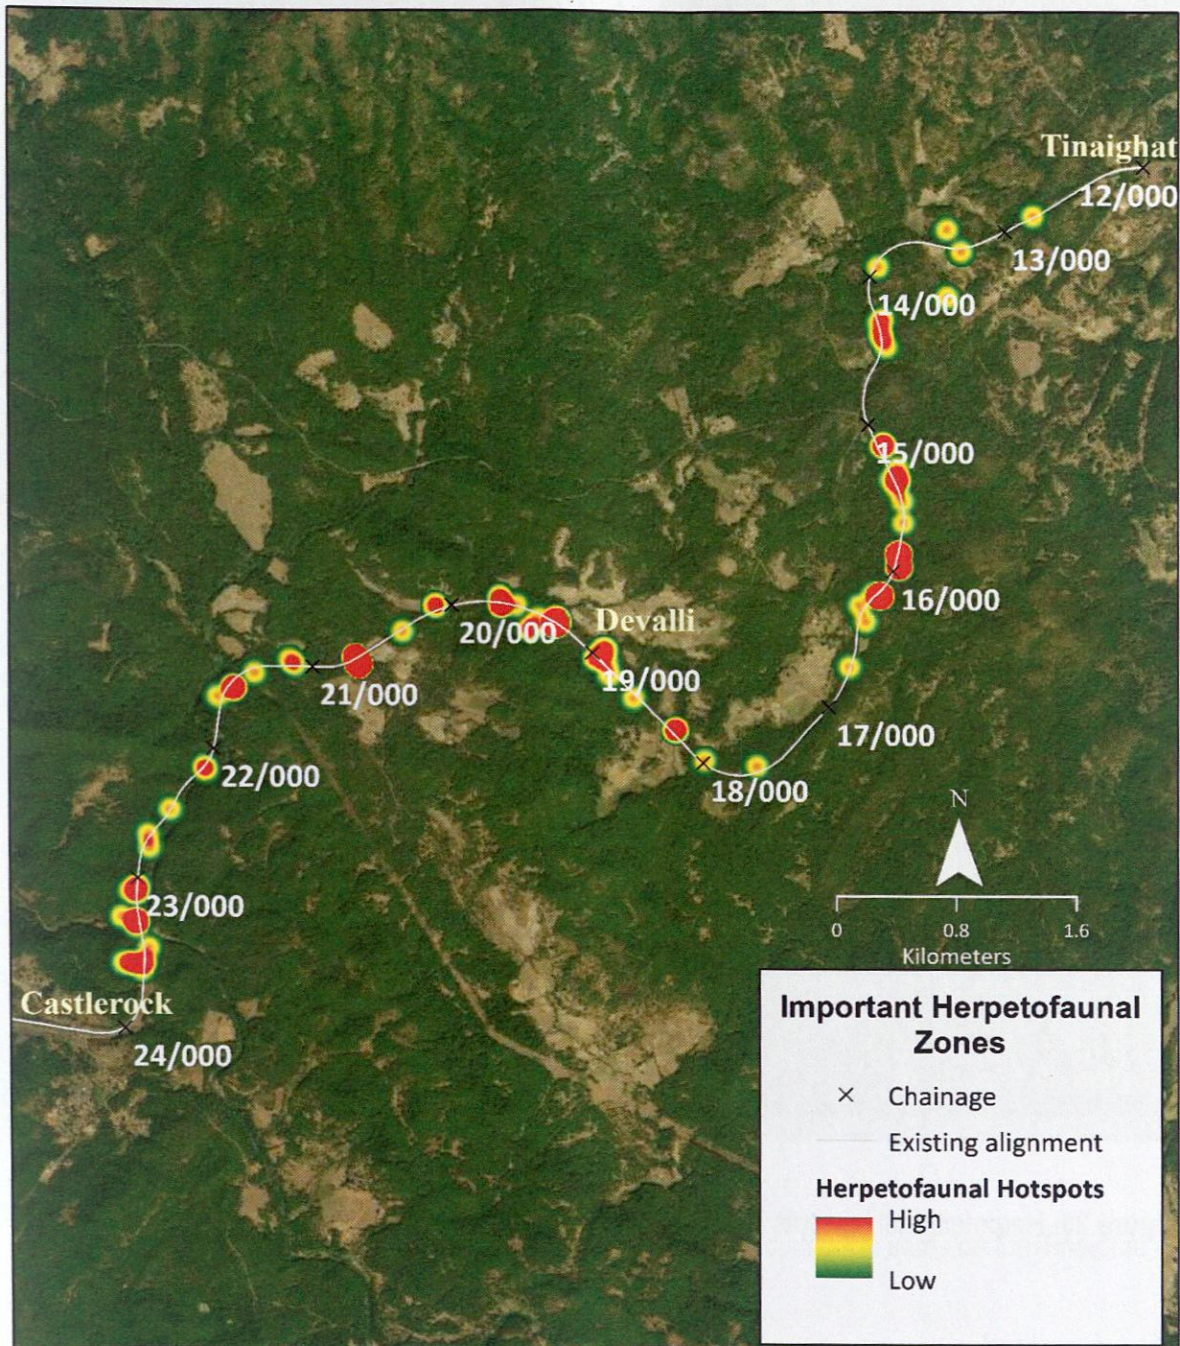
Figure 24: Herpetofaunal hotspots identified during the study on the Tinaighat – Castlerock railway section

Hotspots of animal activity/presence (herpetofauna– Figures 24 and 25; and mammals – Figures 26 and 27) were visualised by overlapping all animal signs, sightings, photo-captures and mortality data using kernel density analysis in GIS-platform. We used an optimum search radius of 150 m around each presence location to create hotspots of animal presence. These were then combined with the hotspots identified in the IISc reports (Sukumar and Sitharam, 2017), and potential animal crossing zones were thus delineated. Details of these potential animal crossing zones are given in Table 11.

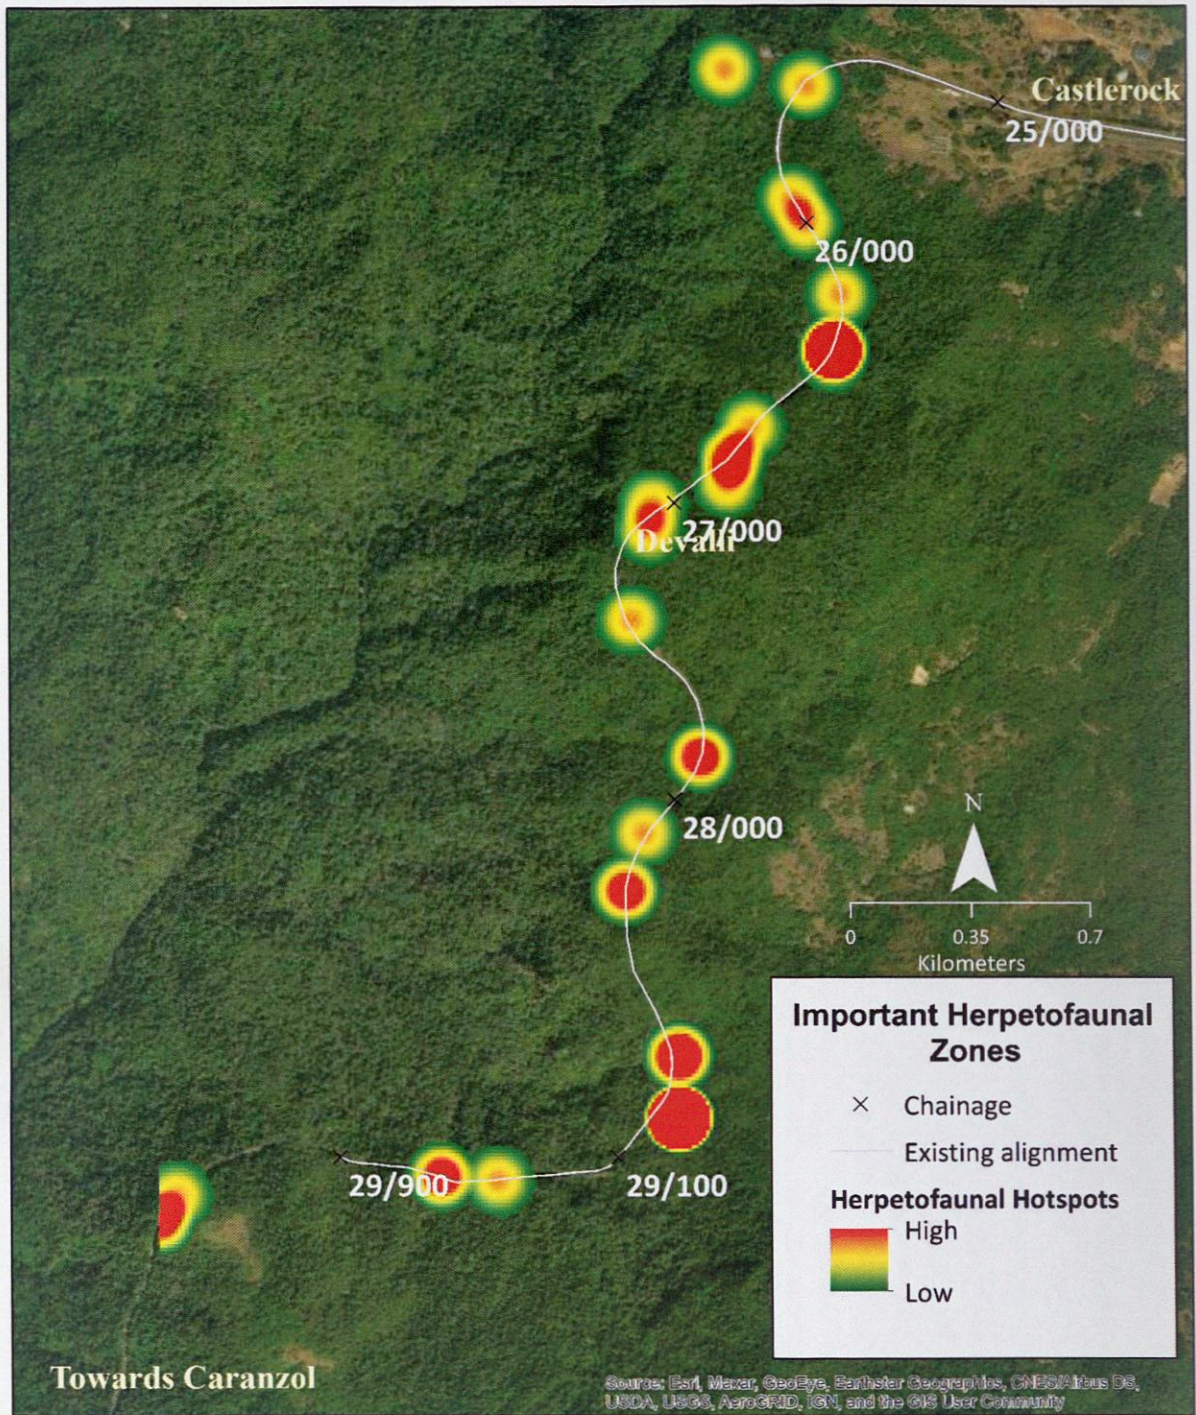
Figure 25: Herpetofaunal hotspots identified during the study on the Castlerock - Caranzol railway section

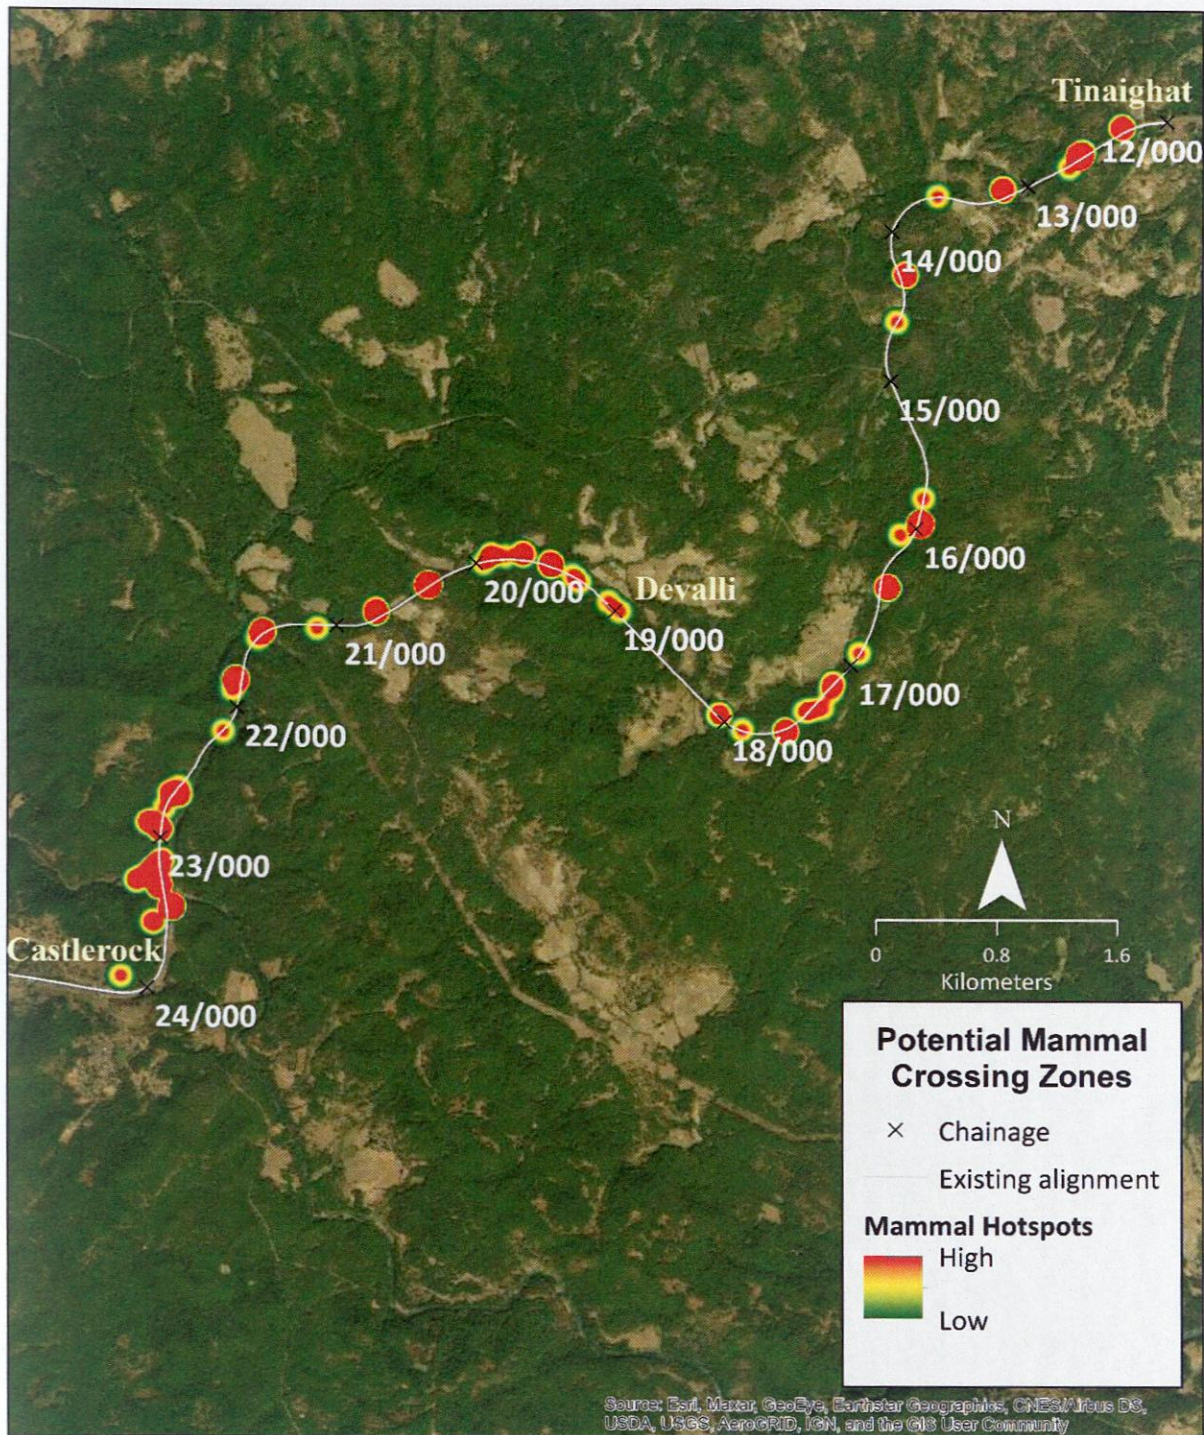
Figure 26: Hotspots of mammal presence/movement identified during the study on the Tinaighat – Castlerock railway section

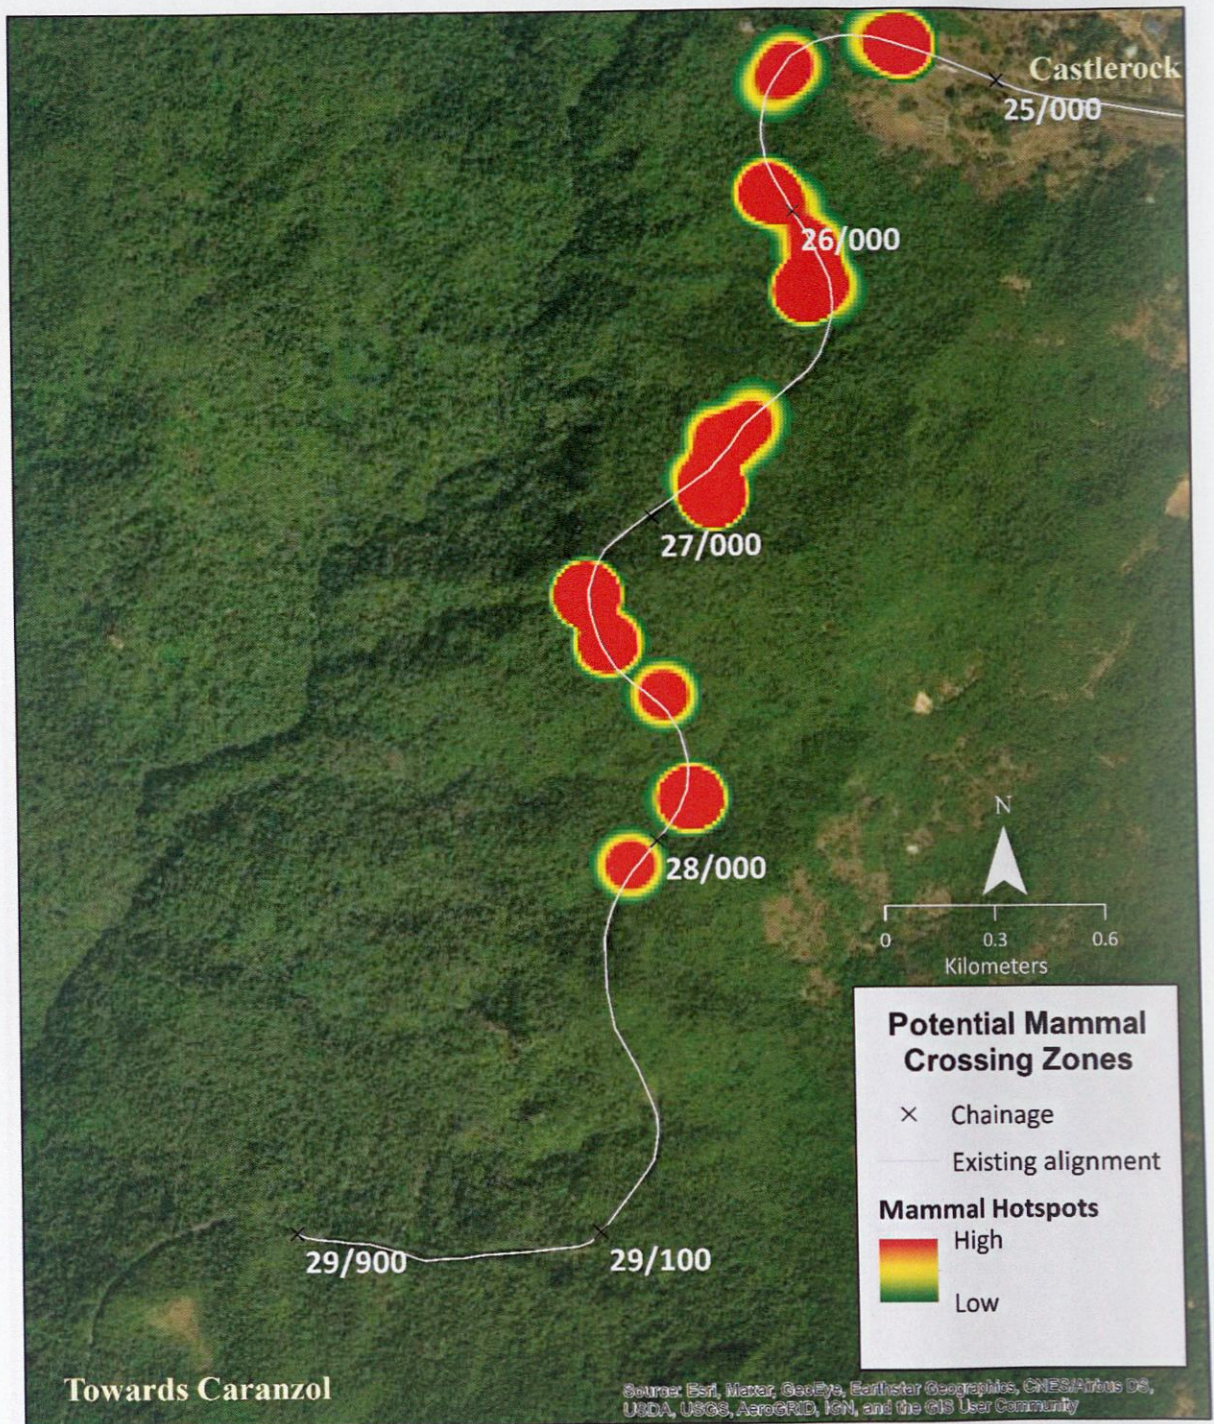
Figure 27: Hotspots of mammal presence/movement identified during the study on the Castlerock - Caranzol railway section

Based on the mammal hotspots thus obtained, major mammal presence hotspots and potential crossing were delineated based on the combined evidence of the present survey and IISc surveys.

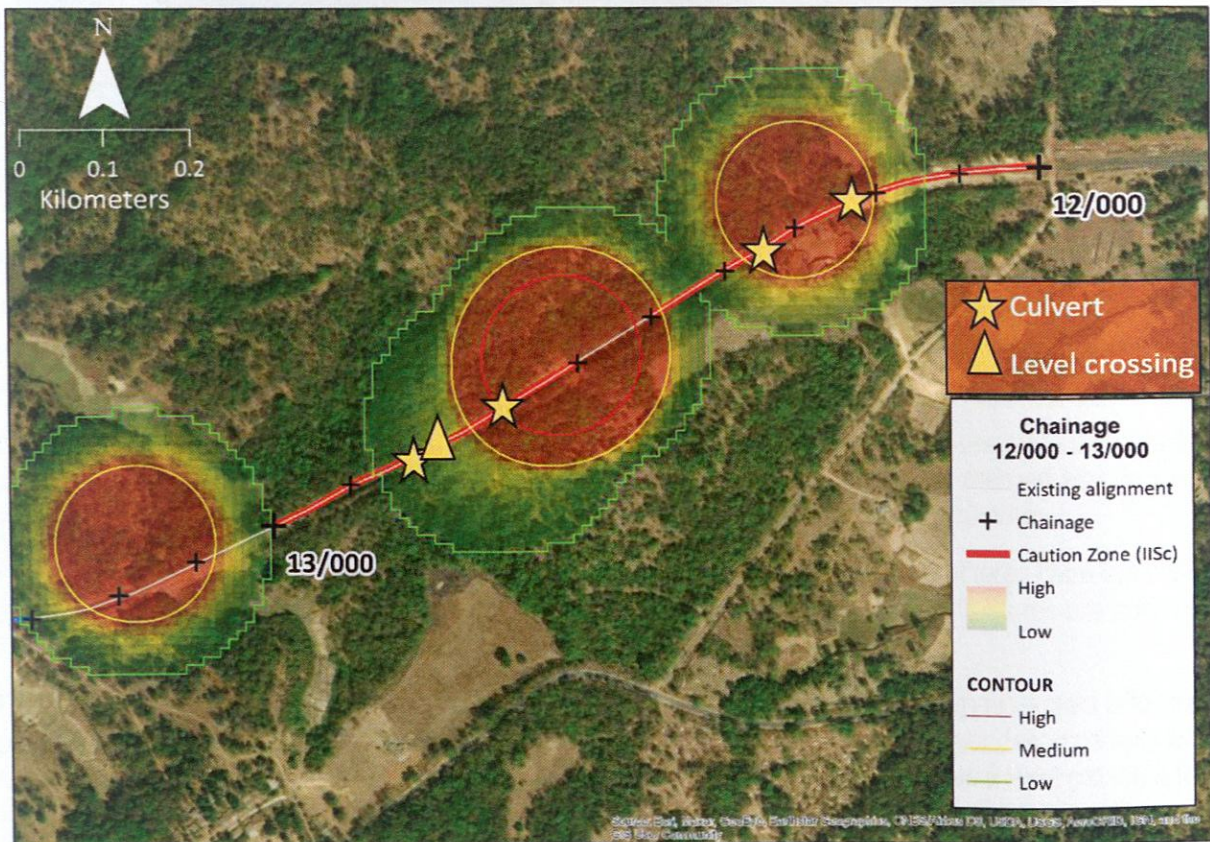
Figure 28: Locations of mitigation measures on chainage 12/000 – 13/000 to be constructed on existing and proposed railway track (NOTE: locations are approximated to the nearest chainage).

Increase in dimensions with ledges for structures 1 and 2 is recommended to make the structures more suitable for use by animals. Ledges are to be provided within all crossing structures.

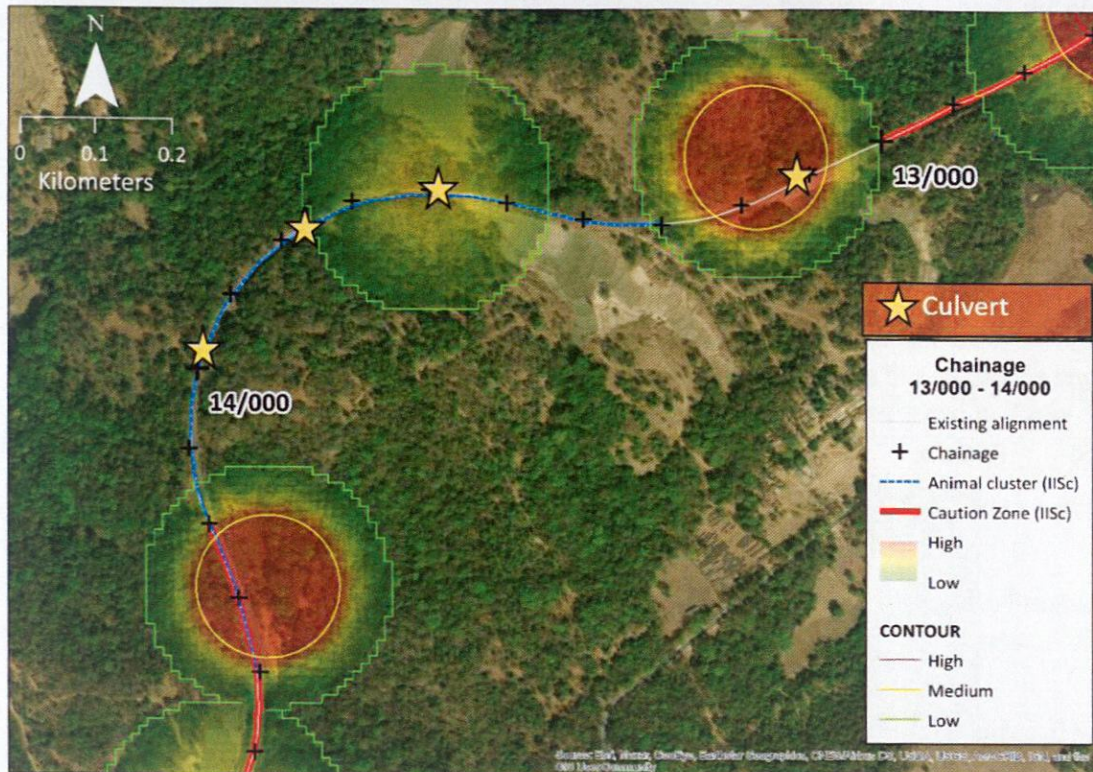
Figure 29: Locations of mitigation measures on chainage 13/000 – 14/000 to be constructed on an existing and proposed railway track
(NOTE: locations are approximated to the nearest chainage).

An increase in dimensions for structures 2, 3 and 4 is recommended with ledges to make the structures more suitable for use by animals. The RCC pipe culvert at chainage 13/772 should be converted to an RCC box culvert measuring 3 x 5 x 2.5 m. The additional culverts should be constructed to the right of the existing culvert (towards Tinaighat).

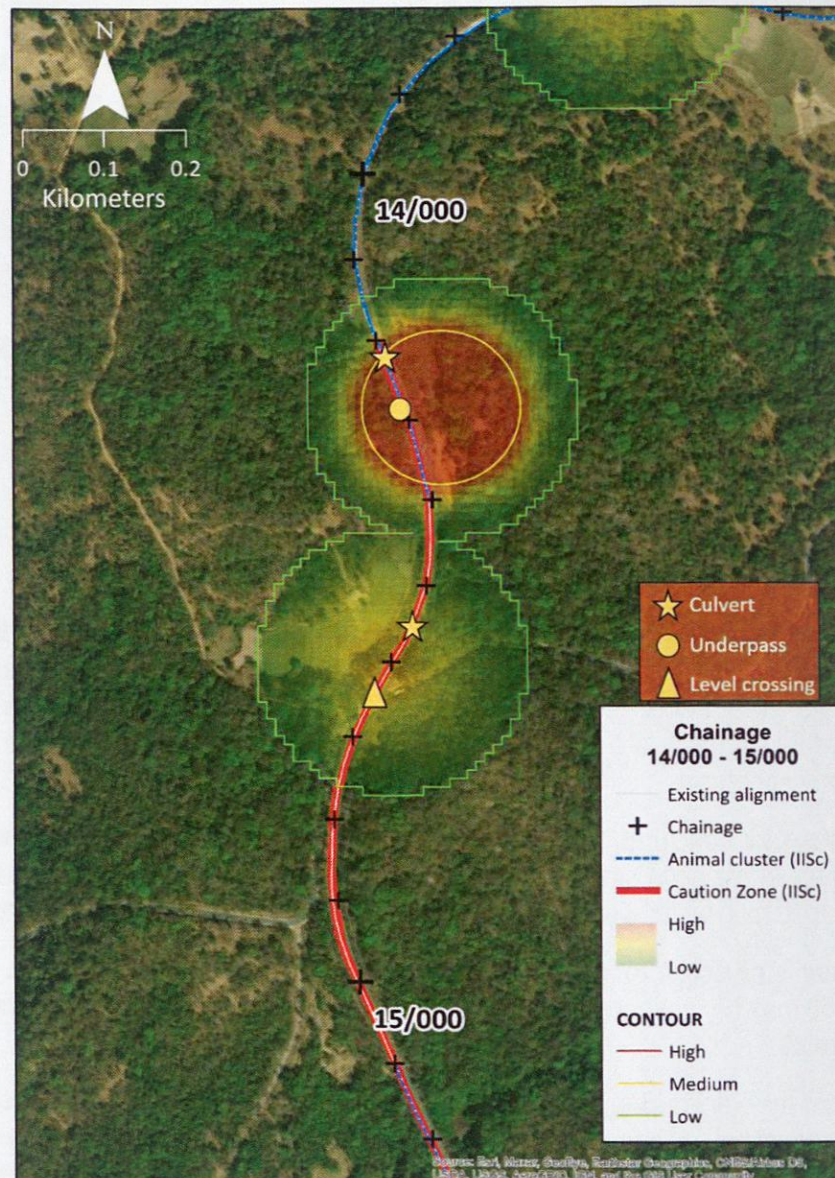
Figure 30: Locations of mitigation measures on chainage 14/000 – 15/000 to be constructed on existing and proposed railway track
(NOTE: locations are approximated to the nearest chainage).

Increase in dimensions for structures 1 and 2 is recommended to make the structures more suitable for use by animals. The two drainage structures between 14/230 and 14/295 may be merged as one long underpass spanning 20 m in width. Ledges are to be provided within all crossing structures.

The level crossing of the Panjim-Balgaum road at 14/650 is proposed to be decommissioned after the construction of the flyover at 14/940. The road across the railway line would also get decommissioned. In such a scenario, it is proposed to maintain the road level crossing of 50 m width as a level crossing for wild animals. Other specifications for the animal level crossing have been provided in the section 'General Recommendations'.
