December 2020

MITIGATION MEASURES FOR DOUBLING OF THE TINIAGHAT - CASTLEROCK - CARONZOL SWR RAILWAY TRACK, KARNATAKA

भारतीय वन्यजीव संस्थान
Wildlife Institute of India

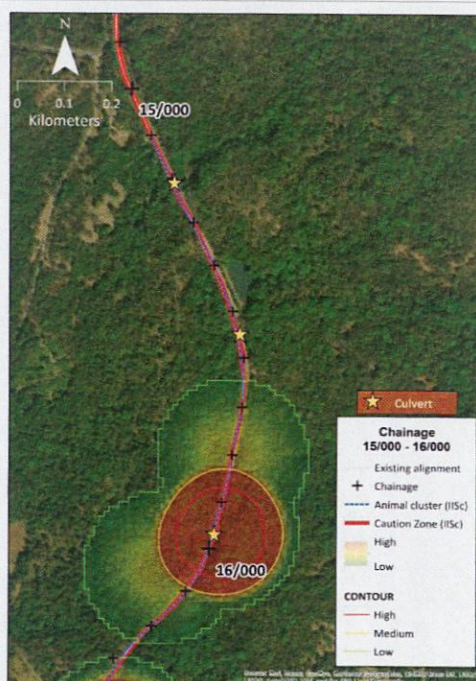
Figure 31: Locations of mitigation measures on chainage 15/000 – 16/000 to be constructed on existing and proposed railway track (NOTE: locations are approximated to the nearest chainage).

In this section, we found multiple captures of gaur, langur, porcupine and wild pig during our camera trapping exercise, as well as sighting of the elusive Malabar flying squirrel. Three perennial streams are existing in this section at the chainages 15/962, 15/552, and 15/213 which are crucial habitat for herpetofauna especially for amphibians during the breeding season. In this section we have recorded around 10 species of herpetofauna, as well as rail kill of *Dendrelaphis* sp. Thus this section is important for mammals, arboreal species and herpetofauna. The details of structures are given in Table 15 and Figure 31.

Increase in dimensions for all three structures is recommended to make the structures more suitable for use by animals. Ledges are to be provided within all crossing structures.

S. No.	Chainage	Structures on Existing Railway Track		Structures planned on Proposed Railway Track		Modification of proposed structure to act as mitigation measures	
		Structure type	Dimension (m) (No. x width x height)	Structure type	Dimension (m) (No. x width x height)	Structure type	Structure type (No. x width x height)
1.	15/213	RCC box	1 x 2.35 x 2.65	RCC box	1 x 2.35 x 2.65	RCC box	4 x 5 x 3
2.	15/552	RCC box	1 x 2.45 x 2.0	RCC box	1 x 2.45 x 2.0	RCC box	2 x 5 x 4.5
3.	15/962	RCC box	1 x 2.4 x 1.85	RCC box	1 x 2.4 x 1.85	RCC box	3 x 5 x 4.5

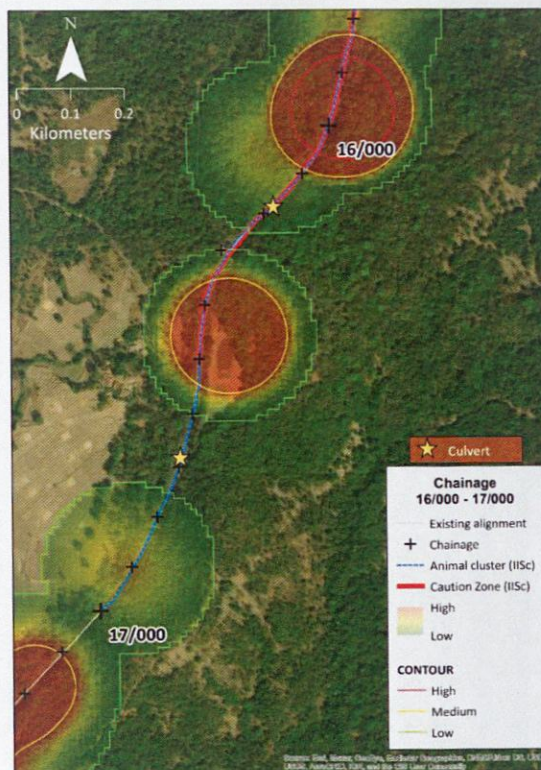
Figure 32: Locations of mitigation measures on chainage 16/000 – 17/000 to be constructed on existing and proposed railway track (NOTE: locations are approximated to the nearest chainage).

Increase in dimensions for both structures is recommended to make the structures more suitable for use by animals. Ledges are to be provided within all crossing structures. The details of structures are given in Table 16 and Figure 32.

S. No.	Chainage	Structures on Existing Railway Track		Structures planned on Proposed Railway Track		Modification of proposed structure to act as mitigation measures	
		Structure type	Dimension (m) (No. x width x height)	Structure type	Dimension (m) (No. x width x height)	Structure type	Dimension (m) (No. x width x height)
1.	16/188	Pipe culvert	1 x 2 x 1.25	RCC box	1 x 2.92 x 1.8	RCC box	2 x 5 x 2.5
2.	16/688	RCC box	1 x 1.83 x 2.88	RCC box	1 x 1.83 x 2.88	RCC box	2 x 5 x 3

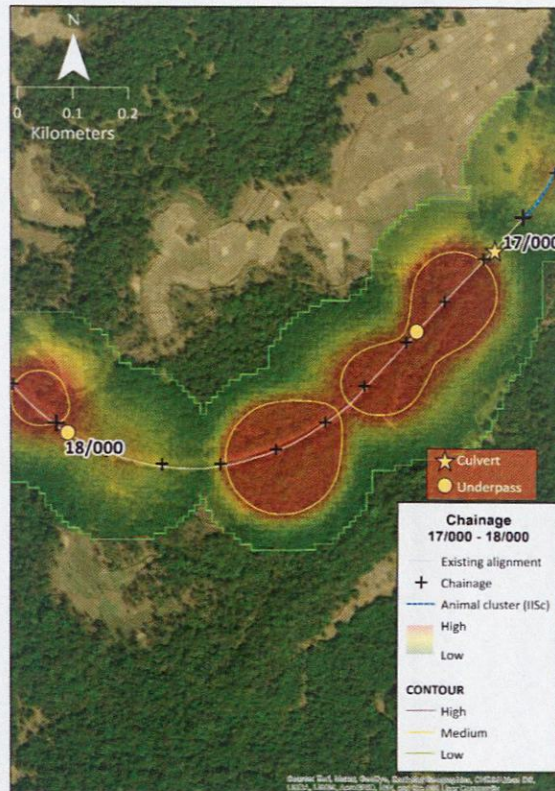
Figure 33: Locations of mitigation measures on chainage 17/000 – 18/000 to be constructed on existing and proposed railway track
(NOTE: locations are approximated to the nearest chainage).

Increase in dimensions for structure 1 is recommended to make the structure more suitable for use by animals. Ledges are to be provided within all crossing structures. The details of structures are given in Table 17 and Figure 33.

Two non-drainage underpasses are recommended at chainages 17/280 and 17/950. Adequate height for the same is available on both sides of the existing track.

S. No.	Chainage	Structures on Existing Railway Track		Structures planned on Proposed Railway Track		Modification of proposed structure to act as mitigation measures	
		Structure type	Dimension (m) (No. x width x height)	Structure type	Dimension (m) ((No. x width x height)	Structure type	Dimension (m) (No. x width x height)
1.	17/074	RCC pipe	1 x 1.2	RCC box	1 x 1.2 x 1.8	RCC box	1 x 5 x 2
2.	17/280	NIL	NIL	NIL	NIL	Underpass	2 x 5 x 3
3.	17/950	NIL	NIL	NIL	NIL	Underpass	1 x 50 x 5.5

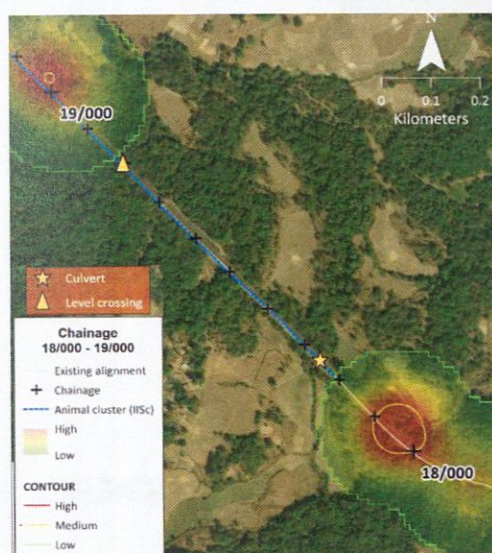
Figure 34: Locations of mitigation measures on chainage 18/000 – 19/000 to be constructed on existing and proposed railway track (NOTE: locations are approximated to the nearest chainage).

Considering the above factors, the details of mitigation measures proposed for this chainage are given in Table 18 and shown in Figure 34.

S. No.	Chainage	Structures on Existing Railway Track		Structures planned on Proposed Railway Track		Modification of proposed structure to act as mitigation measures	
		Structure type	Dimension (m) ((No. x width x height)	Structure type	Dimension (m) ((No. x width x height)	Structure type	Dimension (m) (No. x width x height)
1.	18/251	RCC box	2 x 3.34 x 3.6	RCC box	2 x 3.34 x 3.6	RCC box	2 x 3.34 x 3.6
2.	18/800	NIL	NIL	NIL	NIL	Level crossing with early warning system	50 (width)

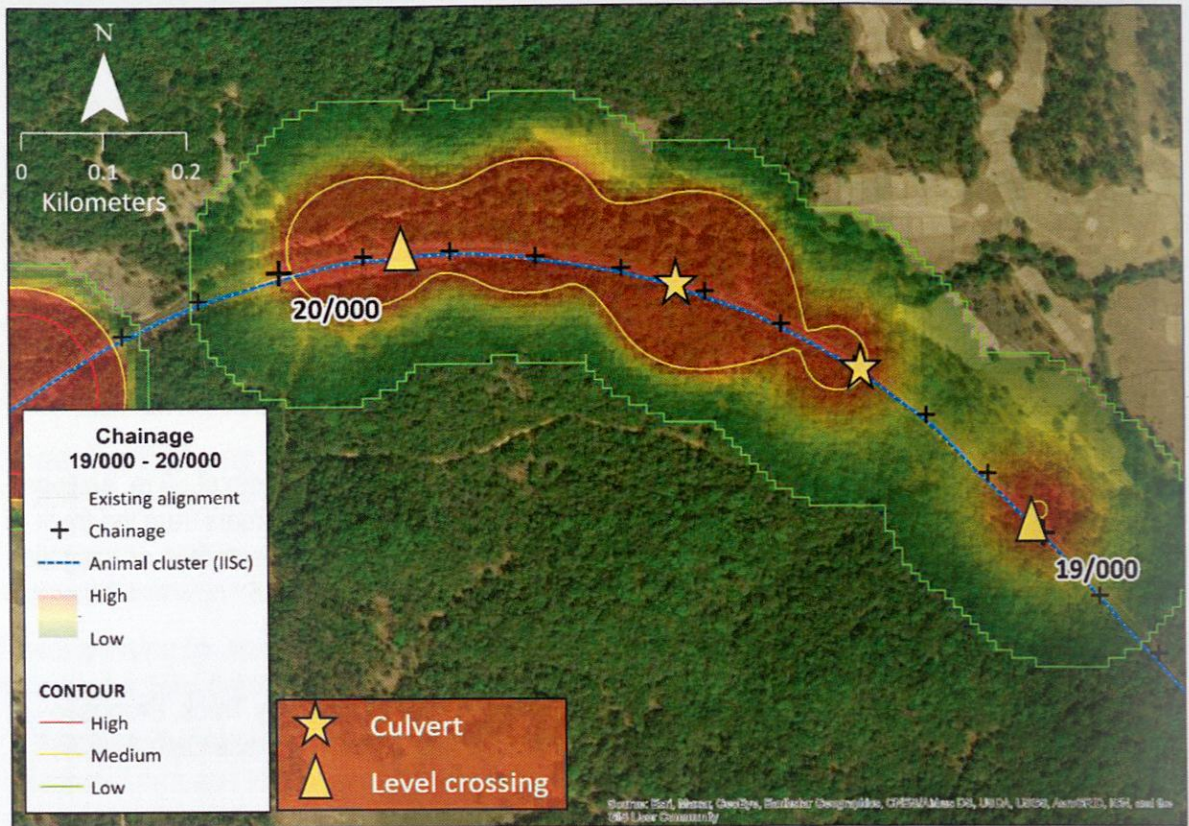
Figure 35: Locations of mitigation measures on chainage 19/000 – 20/000 to be constructed on existing and proposed railway track
 (NOTE: locations are approximated to the nearest chainage).

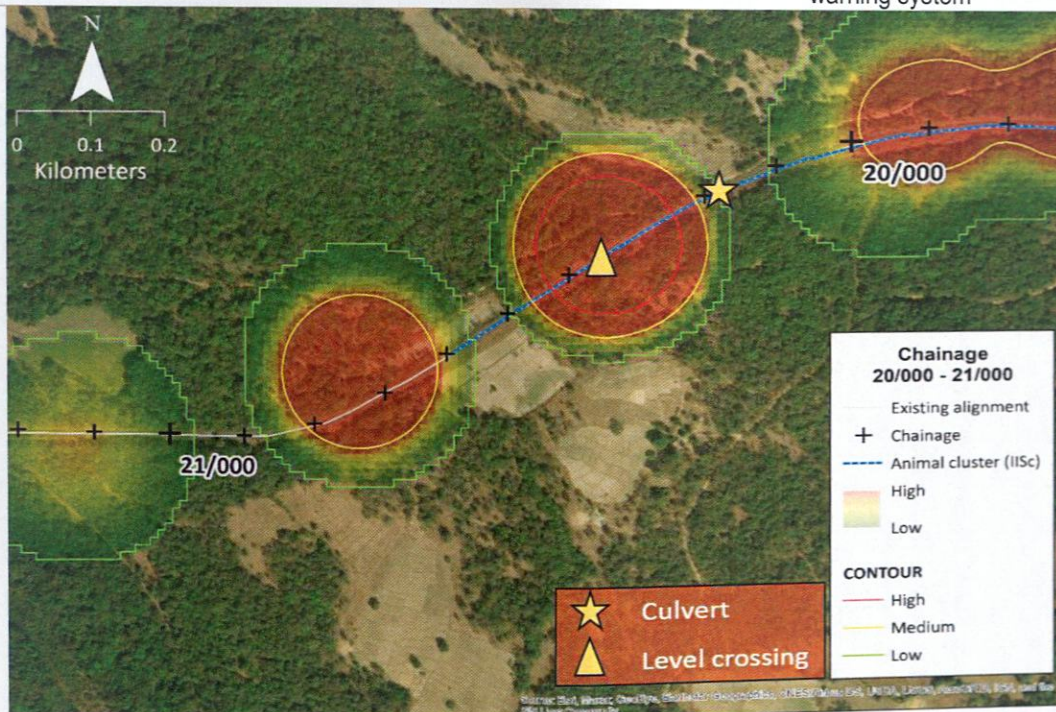
Figure 36: Locations of mitigation measures on chainage 20/000 – 21/000 to be constructed on existing and proposed railway track (NOTE: locations are approximated to the nearest chainage).

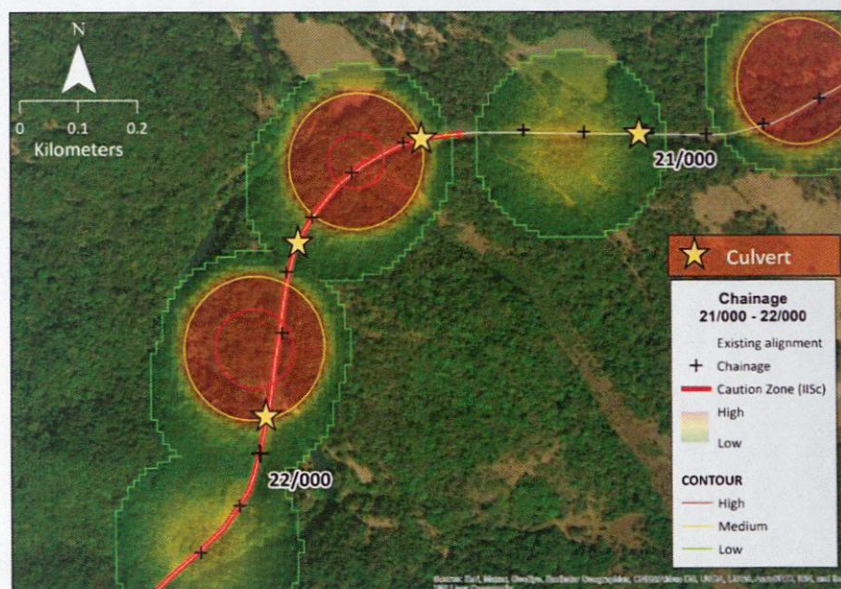
Figure 37: Locations of mitigation measures on chainage 21/000 – 22/000 to be constructed on existing and proposed railway track (NOTE: locations are approximated to the nearest chainage).

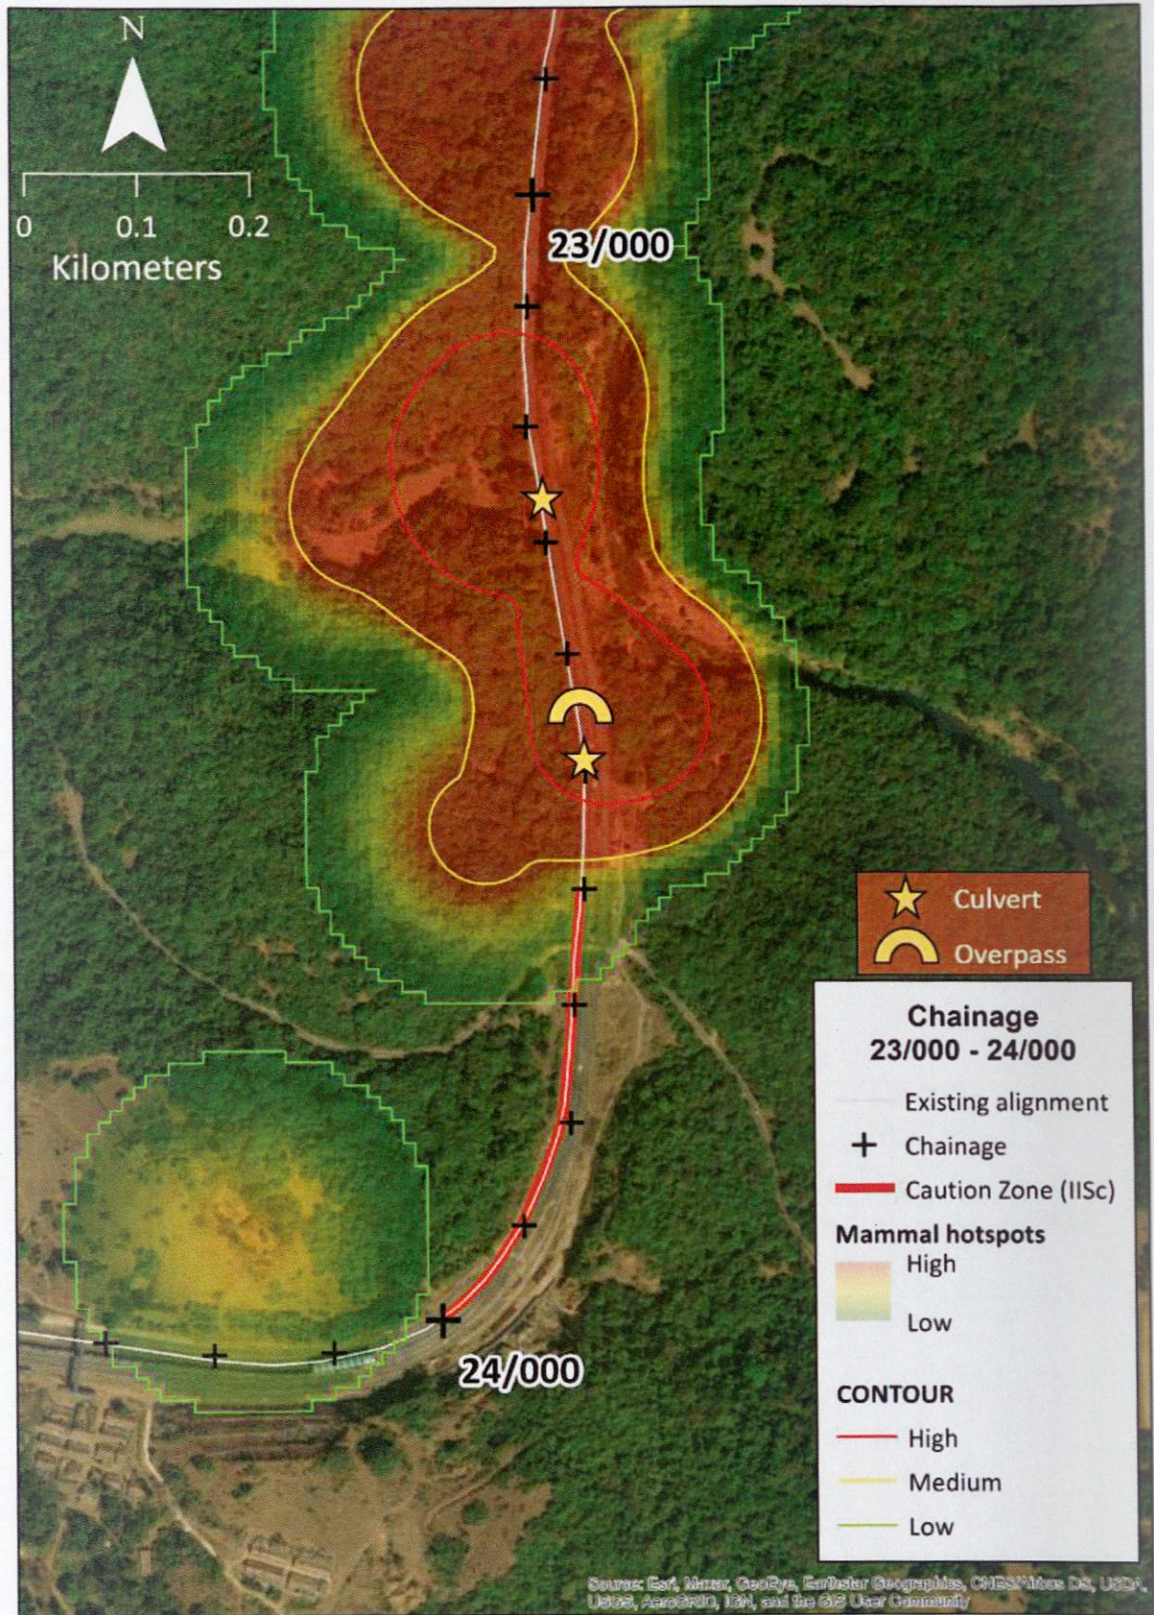
Figure 39: Locations of mitigation measures on chainage 23/000 – 24/000 to be constructed on existing and proposed railway track
 (NOTE: locations are approximated to the nearest chainage).

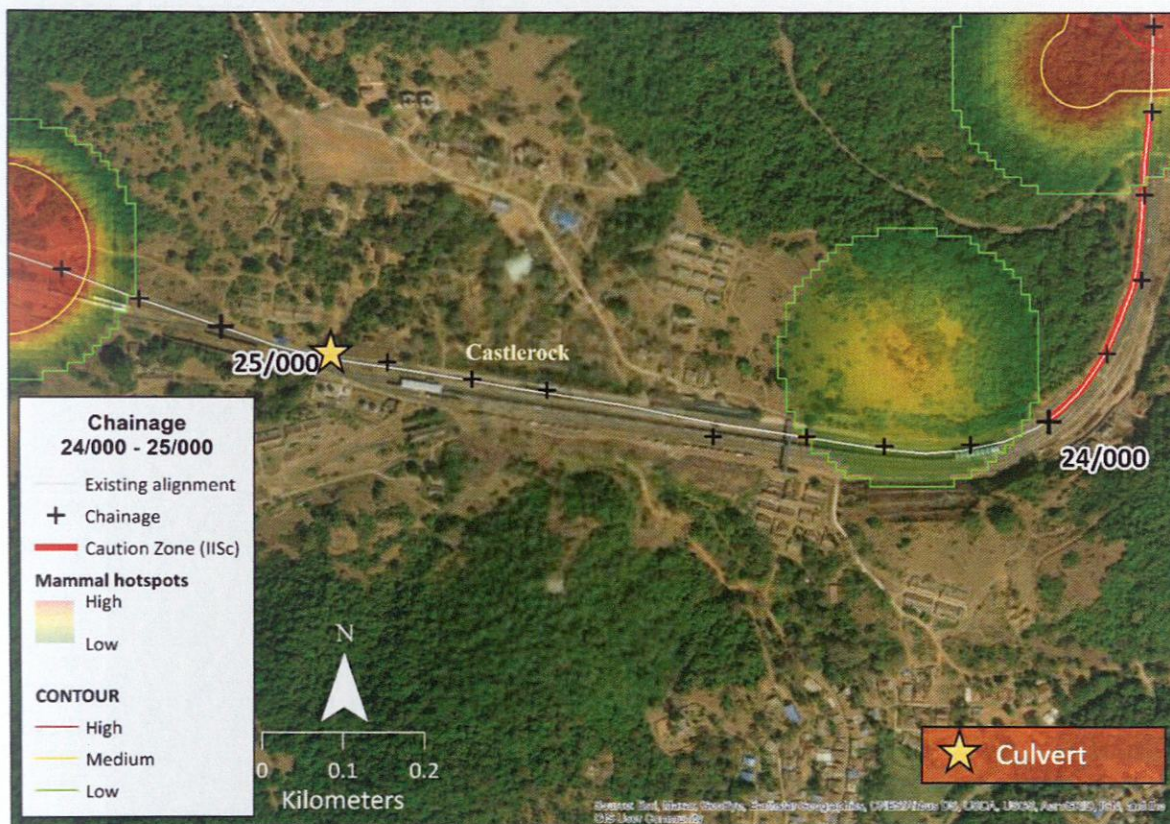
Figure 40: Locations of mitigation measures on chainage 24/000 – 25/000 to be constructed on existing and proposed railway track (NOTE: locations are approximated to the nearest chainage).

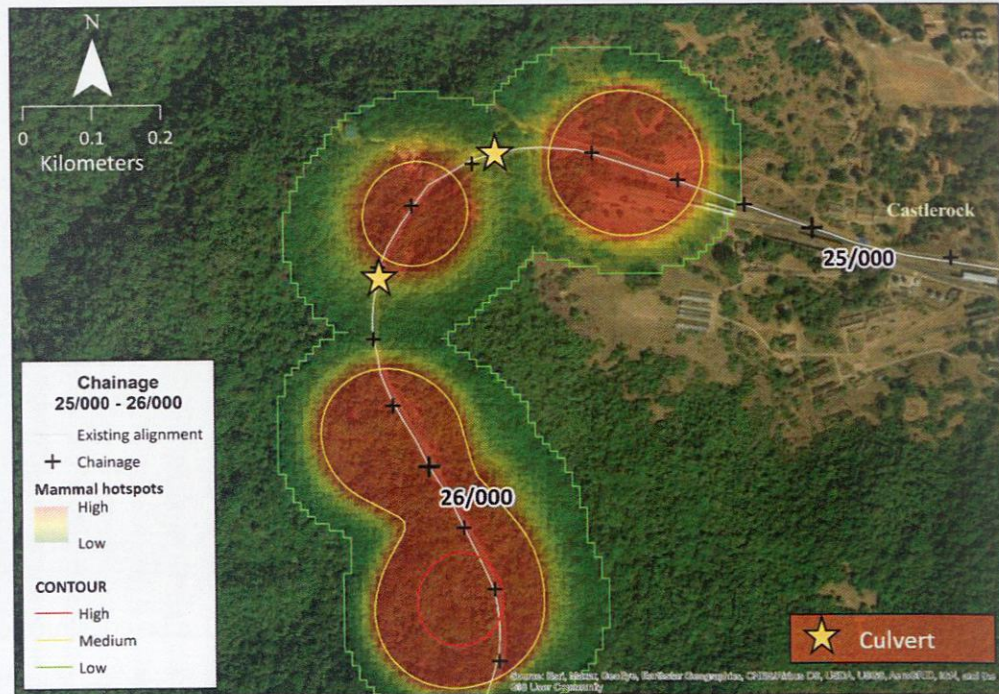
Figure 41: Locations of mitigation measures on chainage 25/000 – 26/000 to be constructed on existing and proposed railway track (NOTE: locations are approximated to the nearest chainage).

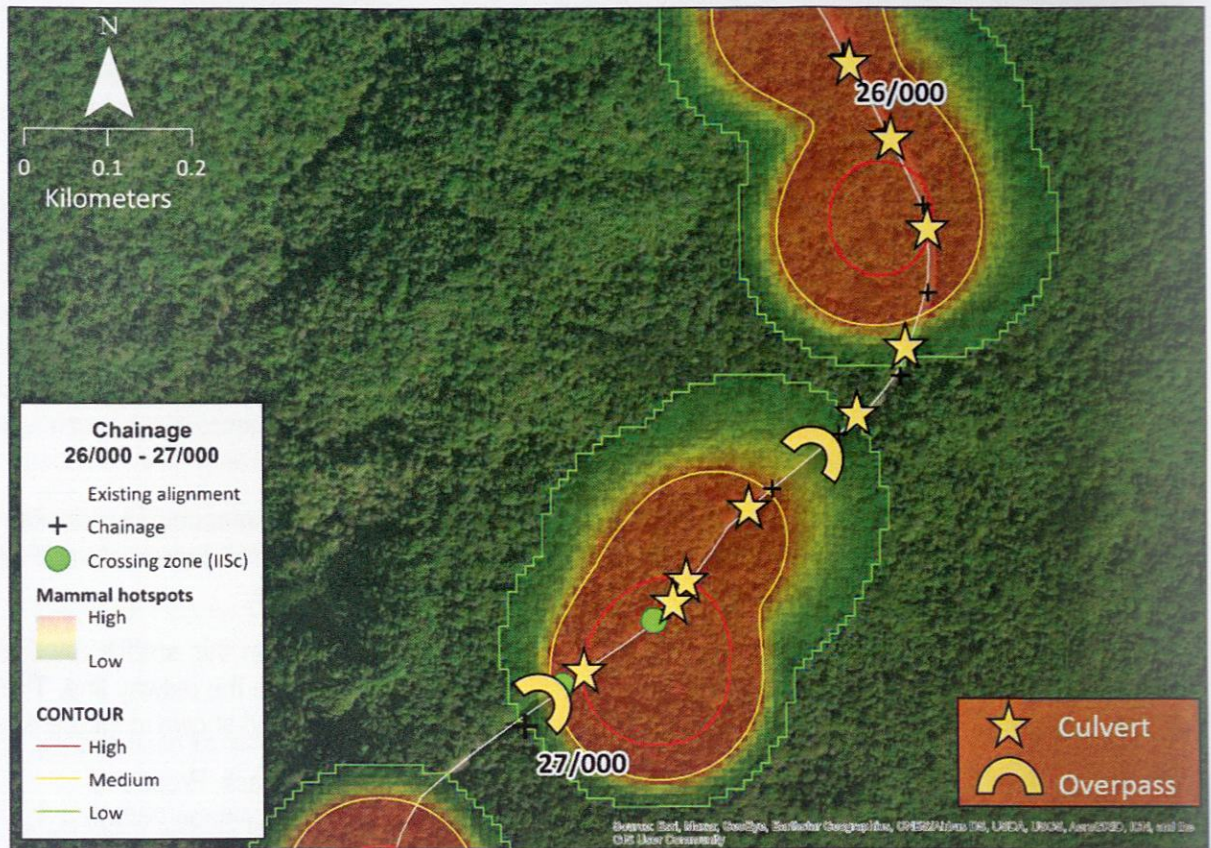
Figure 42: Locations of mitigation measures on chainage 26/000 – 27/000 to be constructed on existing and proposed railway track
(NOTE: locations are approximated to the nearest chainage).

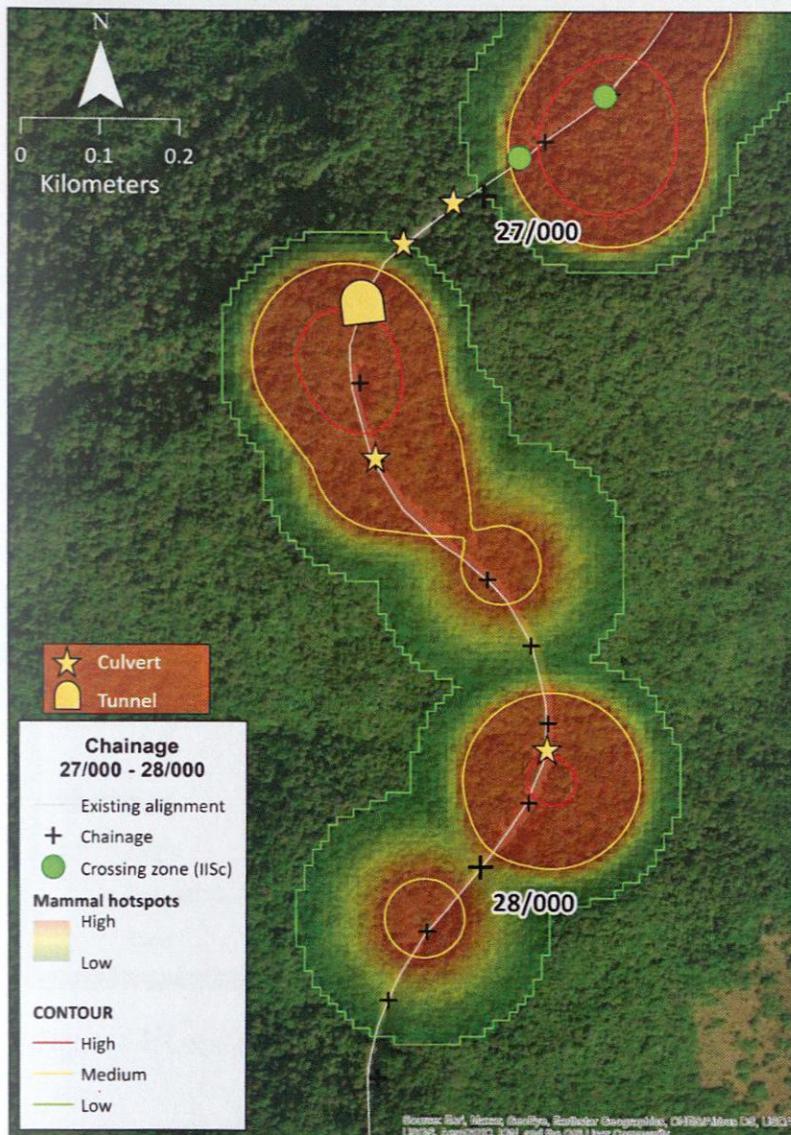
Figure 43: Locations of mitigation measures on chainage 27/000 – 28/000 to be constructed on existing and proposed railway track (NOTE: locations are approximated to the nearest chainage).

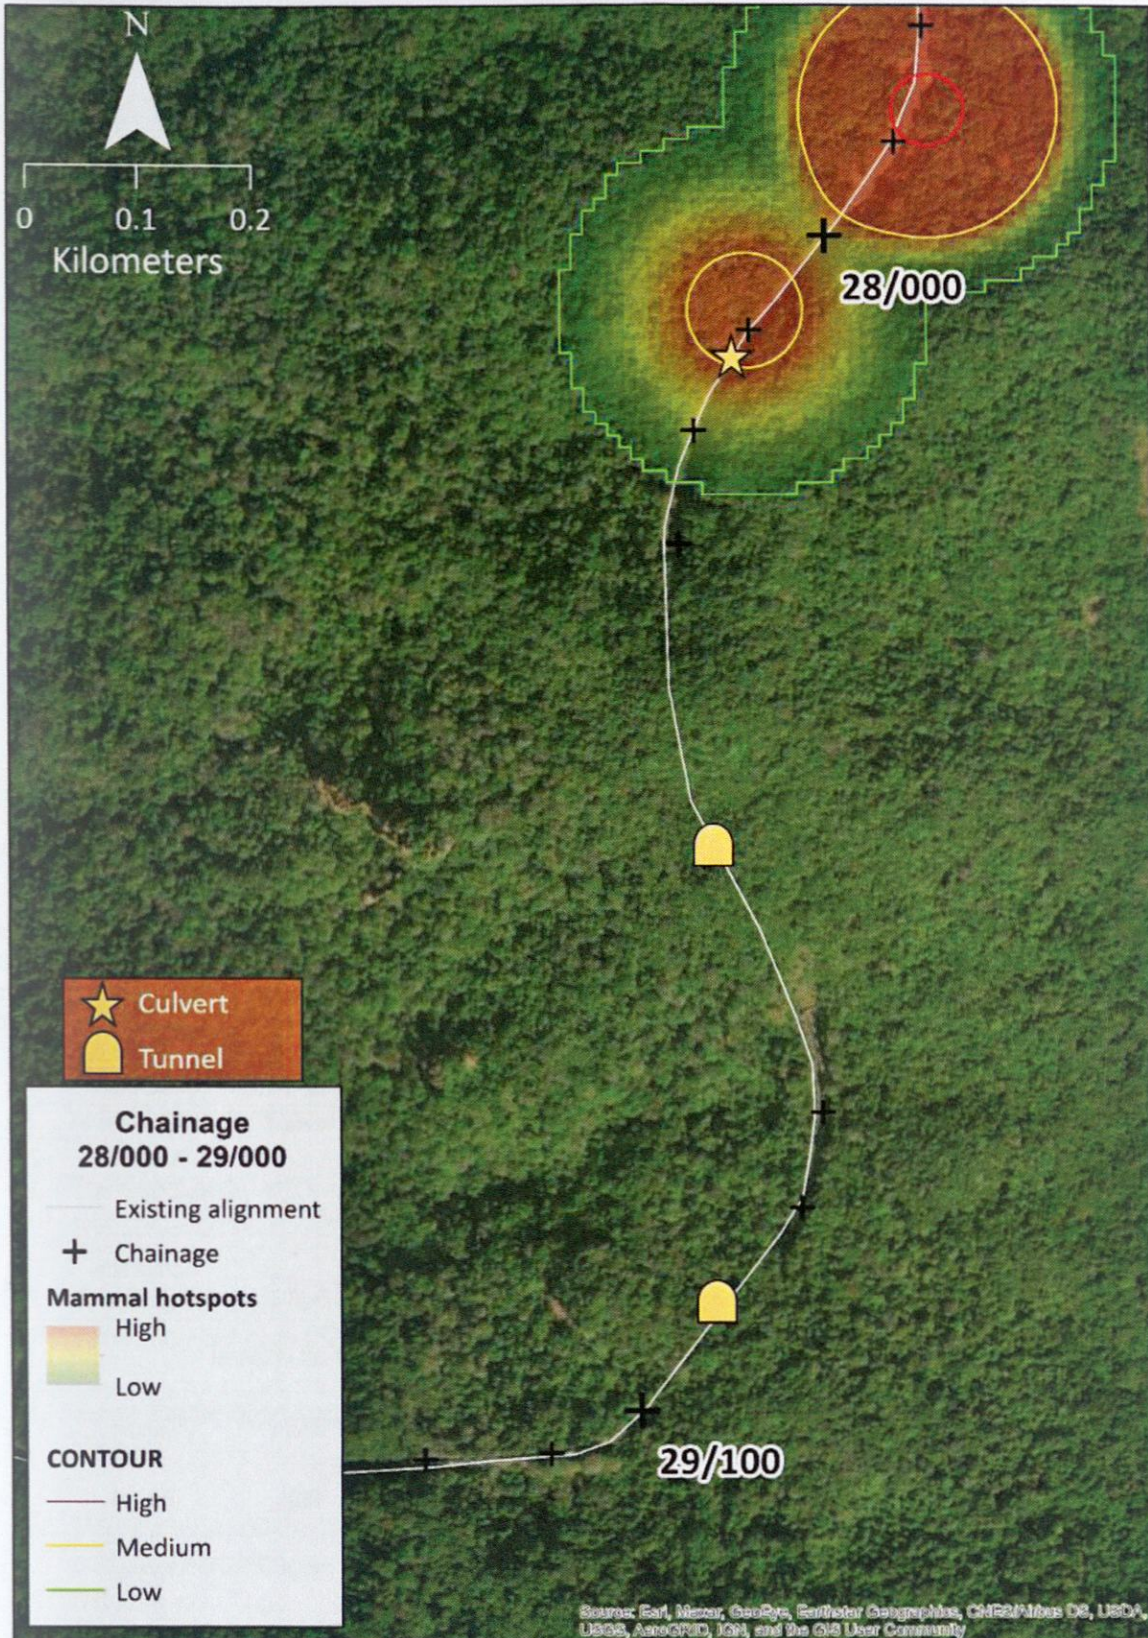
Figure 44: Locations of mitigation measures on chainage 28/000 – 29/000 to be constructed on existing and proposed railway track (NOTE: locations are approximated to the nearest chainage).

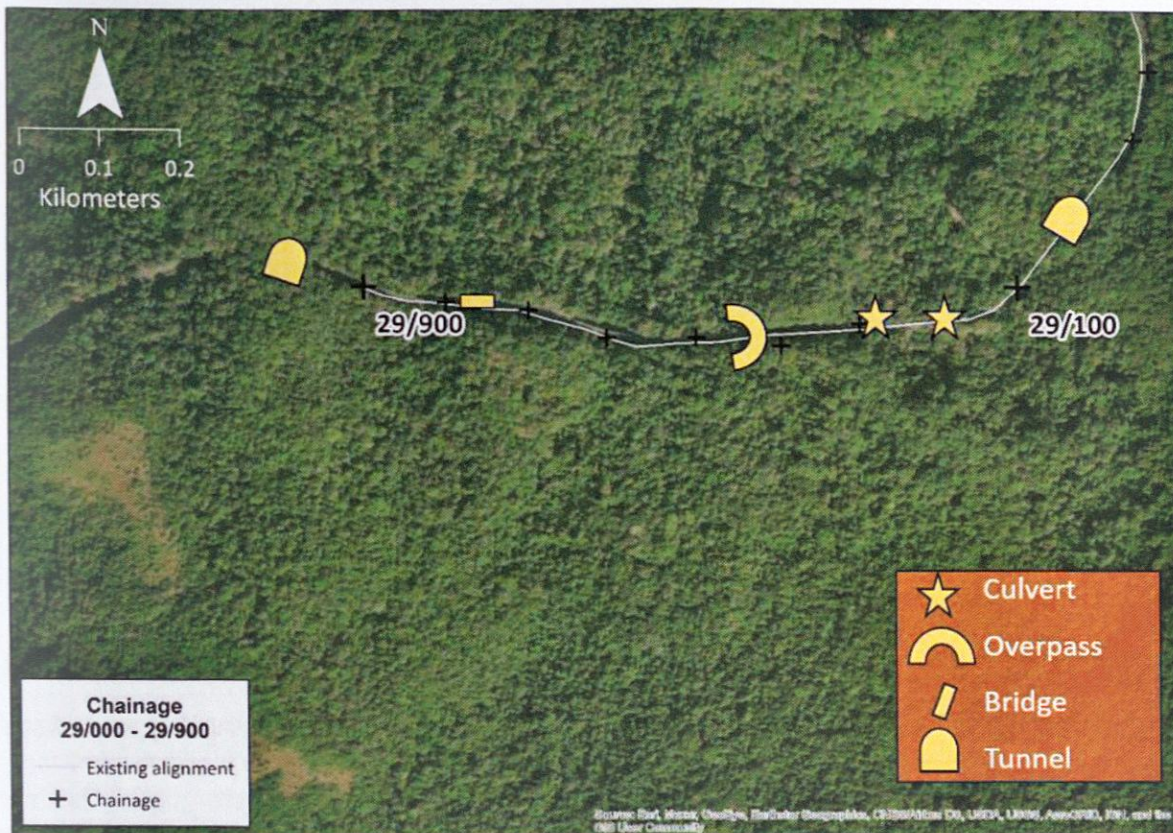
Figure 45: Locations of mitigation measures on chainage 29/000 – 29/900 to be constructed on existing and proposed railway track
(NOTE: locations are approximated to the nearest chainage).

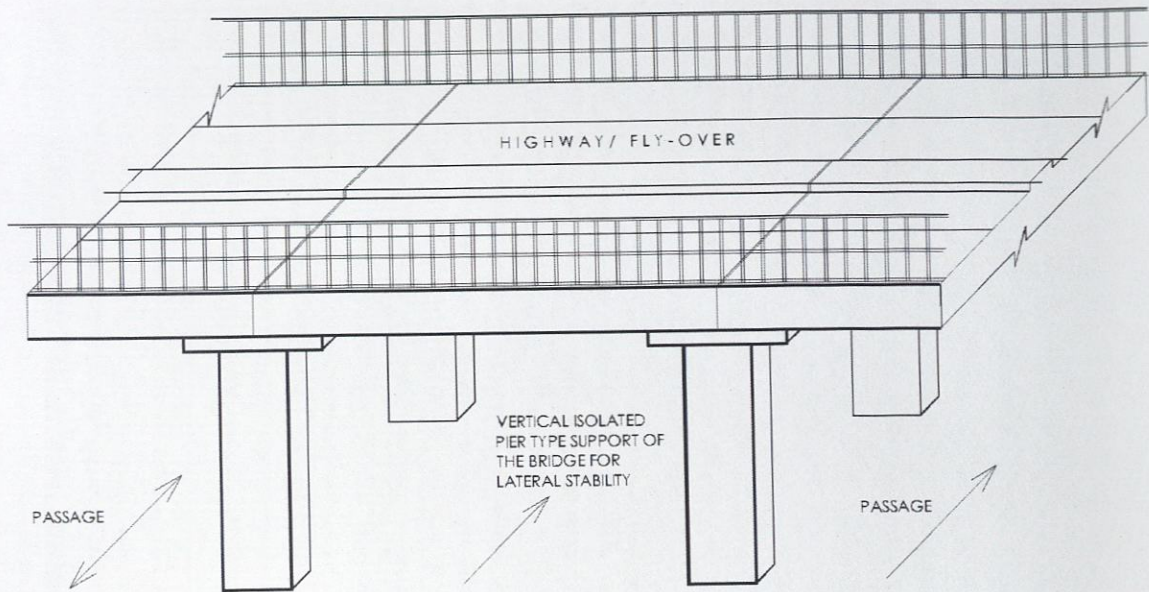
Figure 46: Pillar-type divisions are to be used for culverts instead of wall-type divisions
(Source: WII, 2016)

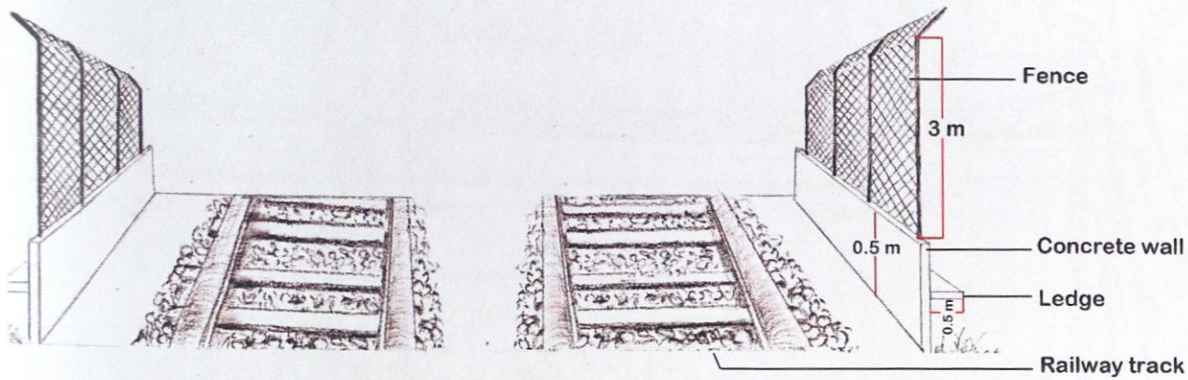
Figure 47: Fencing design for the doubled railway track alignment: The top of the fence should face outwards. A concrete base of 0.5 m height is to be provided above which chain-link fencing (3 m high) should be installed.

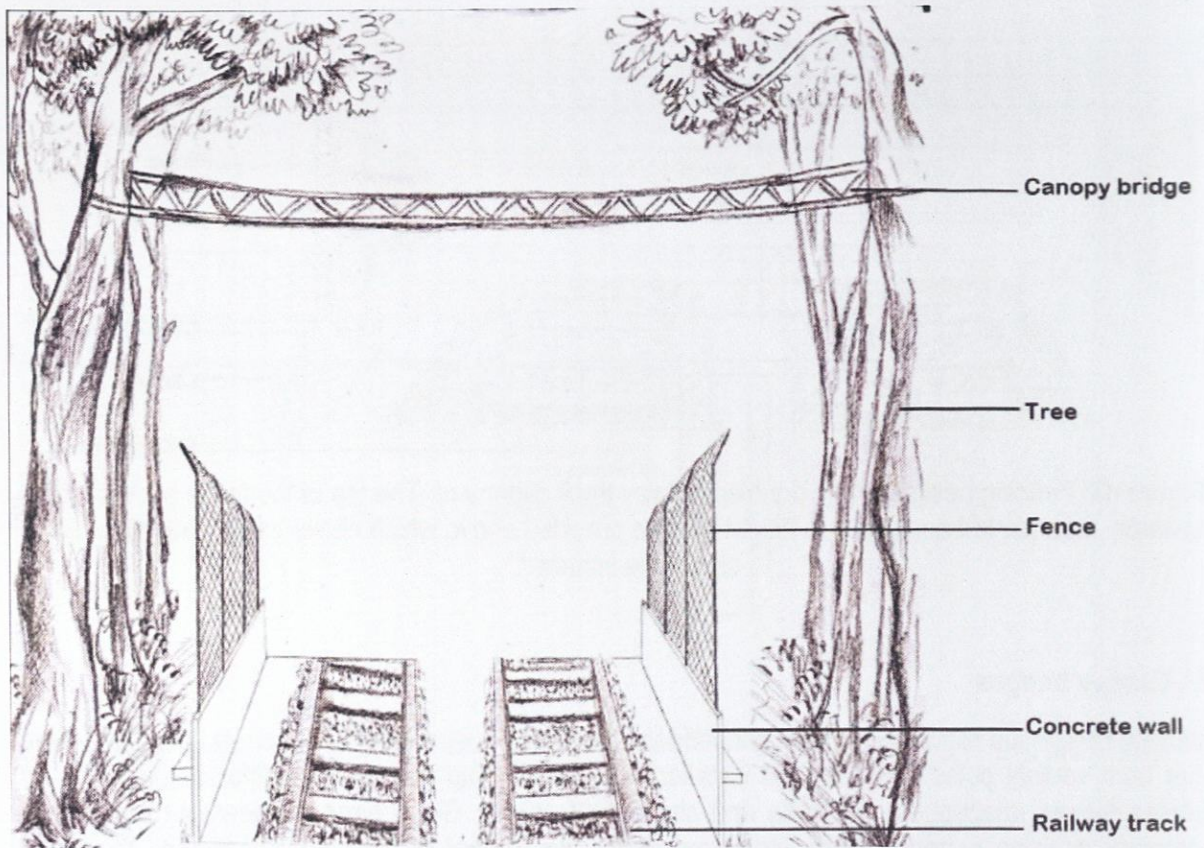
Figure 48: Canopy bridge design to be built across the doubled railway track for arboreal mammals.

To enhance connectivity for arboreal species in the landscape, provision of canopy bridges has been recommended at every kilometer of the railway track.

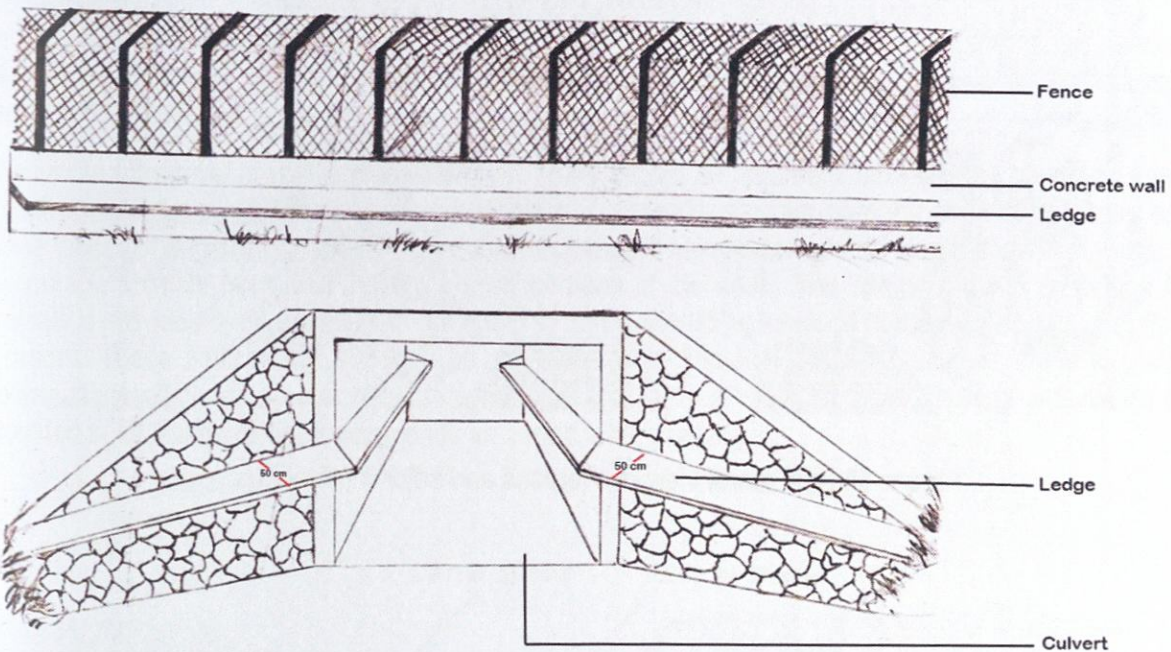
Figure 49: A. Ledges or shelves measuring 50 m wide are to be installed in all crossing and drainage structures. The ends of the shelves should be brought to ground level and fencing along the railway track should continue above all below-grade structures.

Increase in dimensions with ledges for structures 1 and 2 is recommended to make the structures more suitable for use by animals. Ledges are to be provided within all crossing structures.

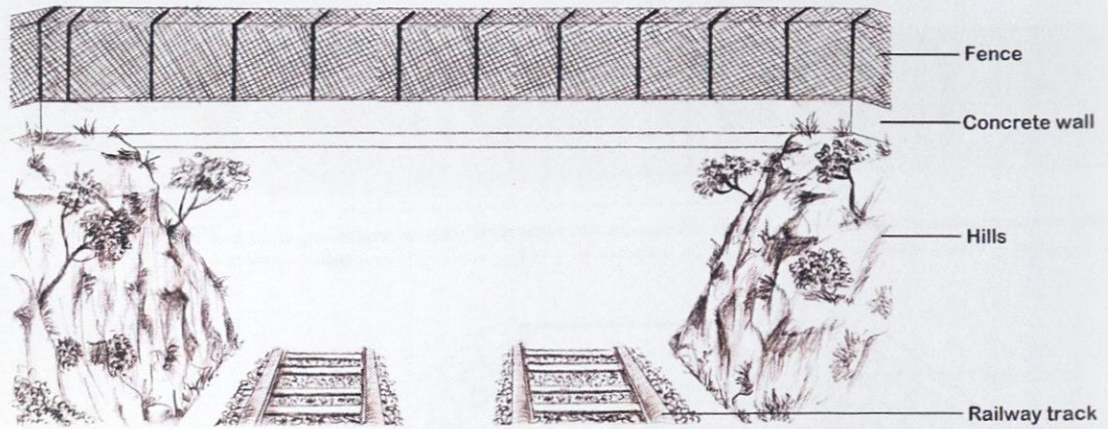
Figure 50 (a): Lateral view of overpass and adjoining features

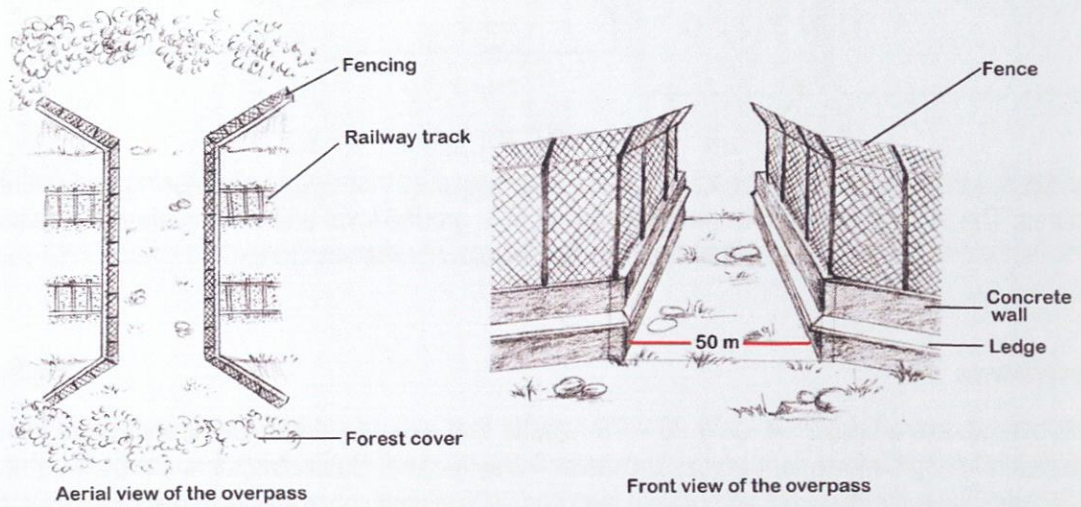
Figure 50 (b): Aerial and frontal view of the overpass.

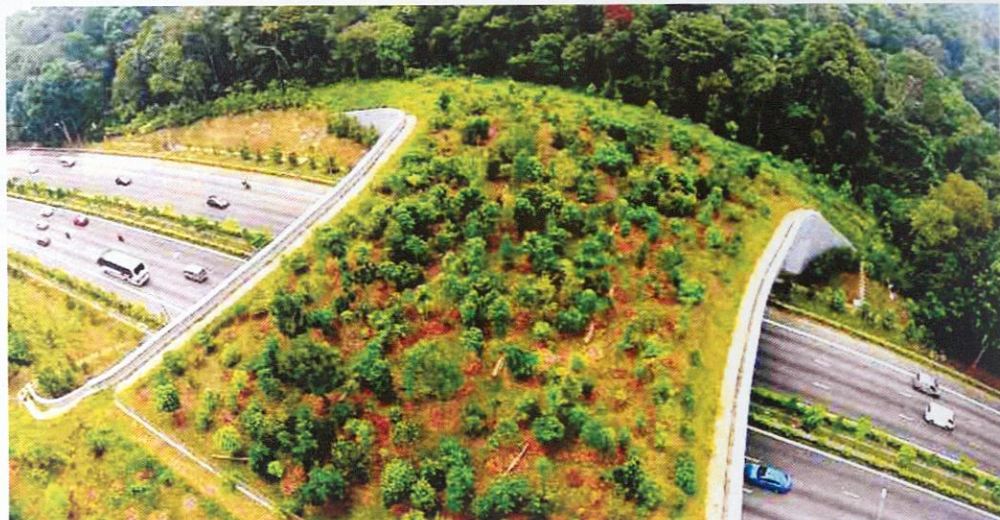
Figure 50 (c): Overpass representations (<https://arc-solutions.org/new-materials/>)

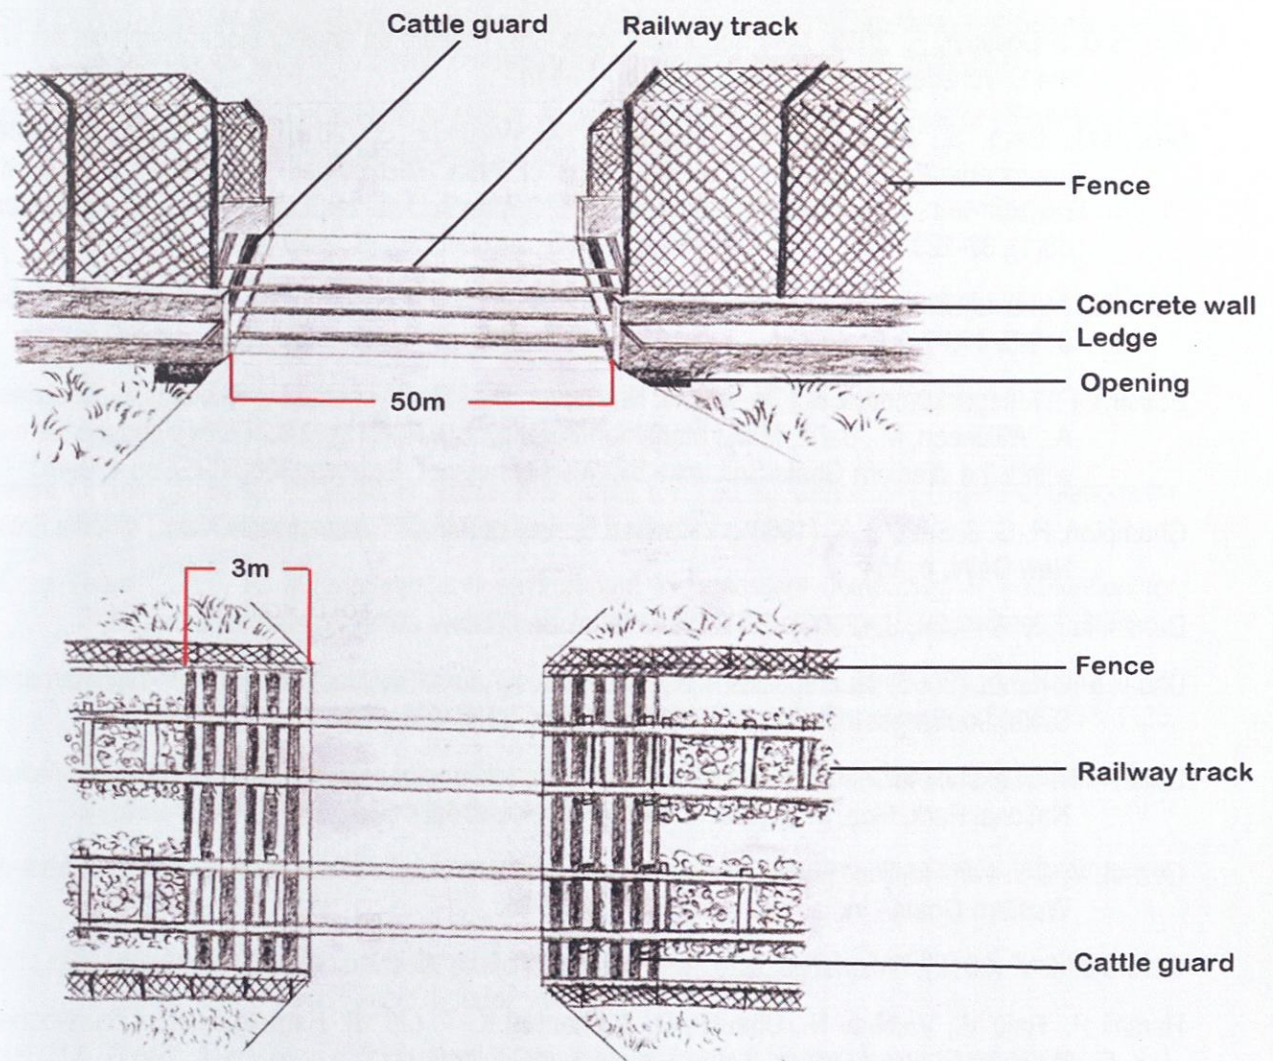
Figure 51: Layout of level crossings for animals.

The level crossing of the Panjim-Balgaum road at 14/650 is proposed to be decommissioned after the construction of the flyover at 14/940. The road across the railway line would also get decommissioned. In such a scenario, it is proposed to maintain the road level crossing of 50 m width as a level crossing for wild animals. Other specifications for the animal level crossing have been provided in the section 'General Recommendations'.
